## SITE INVESTIGATION FACTUAL REPORT

Report No: [REDACTED]  
Client: Sedgwick International UK - Maidstone  
Site: 124 Greencroft Gardens, London  
Client Ref: [REDACTED]  
Date of Visit: 01/09/2020

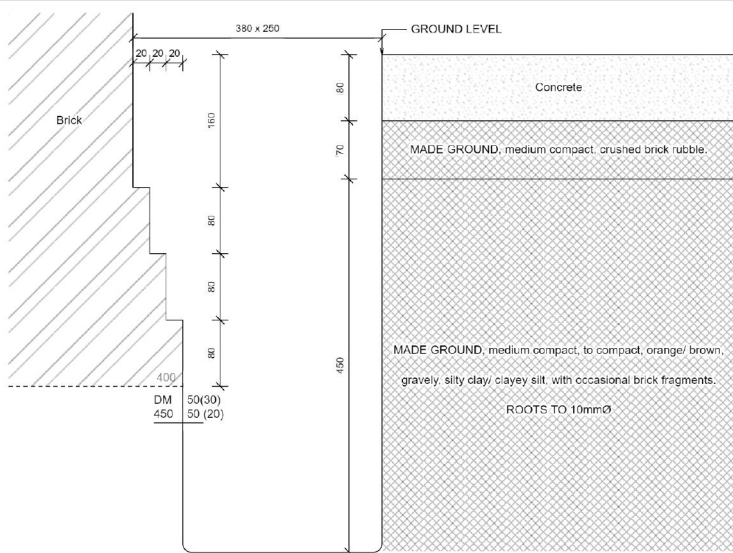
TP 1

For Strata below 600mm see Bore Hole log
