ARBORICULTURAL ASSESSMENT REPORT

For:	Client:	Sedgwick International UK
	Insurer:	Allianz Insurance Plc
Site:	Policyholder:	Foursite Limited
	Risk Address:	128 Greencroft Gardens, London, NW6 3PJ
Refs:	PRI Ref:	
	Client Ref:	
	Insurer Ref:

Arborist Name:	Edward Clear	Date:	04/02/2021
QC:	Thomas Peppiatt	Date:	08/02/2021

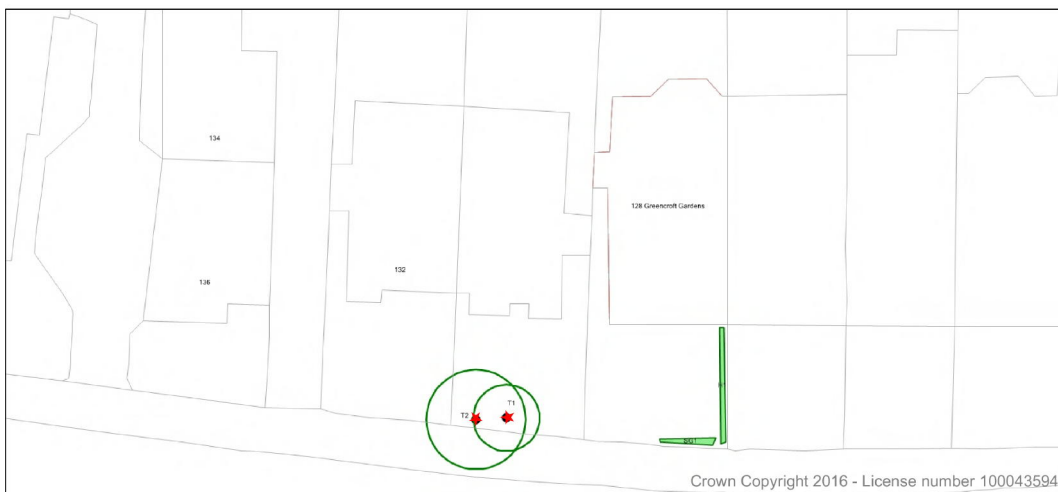
7.0 APPENDIX 2: SITE PLAN

Location:	128 Greencroft Gardens, London, NW6 3PJ
Job Ref:	[REDACTED]
Survey Date:	04/02/2021 - NTS
By Property Risk Inspection - Insurance Services

Tree No:	Species	Works Required
T1	Lime	Fell and treat stump (deciduous)
T2	Lime	Fell and treat stump (deciduous)
