The Heath & Hampstead Society

Planning Ref: 2021/0509/T

Address: 9 Willoughby Road

Date: 3rd March 2021

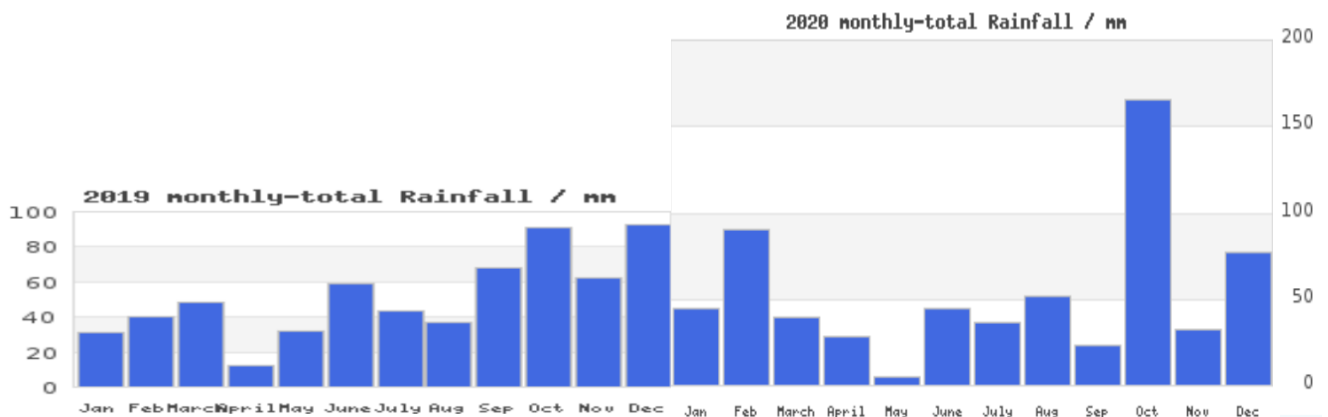
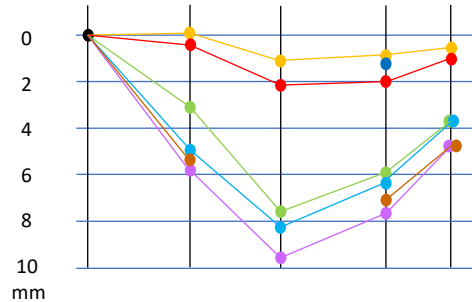
Movement data with regards to rainfall (from nw3weather.co.uk) has been plotted, and is shown below:

In comparing the timing of movement and rainfall it is clear that although the tree, being so close to the house, naturally has a small effect on movement, it is far from the main cause of movement.

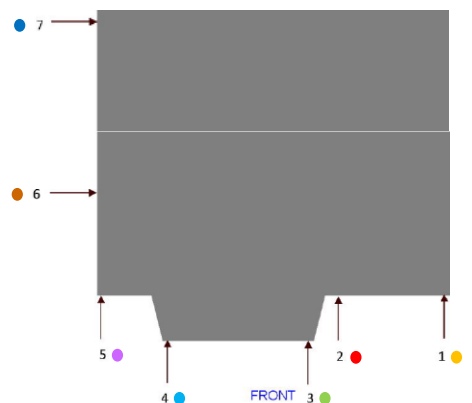
The maximum range of monitored movement occurs at marker 6 nearest to the ash tree, *but this is still shy of 1cm*. No markers were placed on the party wall towards the rear of the building despite the worse cracks being associated with this area. Markers were all placed externally at ground level: a little above the unmarked 'manhole in the road... with an assumed value of 10.000m' that was deemed the reference datum.

Marker 7 is the nearest marker to the party wall yet moves a maximum of 1.2mm. Even projected up to the third floor, any cracking produced by such movement would be little more than 'hair-line'. Since this is less than one might expect from mere clay expansion-contraction, one would presume this was fixed to some extent by its support from number 11 Willoughby Road. In view of the pattern of cracking in the external rear wall (away from its attachment to the party wall) and where the cracks are worst, this indicates the Party Wall itself has dropped at its rear part, but the stresses in the rear wall have fallen further along it. That the cracks internally along the ceiling joint with the party wall are tapered from back to front of this joint, including through the bathroom, until there are no cracks mentioned at this joint in the front bedroom, this would indicate to a geotechnical engineer with relevant experience where the problem lies and help determine why.

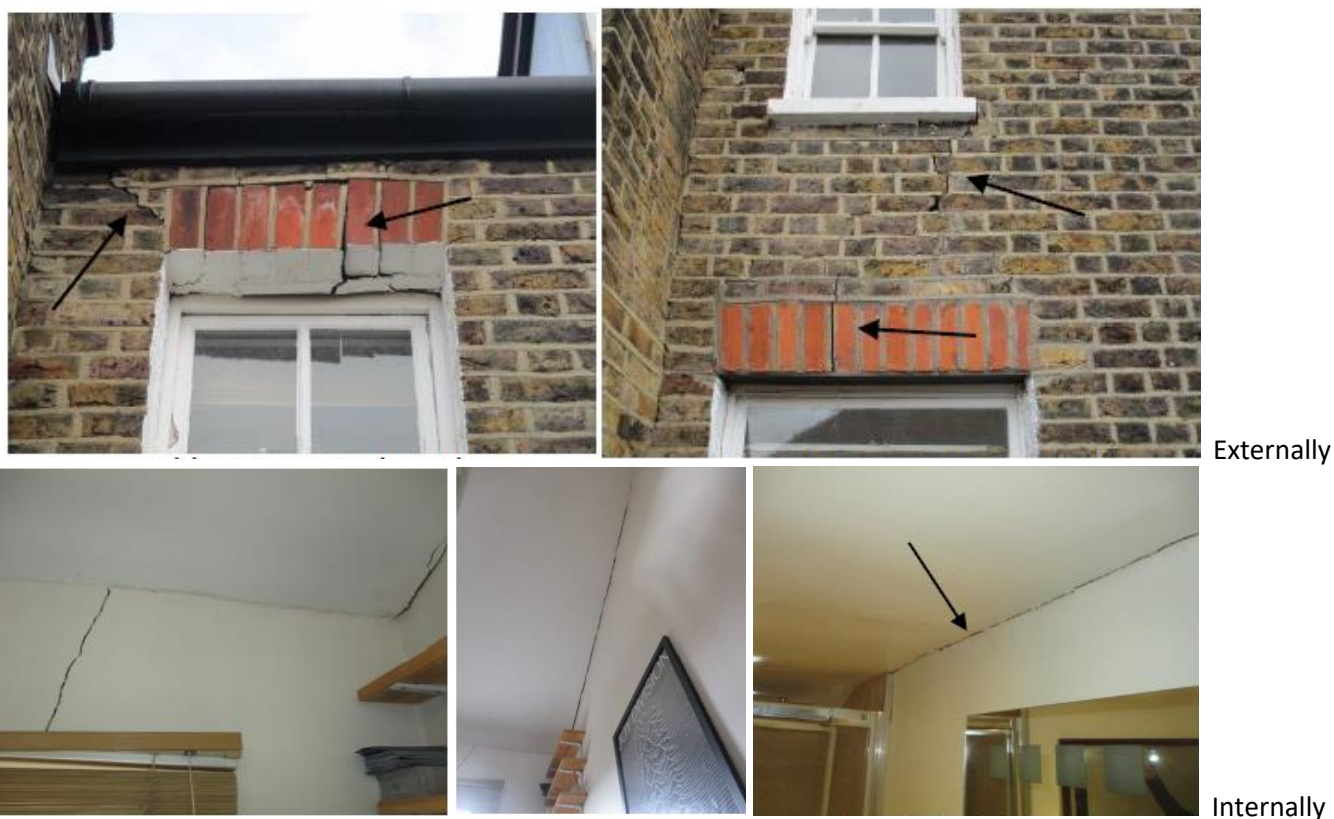
This is a strong indication that something is acting on the rear party wall, but since monitoring shows that tree-related movement is small, this tends to point towards an episode after re-decoration in 2017 but prior to movement monitoring that caused the subsidence of this wall, separate from the influence of the ash tree roots.

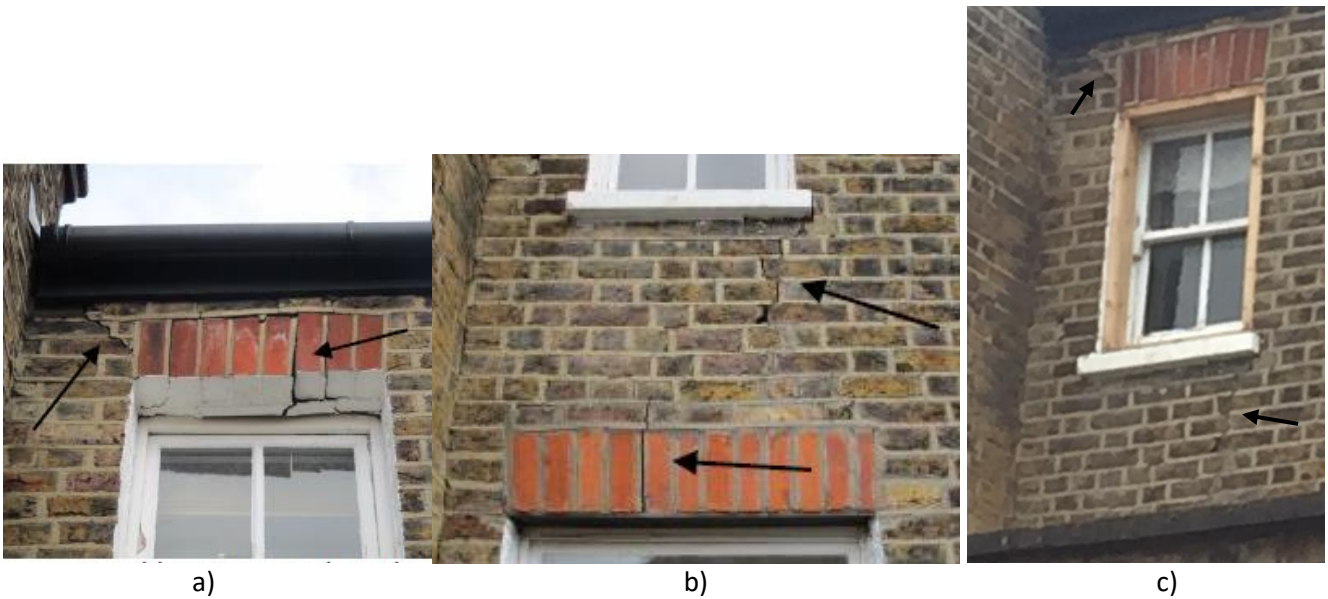
The top window had some serious cracking to its lintel above and there were cracks below the window too going from the right side of the window sill diagonally down and left to the window below. This window had cracks between the 4th and 5th from the left vertical red bricks in the lintel above it.

a) and b) photographs for Tech Report November 2019; c) photograph taken from Rudall Crescent March 2021.

This photograph is at an angle which reduces the view of the stepped nature and width of the cracks and cannot show the window below. However it shows that although there has been temporary support for the window and patching of the severe top lintel cracking, the diagonal crack to the left of the lintel is as before, as is the diagonal crack from the right windowsill to the window below. There has been no recovery which it is essential to demonstrate for vegetation-related subsidence.

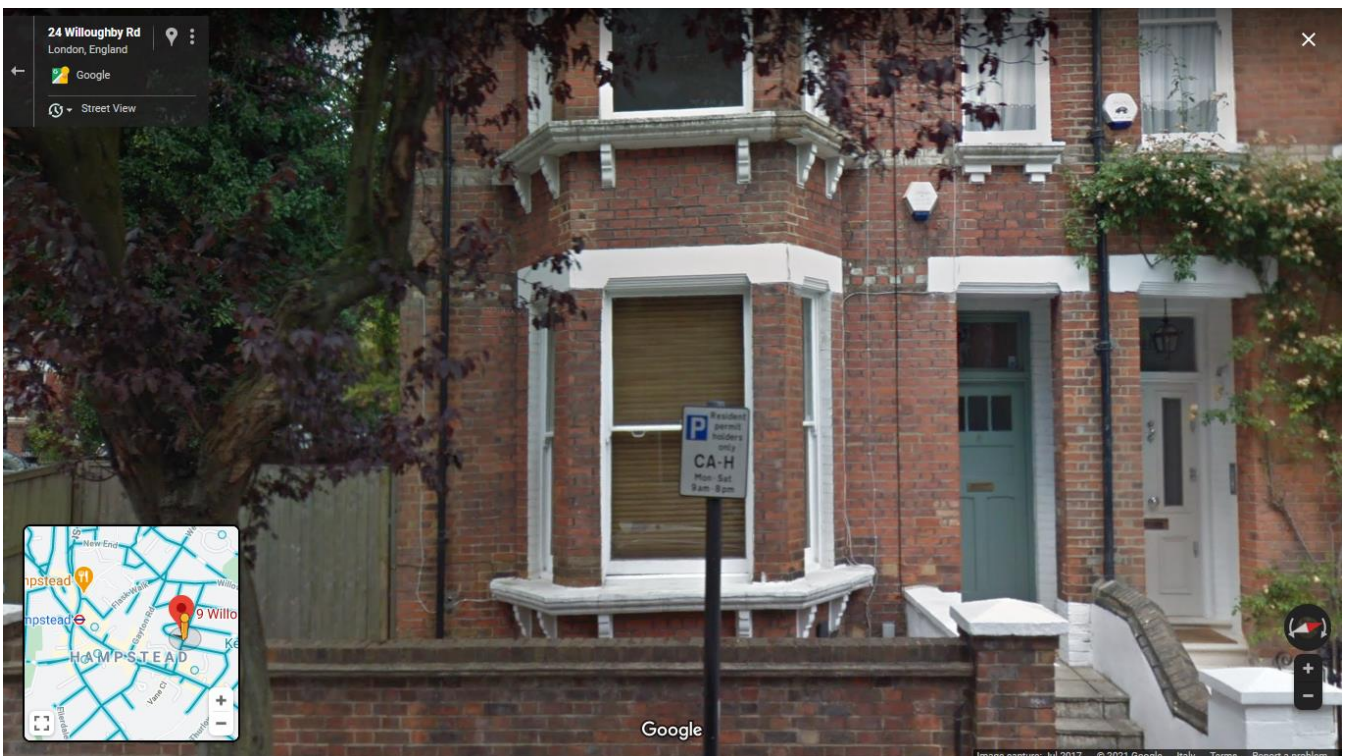
Looking at the house from Willoughby Road with Street View, it is clear that subsidence without recovery has been occurring for many decades, being already present in 2008:

Street View of 9 Willoughby Road in July 2019 (latest available)

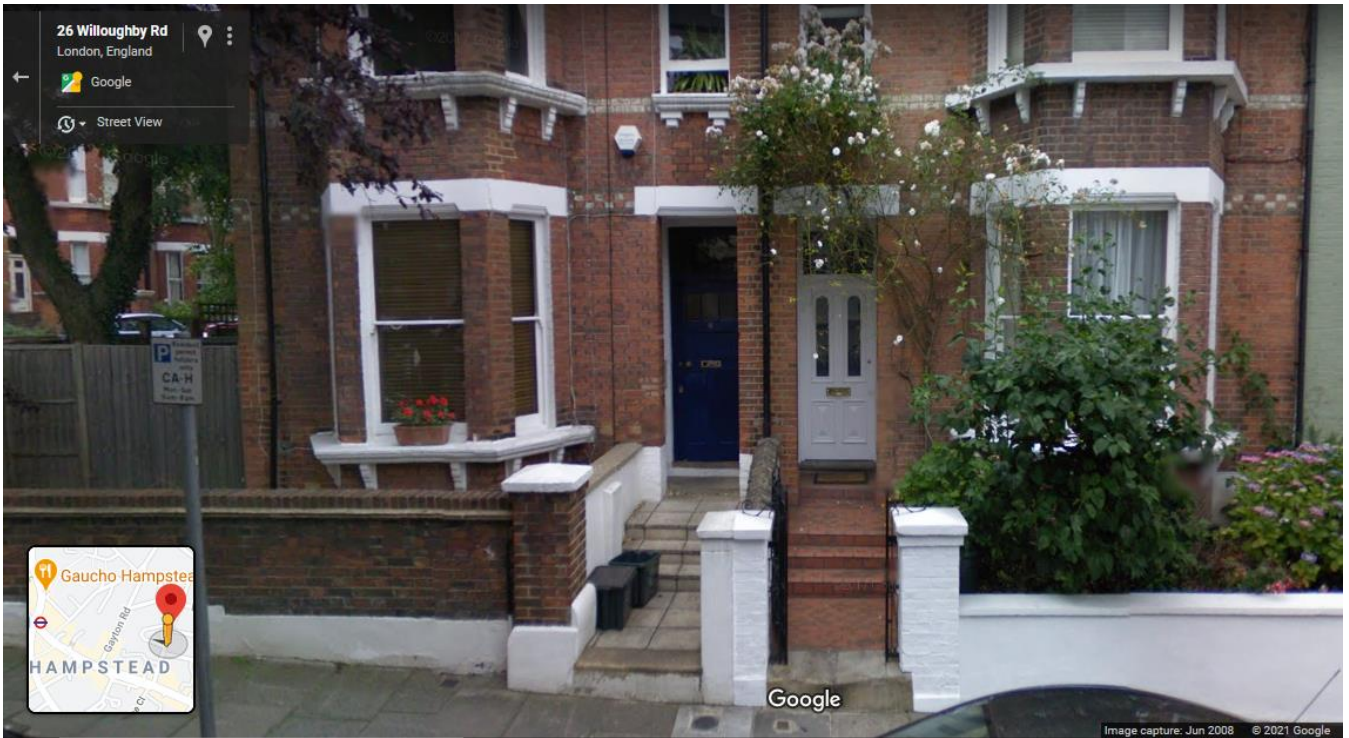
Most comparable Street View of 9 Willoughby Road in June 2008 with the -

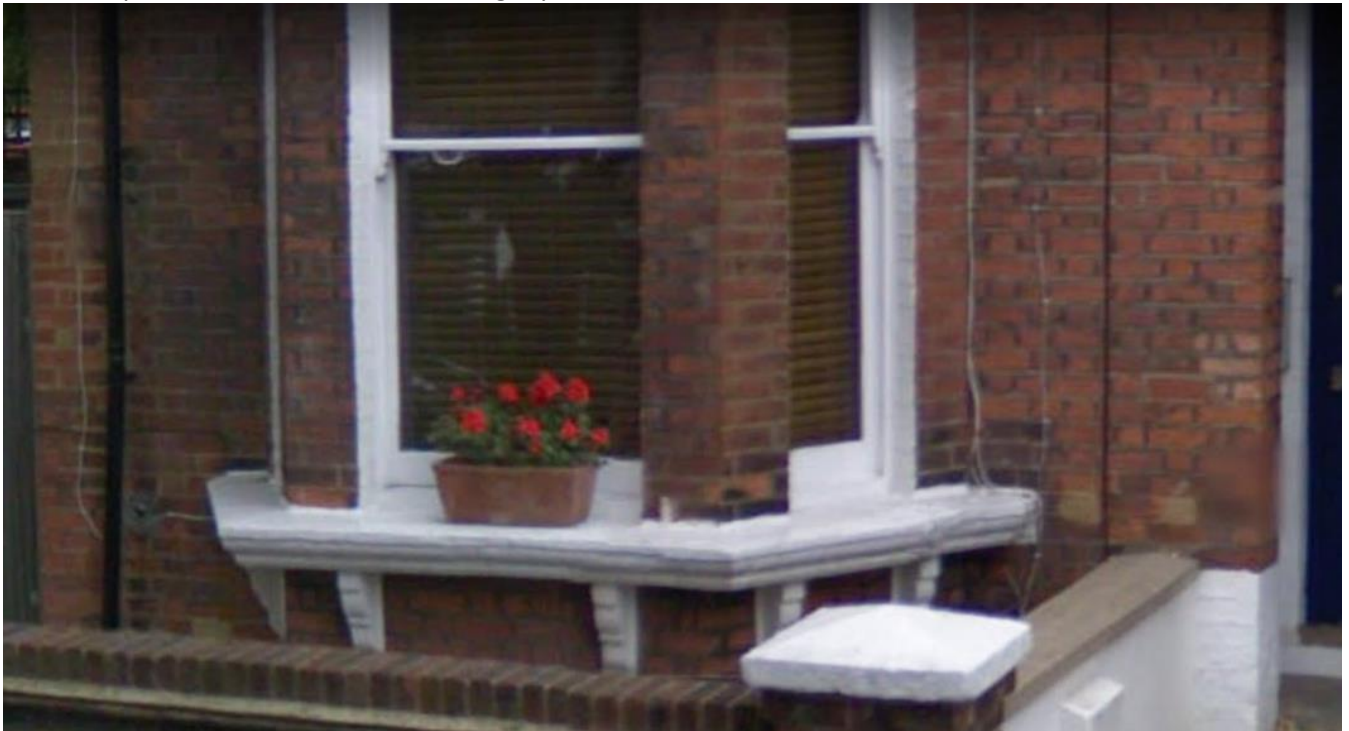
- tell-tale gap under the left side of the sash window when fully closed

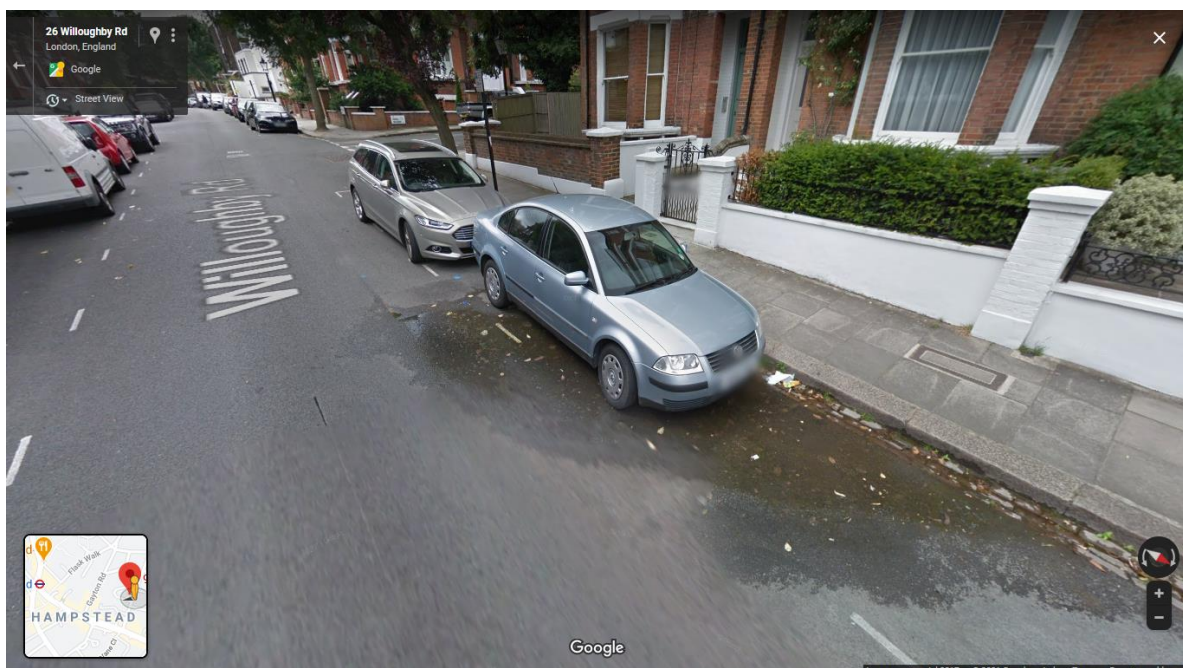
There seems to have been a mains water leak picked up in July 2017 on Street View where water can be seen to be emerging from between seams in the roadway tarmac:
