Re: Trees at 12 Park Village West, London NW1 4AE

Tree Condition Letter: 12 Park Village West, London NW1 4AE
 Instructing party: Tony Cox on behalf of Sir Cameron Mackintosh, 1 Bedford Square, London WC1 3RB
 Prepared by: Adam Hollis of Landmark Trees, Holden House, 4th Floor, 57 Rathbone Place, London W1T 4JU

12 Park Village West, London
C737-P-31012019 Proposed arboricultural works

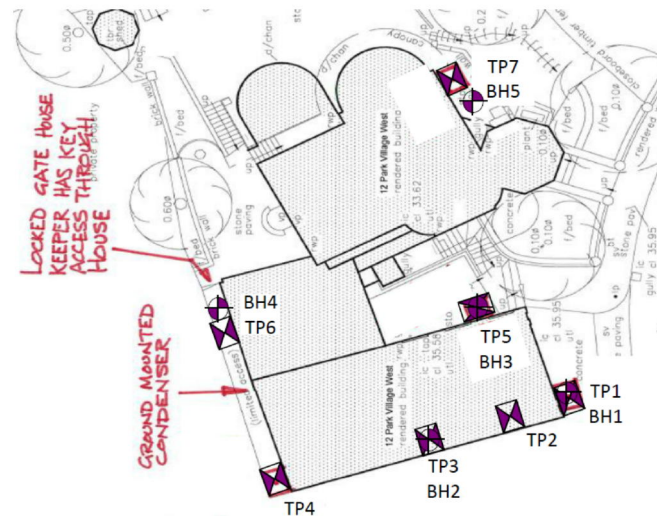
Figure 1: 2015 site investigation locations; the 2020 investigations to inform Camden's planning decision re-opened Trial Pits 1, 2, 3 and 4 as well as re-drilling boreholes 1 and 5. The mature lime tree (T1) near TP6 / BH4 was approved by the council for removal in 2019 and these adjacent pits were not reopened to inform the planning process, as the tree was no longer considered a material constraint on development.

The 2020 Connaughts site investigations (SI) found the soil to have a very high level of plasticity, which is indicative of a greater potential for volumetric change (associated with ground movement) and that the soil in general is borderline desiccated (associated with soil shrinkage) with some samples showing significant desiccation but others no desiccation (i.e. suggesting differential patterns of shrinkage across the site, which may lead to subsidence of low-rise buildings). It will be noted that two of the 2020 site investigations were located external to the garage and two were inside it. The trial pits inside the garage showed limited rooting within the foundation sections. Of the trial pits outside the garage, Trial Pit 1 showed rooting at or below foundation depth, whilst the depth of foundations could not be ascertained in Trial Pit 4 with rooting noted at the maximum excavated depth.

Of those species with roots encountered in trial pits, the birches (T32 & 33) and lime (T1) stand within statistically significant proximity to the coach house / studio, with lime having a high damage to frequency ratio and birch a relatively low one. The seat of damage is at the northern end of the coach house, nearer to lime (T1), and lime roots were discovered in the northern pit TP4. This tree has of course already been implicated in damage to garden structures and consented for felling (see p.1 second paragraph above). The anomaly here is the significant presence of plane roots in 2015's TP6, closest to T1. This pit stands at some (30m+) distance from the only obvious plane tree in the area (T25), with considerable intervening obstacles of level change and built infrastructure. It may be that another London plane in e.g. Pennethorne House was removed prior to 2015.

In conclusion then, tree-related soil shrinkage or subsidence seems the most likely cause of structural damage, in the presence of a desiccated and highly shrinkable clay, with the lime (T1) as the most likely causal agent, given its proximity to the locus of damage, presence of roots in the adjacent trial pit (TP4) and overall high damage-to-frequency ratio. However, there may be other (or even alternative) agents or causes. We recommend the use of level monitoring to help determine a pattern of seasonal movement indicative of vegetative influence and a 'direction of travel' (level distortion) towards individual trees or shrubs. We recommend any outstanding tree works be carried out and further reviewed in the light of level monitoring. Regardless of level monitoring, we recommend the neighbour be approached on the subject of removing their liquidambar and maintaining other vegetation to alleviate future risk to the property. I would also recommend a structural engineer give thought to deepening / future proofing the foundations themselves, and at the very least, a heave risk assessment be carried out in the light of the proposed felling.

There are therefore various indicators that the damage apparent is, at least partly, the result of vegetation-related subsidence. We would recommend that, given the evidential requirements of the London Tree Officers Association's [Risk Limitation Strategy for Tree Root Claims](#), particularly within Conservation Areas protecting trees and their amenity, further investigations be undertaken to confirm or reject this hypothesis. Such investigations should include identification of the roots found within the trial pits (usually facilitated by the site investigations team, as per the 2015 SI report, by way of a specialist laboratory service) and monitoring of site levels at locations determined by a structural engineer. The change of seasons / commencement of spring growth can be a useful moment to determine the influence of vegetation, and level monitoring can be helpful in distinguishing between multiple trees potentially implicated in subsidence (including the anomalous plane tree roots). Additional consideration should be given to the underpinning of the affected structures but ultimately, a decision on how to proceed should be made by a structural engineer and the insurer. Whilst we are mostly considering the occurrence of subsidence from continued tree growth, the structural engineers should also be consulted on the alternative risk of heave following the removal of T1 lime and any other proposed removals (e.g. T22 plum). Tree works recommended previously by ourselves and Harris Bugg Studio but not carried out, should be attended to as a matter of course and at the earliest convenience.

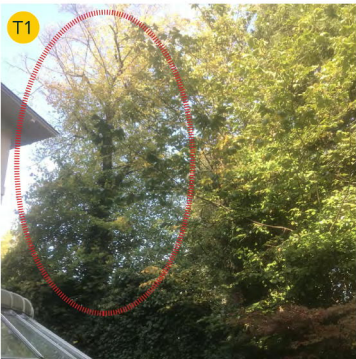
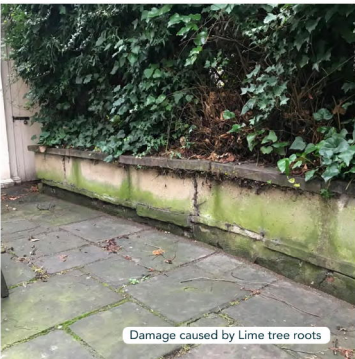
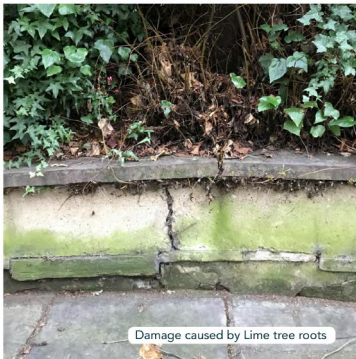
T1: Removal of lime tree on the boundary of the property. Tree roots causing extensive movement to the fabric of the garden and to the ground around the property, undermining stability and structures.

Options have been explored and tested to retain the tree, but a satisfactory, long-term solution that would include the retention of

the tree has not been reached. Design testing has included:

- 1) Extending the entire planting bed into the terrace area. This would hinder access to the house and compromise the currently clear aspect towards the listed building from elsewhere on the property;
- 2) Extending the planting bed in a localised zone immediately around the rootball area. This would appear out of character with

the rest of the hard landscaping within the garden, and would only prolong an issue that has already been identified due to the continued growth of the tree and rootball.

Following exploration of the above potential approaches, a practical and long-term solution would be the removal of T1 and its replacement elsewhere in the garden with a tree more appropriate to the scale of the locality and site conditions. Please see the following page for further information on suggested alternatives.

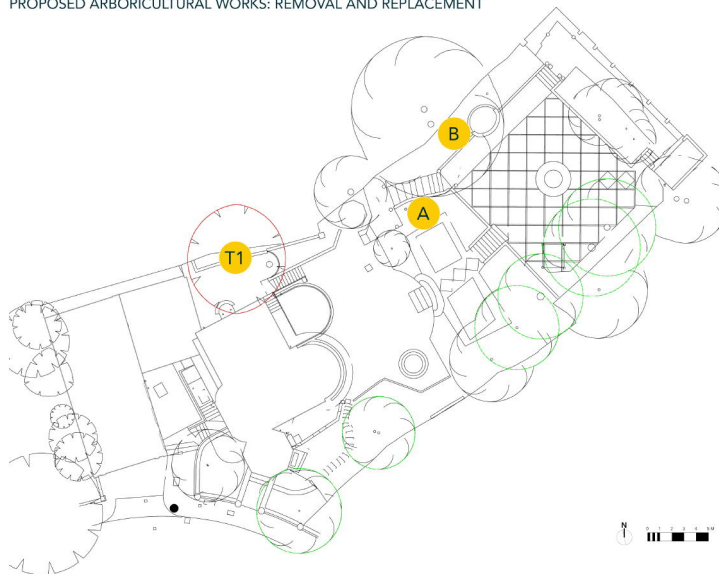
T1: Lime tree for removal

It is proposed that a replacement tree will be planted within the garden to compensate for the removal of T1, with proposed locations shown as 'A' and 'B' on the plan opposite. Note that for a small garden with an already high proportion of medium-to-large trees, replanting like-for-like would not be in the long term interests of the tree due to the pressures of competition for establishment. A smaller species that can tolerate partial shade from the larger, surrounding trees would be more suitable to such conditions and be more likely to establish satisfactorily.
