## METHOD STATEMENT

St George's Cathedral / Christ Church

Netting Removal and Tower and Cornice Repairs

Rev 00 · March 2021

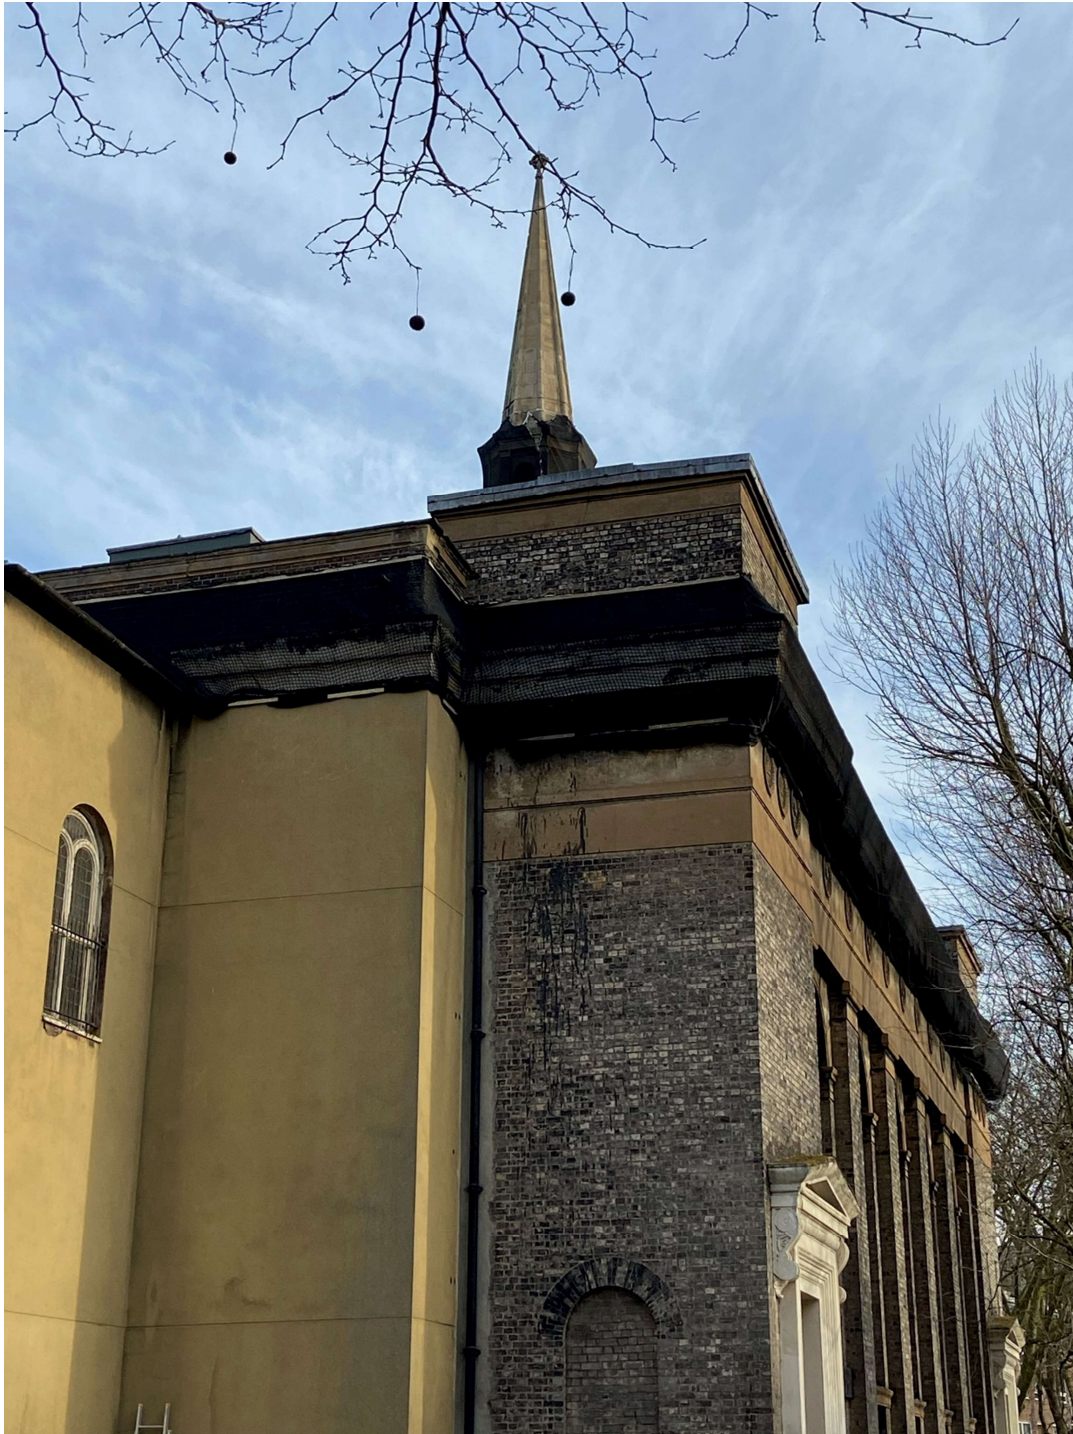
*Img. 1; Netting installed to the cornice*

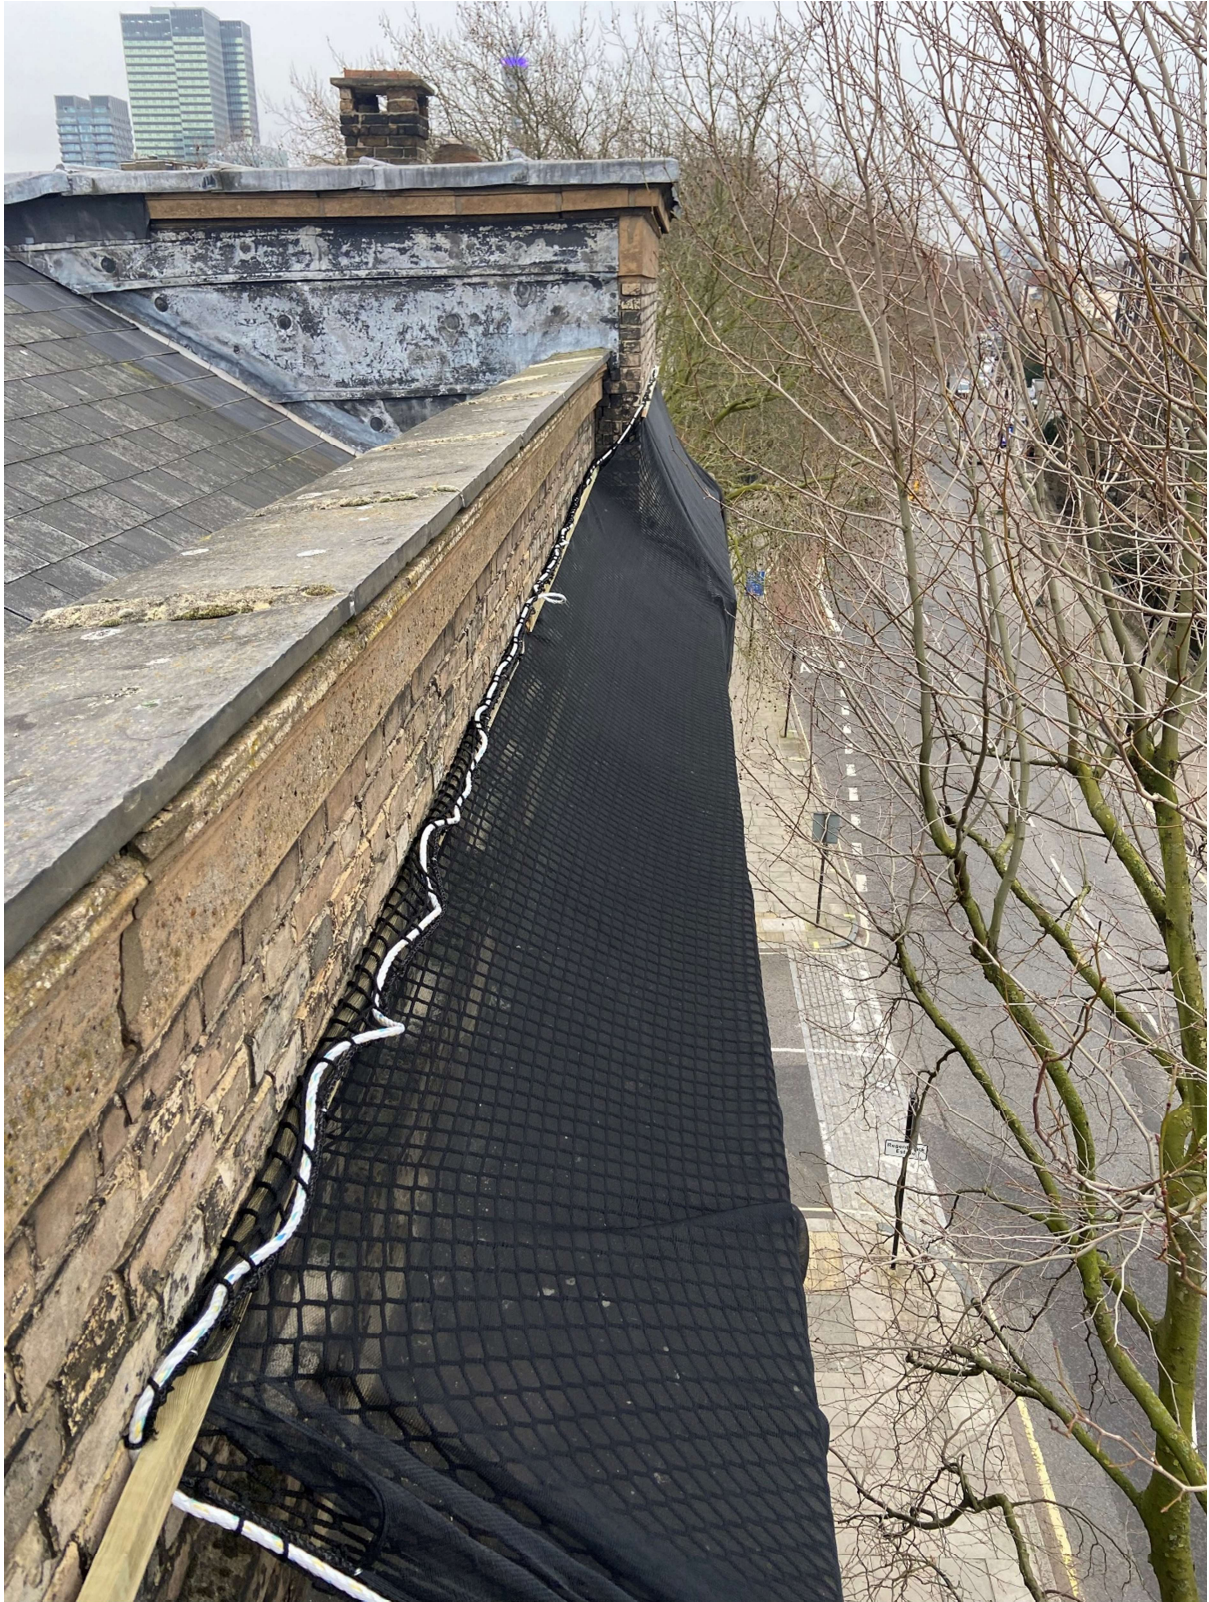
*Img. 2; Close-up view of black netting installed to sky-facing edge of cornice*

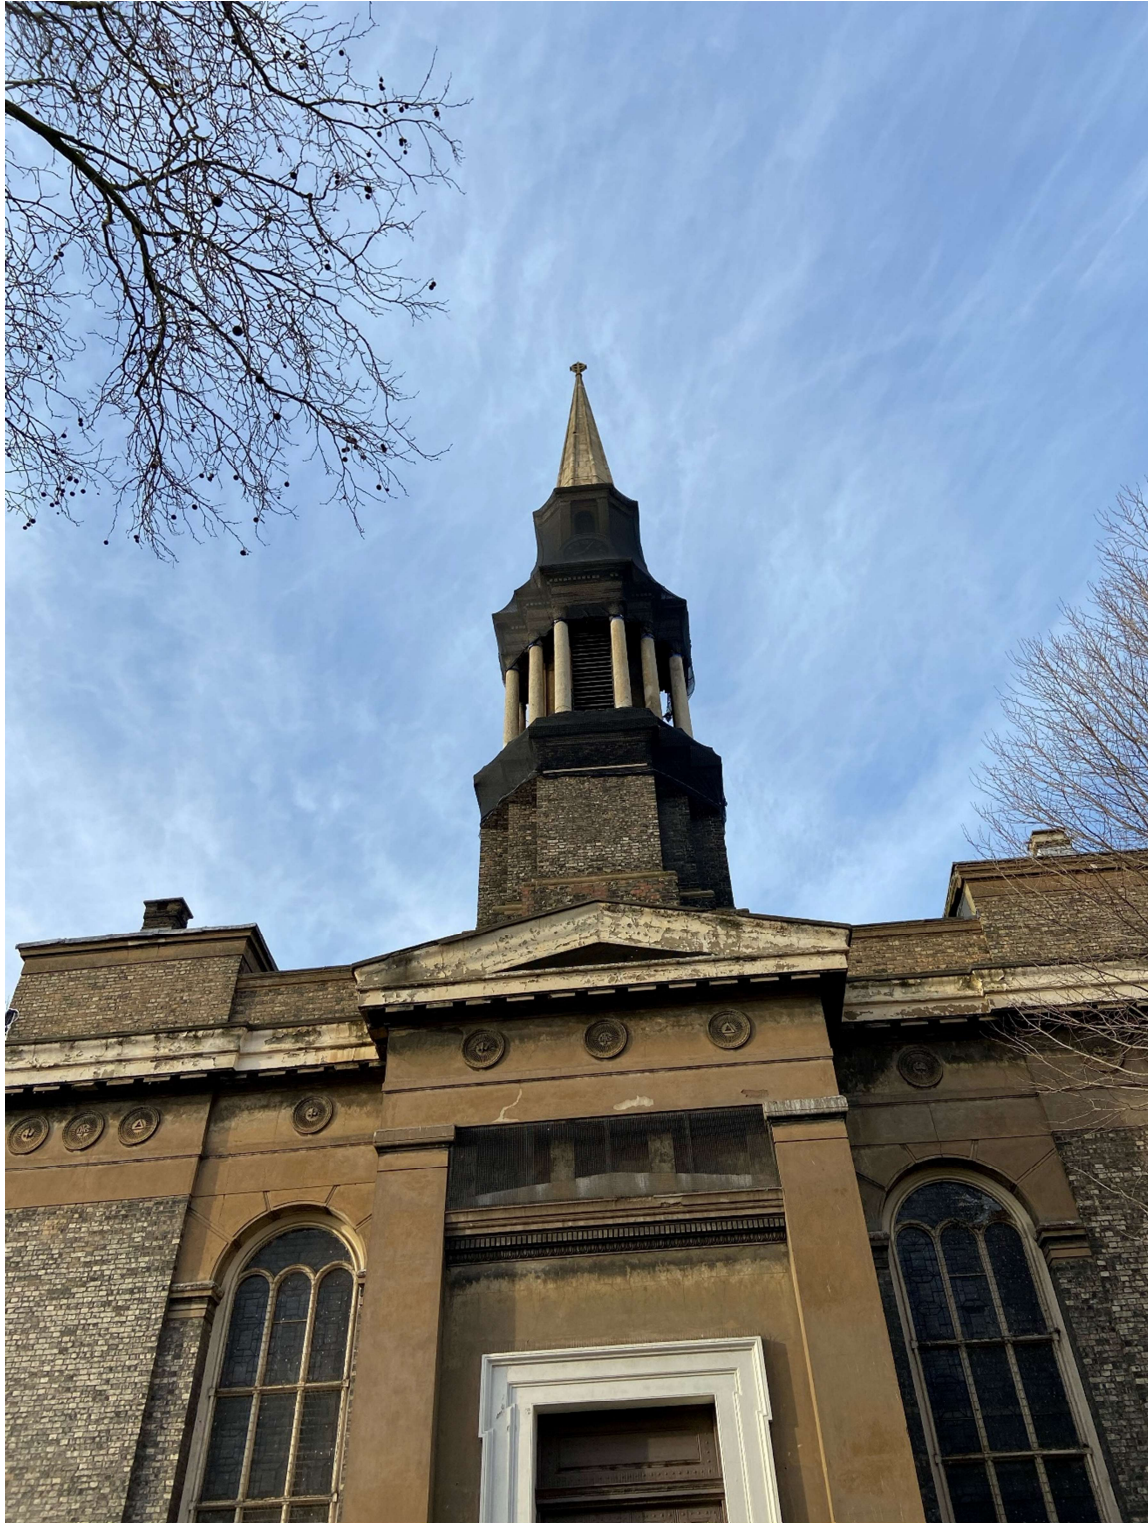
*Img. 3; Black netting installed to tower*
