TECHNICAL REPORT ON A SUBSIDENCE CLAIM

[REDACTED]
**Fairhazel Co-Operative Limited
Flat 1
26 Canfield Gardens
London
NW6 3LA**

[REDACTED]
DATE 15 December 2018

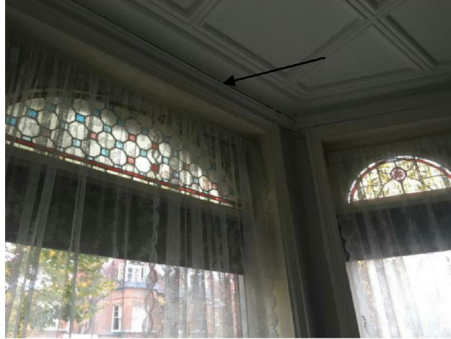
Front lounge – cornice crack

Horizontal crack along front cornices to bay 1 to 6mm

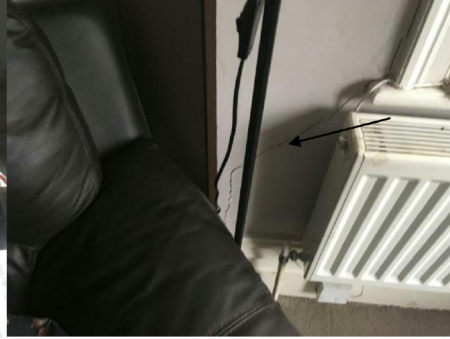
Front lounge – diagonal crack to right side bay

Diagonal crack to left of bay and right 1 to 4mm

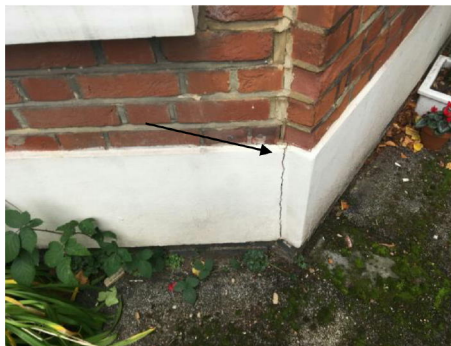
Vertical crack to left side junction of bay

Vertical crack to left junction of bay and left brick mullions to rendering with stepped crack below central window

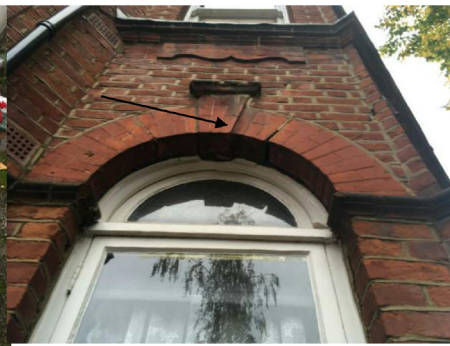
Crack to brick arch

Separation to right side reveal of left side window and gap of 18mm to brick arch above

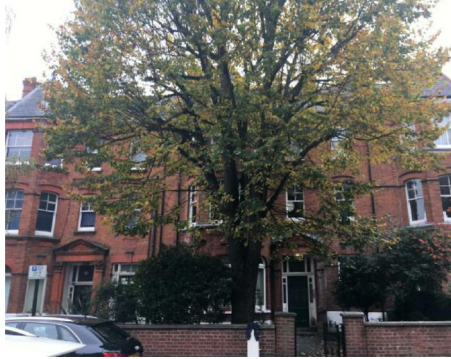
Tree T1

T1 Lime 17 m 9 m Owner

The timing of the event, the presence of shrinkable clay beneath the foundations and the proximity of vegetation where there is damage indicates the shrinkage to be root induced. This is a commonly encountered problem and probably accounts for around 70% of subsidence claims notified to insurers.

The cause of the movement needs to be dealt with first. We have completed a soil risk analysis (VISCAT Assessment) and we are satisfied that your tree T1 (please see drawing) can be removed.

We will obtain a quotation for the recommended tree works and undertake statutory checks for Preservation Orders or whether the tree(s) are in a Conservation Area.

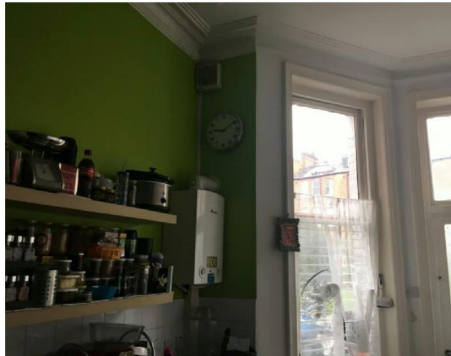
Front kitchen – no visible structural damage

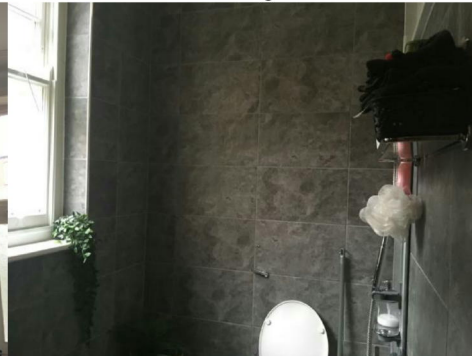
Rear bathroom – no visible structural damage
