Site Investigation Report

Job Information	
Client	Sedgwick
Client ref	
Visit date	10/07/2019
Report date	10/07/2019

Auger were commissioned by Sedgwick to undertake a site investigation and CCTV inspection of the underground drainage within the area of concern at the property.

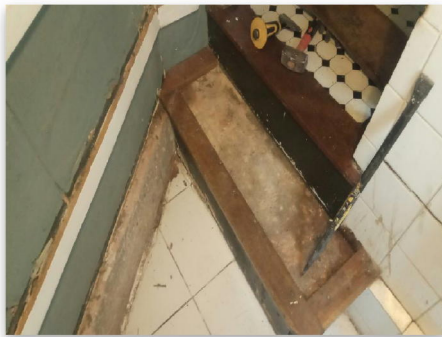
Fig 1.4: Internal cracking

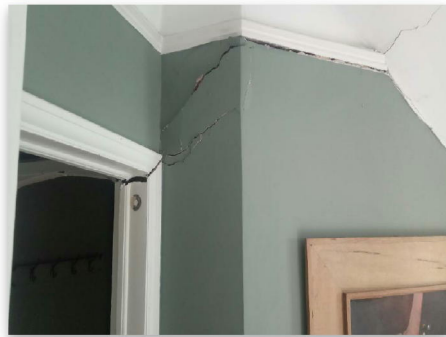
Fig 1.5: Internal cracking

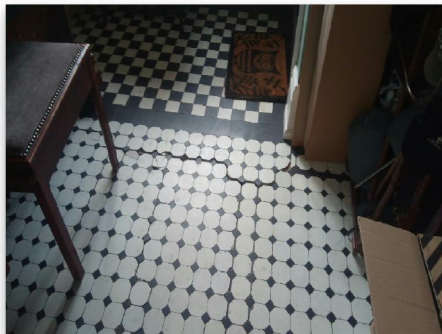
Fig 1.6: Internal cracking

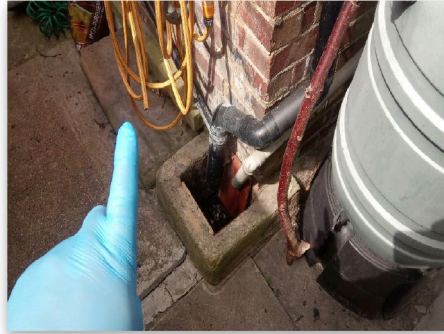
Fig 7.2: FWG1

A visual inspection of the site revealed that FWG1 (which was noted to serve foul waste) has broken / cracked.

Our CCTV survey revealed joint displacements which could be allowing an escape of water.

Recommendations	
Repairs to be Completed	<p>It is recommended that the following repairs are carried out to prevent an escape of water from the system:</p> <p>On line 1, excavate and replace FWG1 and 1m of 100 mm pipework at a depth no greater than 1m through concrete. The above ground drainage will need to be extended 75mm below the gully grate.</p> <p>On line 5, install 3m of 100 mm flexi-liner directly upstream of MH2.</p>
Repair Caveats	<p><i>Once repairs have been undertaken the customer should ensure the drainage system is periodically inspected in the future for any deterioration and kept free flowing / free of blockages. Any damage noted during future inspections should be repaired immediately in accordance with current Building Regulations.</i></p> <p><i>With any repair process, complications and unforeseen circumstances can arise. These scenarios will be reported whilst on-site and could potentially cause an increase in repair costs and inconvenience.</i></p> <p><i>Where any excavation reinstatement of the surface is required, the reinstatement will always attempt to match the previous surface patterns and colouring, however we cannot guarantee an exact match.</i></p> <p><i>If any of the above lining recommendations fail then excavation and replacement of the pipework would be required. This would severely increase the cost of repairs and would provide greater inconvenience to the residents.</i></p> <p><i>The above recommendations allow for the replacement of gullies & connected underground drainage only. The insured should be made aware that the aesthetic appearance of this gully may be different from what is currently in place. We will alter the above ground drainage to extend 75mm below the gully grate. ·</i></p> <p><i>The insured should be informed that the proposed installation to renew the gully will not be a like for like replacement as the current gully has a raise surround/shield preventing splashing of the downpipe onto the surrounding area. The raised gully surround will be removed and a new plastic gully installed. A costing has been included in the quotation to rebuild the surround however the aesthetic appearance of this may be completely different from what is currently in place. ·</i></p> <p><i>Auger have not allowed or will not be held responsible for any alteration or modification to the above ground drainage following the removal of the existing gully and reinstatement of a new gully. The customer must ensure that the above ground drainage correctly expels into the gully pot and avoids overcrowding the gully with numerous downpipes which could lead to the gully overflowing.</i></p> <p><i>All above recommendations are in assumption that there is clear access to excavate without any issues arising such as gas or electric mains in the area of the recommended repairs. If during the excavation of these lines, issues such as gas or electric mains do arise, extra costs will be incurred if a third party is required to attend or alterations to the recommendations are required. ·</i></p> <p><i>Where any excavation reinstatement of the surface is required, the reinstatement will always attempt to match the previous surface patterns and colouring, however we cannot guarantee an exact match.</i></p>
