SJ Stephens Associates

11th December 2019

Re: Walnut Tree at 10 Brookwood Park

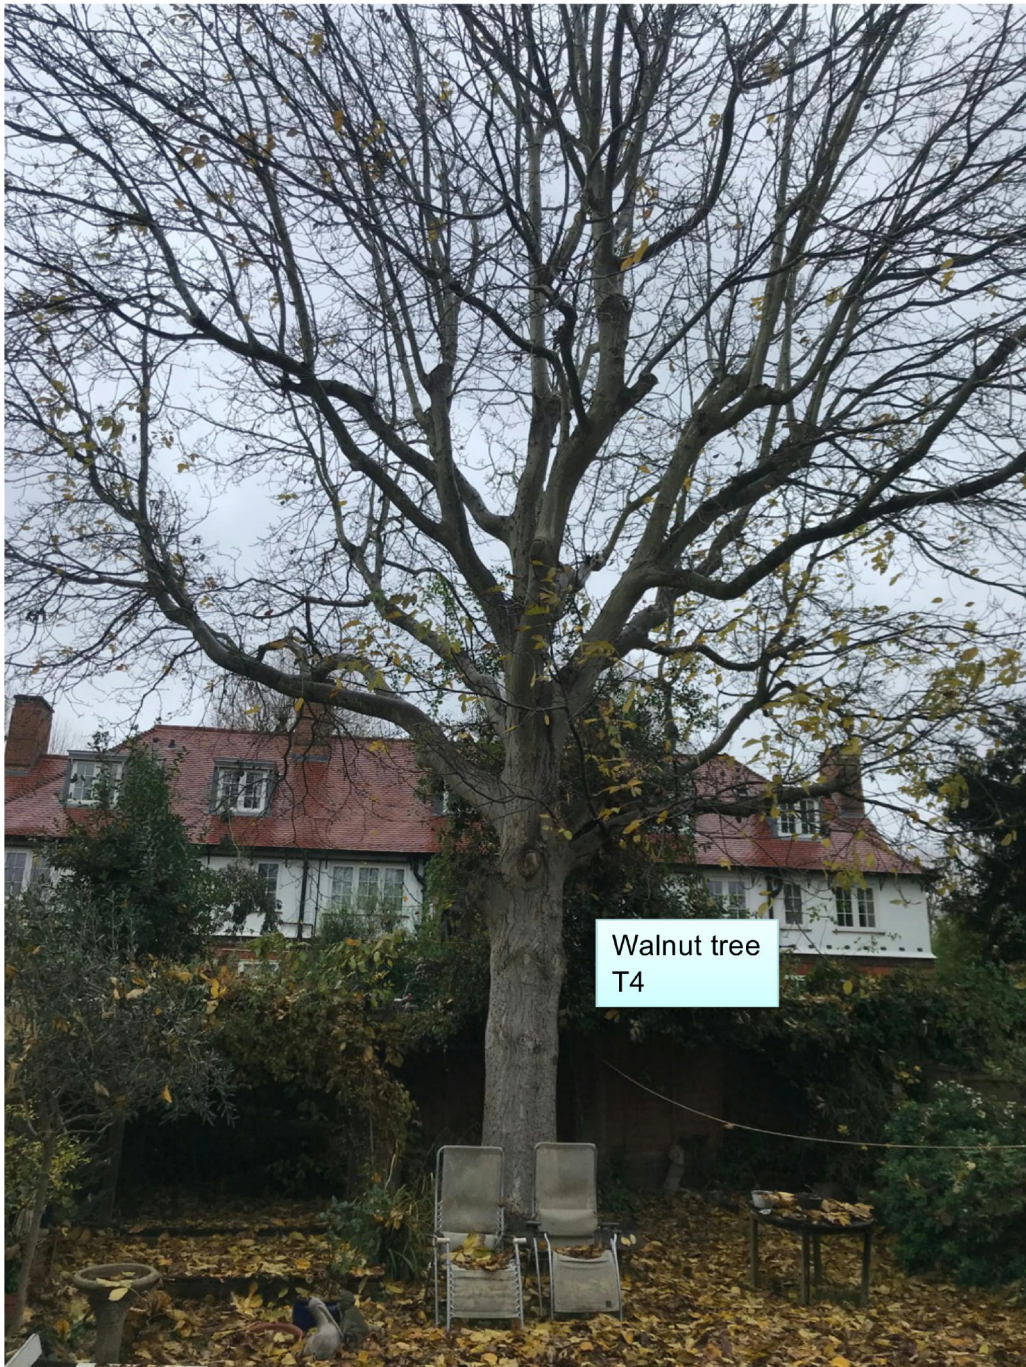
The walnut tree, shown as T4 in the Arboricultural Assessment Report and in the photo attached, is 16.5m in height, with a stem diameter of 720mm and crown spread of approximately 15m. It is 9.6m from the single story rear extension and 11.8m from older two storey part of the house. It is a fine tree, with high amenity value and a life expectancy of greater than 40 years, which I understand is protected by a Tree Preservation Order.

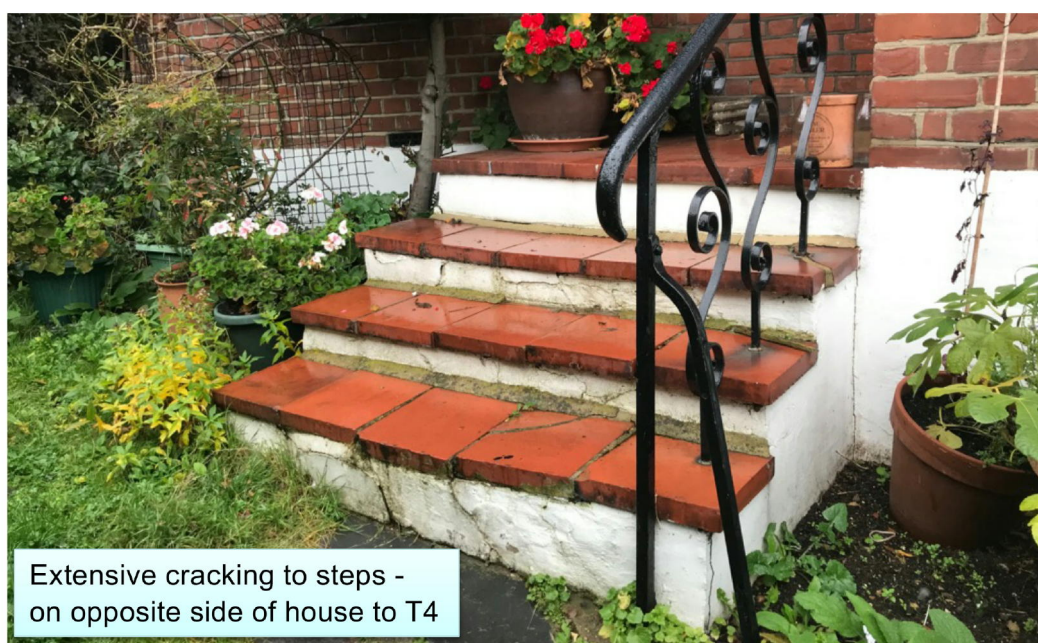
No structural damage has been reported to the single story rear extension. However, the majority of the front hall has visibly sunk by approximately 75mm and the adjacent stairway is showing extensive cracking to internal walls. In addition, there have been repeated problems with movement and cracking to the front steps.

Extensive cracking to steps - on opposite side of house to T4
