## Drainage Investigation Report

For Subsidence Management Services

**Risk Address:** 34 Laurier Road, London, NW5 1SJ

**Visit Date:** 29th October 2020

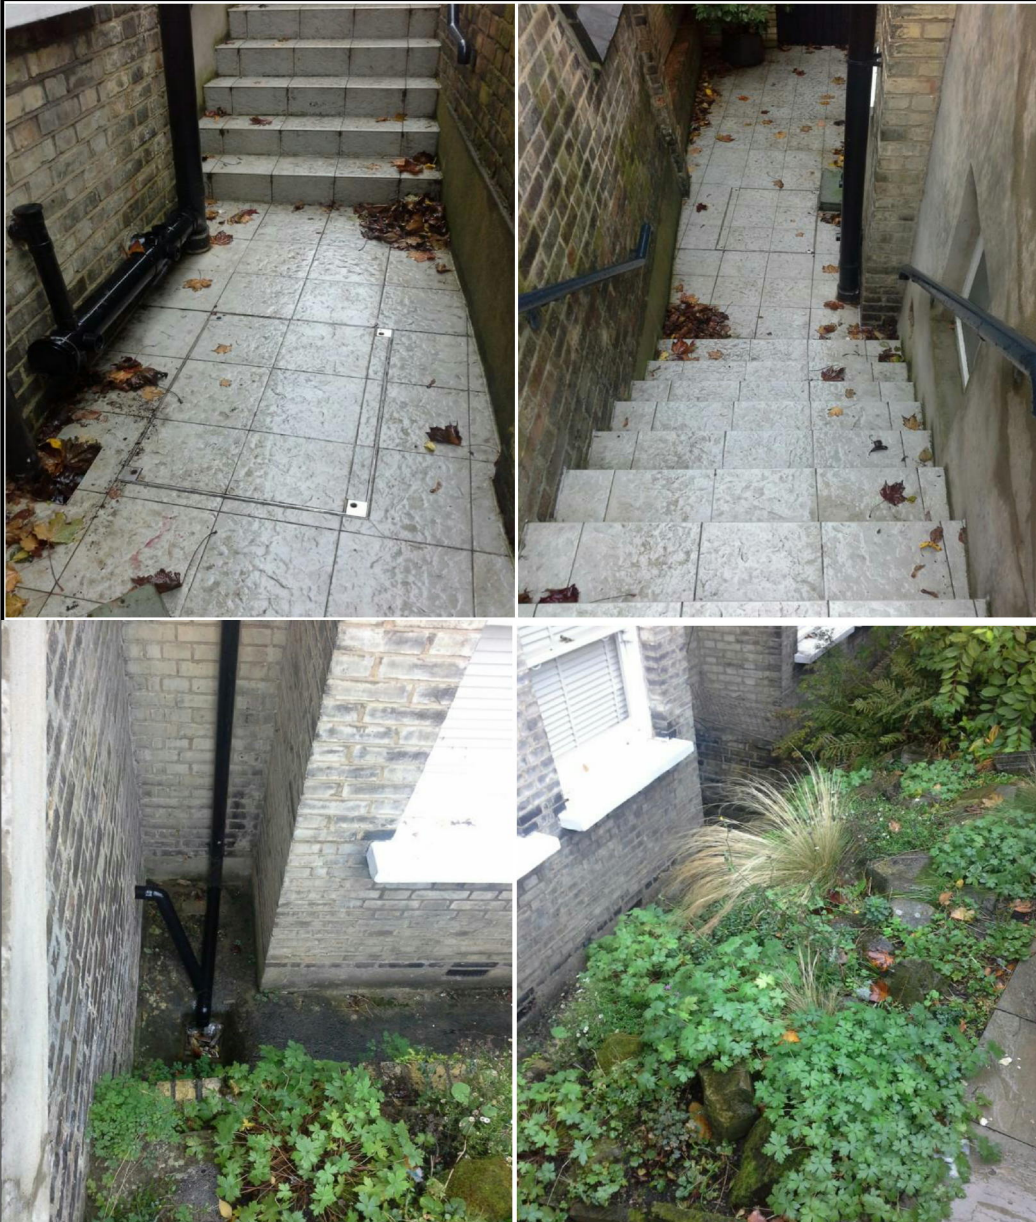
On arrival we found there is a manhole which we were unable to lift as it has screw thread fittings to raise it.

We also noted there is a gully in a basement area. To get to this requires access down steeply sloping ground. Due to the wet weather conditions at the time of our visit we were unable to access this area.

A revisit will need to be arranged with the correct lifting equipment to raise the manhole. We would also recommend an additional engineer is on site to assist with getting the equipment safely to the works area.
