# Drainage Investigation Report

For Subsidence Management Services

**Risk Address:** 34 Laurier Road, London, NW5 1SJ

**Visit Date:** 29th October 2020

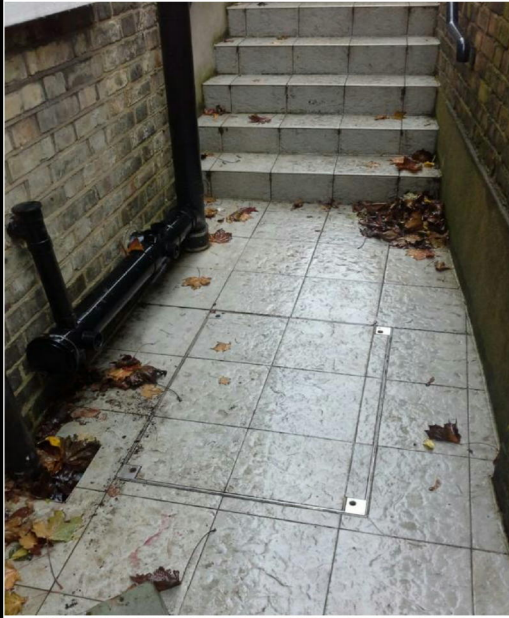
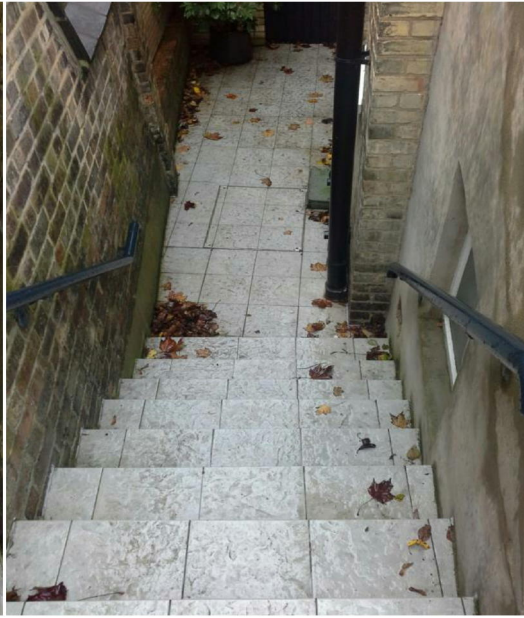
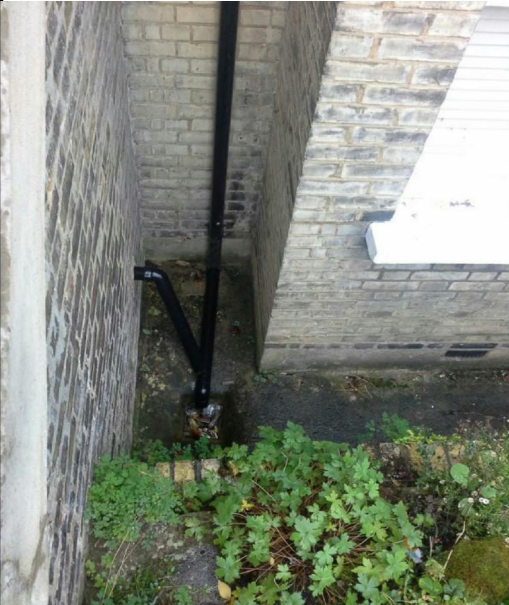
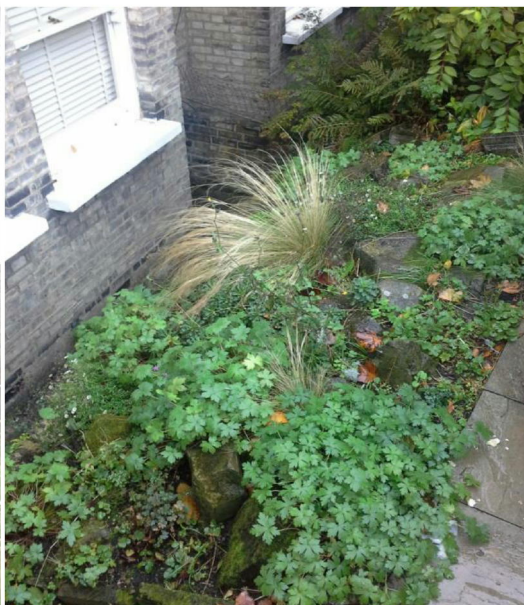
On arrival we found there is a manhole which we were unable to lift as it has screw thread fittings to raise it.

We also noted there is a gully in a basement area. To get to this requires access down steeply sloping ground. Due to the wet weather conditions at the time of our visit we were unable to access this area.

A revisit will need to be arranged with the correct lifting equipment to raise the manhole. We would also recommend an additional engineer is on site to assist with getting the equipment safely to the works area.
