## Arboricultural Consultancy for Esure

| Insured | | Address | 34 Laurier Road, London, NW5 1SJ | | |
| Report Date | 03/12/2020 | | | | |

Damage relates to the front entrance steps of the insured dwelling. Please refer to the engineers report for a full description of the claim history and damage.

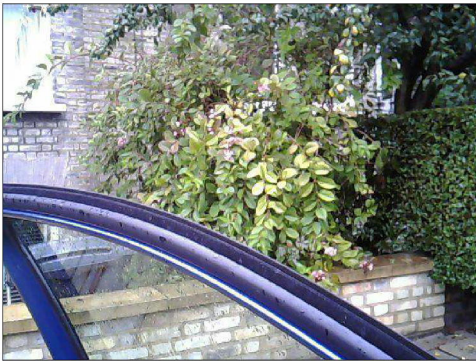
S1 - Weigela

| Tree No. | Species | Age Cat | Approx. Height (m) | Distance to Building (m) * | Ownership | Action | Requirement |
|---|---|---|---|---|---|---|---|
| S1 | Weigela | 1 | 2.5 | 3.5 | C - Insured | Action to avoid future risk | Do not allow to exceed current dimensions by way of regular pruning. |

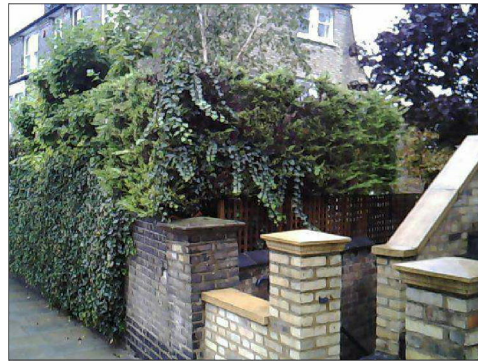
H1 - Cypress

Samples of these roots were recovered from underside of foundations and throughout the borehole, these roots were identified (using anatomical analysis) as having emanated from the genus' Cupressaceae spp. (includes: Cypress), a sample too juvenile for positive identification (also absent of starch) and Prunus spp. (includes amongst others: Plum).

Our survey of the site identified H1 (Cypress) and T5 (Plum), given their position relative to the damage it is in our opinion that the roots identified within TP/BH1 will emanate from this vegetation.

Based on our site investigations, and taking account of vegetation location, relative to the focal area of movement/damage, it is our opinion that H1 and T5 are considered the dominant features, and accordingly we have identified them as the principal cause of the subsidence damage.

| Tree No. | Species | Age Cat | Approx. Height (m) | Distance to Building (m) * | Ownership | Action | Requirement |
|---|---|---|---|---|---|---|---|
| H1 | Cypress | 1 | 2.9 | 1.8 | A - Third Party | Remove | Remove close to ground level. |

Consequently, removal of H1 and T5 will offer the most certain and reliable Arboricultural solution likely to restore long-term stability.

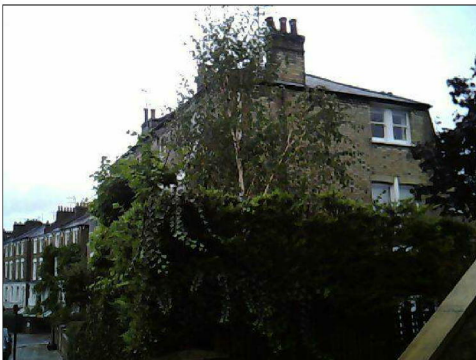
T4 - Birch

| Tree No. | Species | Age Cat | Approx. Height (m) | Distance to Building (m) * | Ownership | Action | Requirement |
|---|---|---|---|---|---|---|---|
| T4 | Birch | 1 | 6 | 4.5 | A - Third Party | Action to avoid future risk | Do not allow to exceed current dimensions by way of regular pruning. |

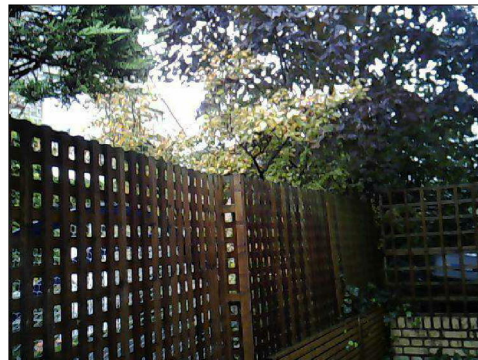
T3 - Snowy Mespil

| Tree No. | Species | Age Cat | Approx. Height (m) | Distance to Building (m) * | Ownership | Action | Requirement |
|---|---|---|---|---|---|---|---|
| T3 | Snowy Mespilus | 1 | 2.8 | 2.5 | A - Third Party | No action | Do not allow to exceed current dimensions by way of regular pruning. |

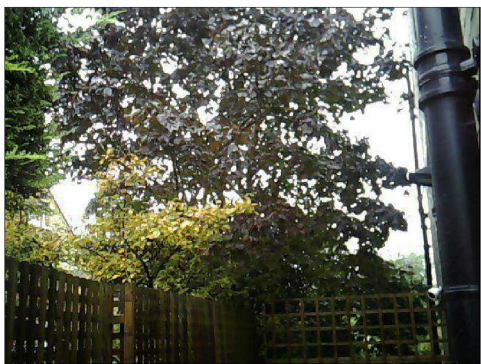
T2 - Acer

| Tree No. | Species | Age Cat | Approx. Height (m) | Distance to Building (m) * | Ownership | Action | Requirement |
|---|---|---|---|---|---|---|---|
| T2 | Maple | 1 | 10.5 | 3 | A - Third Party | Action to avoid future risk | Crown reduce overall canopy by 30% (minimum) to achieve a crown volume reduction in line with BRE IP7/06. Maintain at reduced dimensions by re-pruning back to points of previous reduction on a strict 2-3 year cycle. |

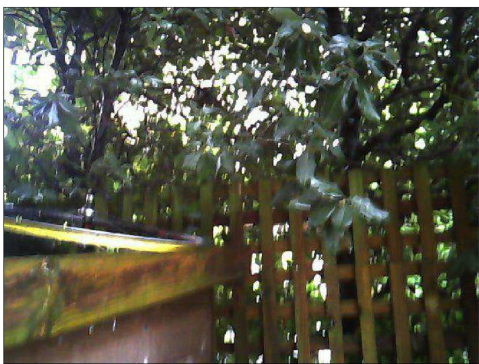
TG2 - Photinia

| Tree No. | Species | Age Cat | Approx. Height (m) | Distance to Building (m) * | Ownership | Action | Requirement |
|---|---|---|---|---|---|---|---|
| TG2 | Photinia | 1 | 4.5 | 2.8 | A - Third Party | Action to avoid future risk | Do not allow to exceed current dimensions by way of regular pruning. |

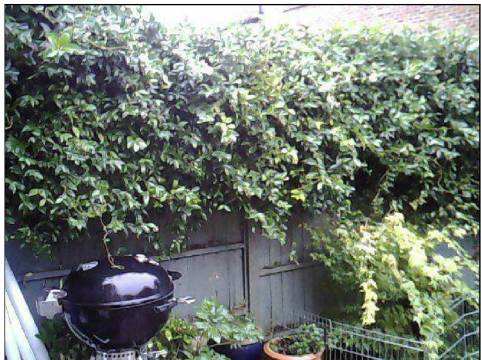
C1 - Jasmine

| Tree No. | Species | Age Cat | Approx. Height (m) | Distance to Building (m) * | Ownership | Action | Requirement |
|---|---|---|---|---|---|---|---|
| C1 | Jasmine | 1 | 2.4 | 2.4 | C - Insured | No action | No works. |

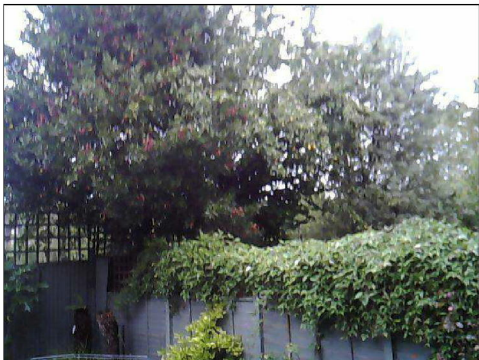
TG1 - Mixed species group

| Tree No. | Species | Age Cat | Approx. Height (m) | Distance to Building (m) * | Ownership | Action | Requirement |
|---|---|---|---|---|---|---|---|
| TG1 | Mixed Species Group:<br>Includes Pear, Bay Laurel & Pittosporum. | 1 | 9.2 | 11.5 | A - Third Party | No action | No Works. |
