Rennie House
Torriano Mews
LONDON
NW5 2RZ

CONCERNING SUBSIDENCE DAMAGE

ENGINEERING APPRAISAL REPORT

Date: 26/02/2021

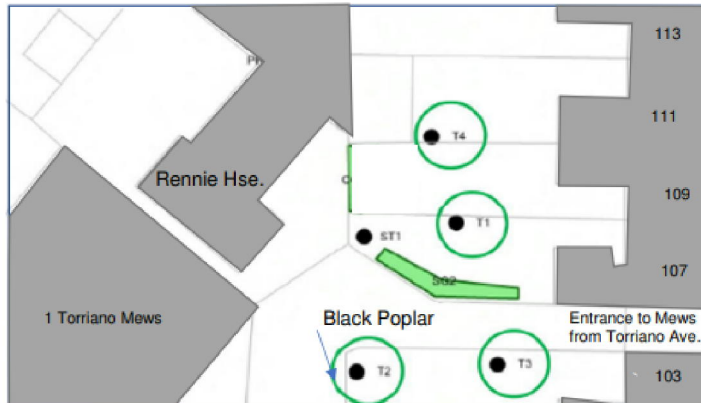
There are trees within influencing distance of the property. In particularly there is a 10m tall Poplar tree (height recorded in September 2019) within 8.5m of the front left corner of the property.

It is recommended that the Poplar tree located in the rear garden of No 103a Torriano Avenue and close to the property is removed to mitigate against further movement. A detailed scope of repairs will be finalised upon conclusion of the mitigation.

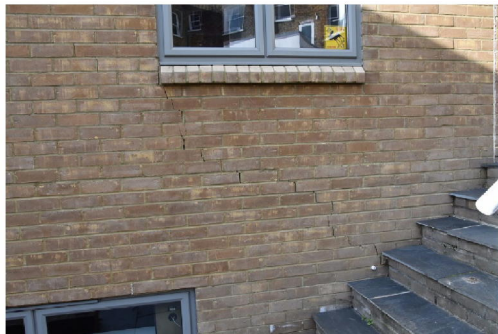
On the front elevation there is a 4mm wide stepped crack below the window to the ground floor bedroom. See the plan above to note the location at the front indicating downwards movement to the left.

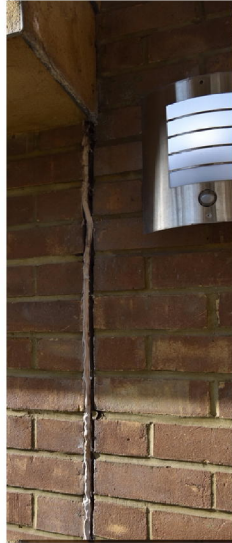
There is a further damage at the vertical expansion joints between the two parts of the building which has disturbed the seals and shows 10mm movement. See the plan above to note the location indicating downwards movement to the left.

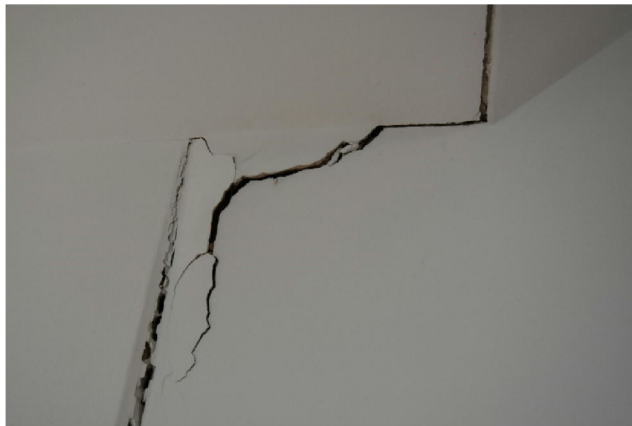
Internal damage takes the form of cracking up to 10mm in width to internal plastered walls in the areas of the ground floor entrance hall and wc, the front right bedroom and the corridor to the bedrooms. The wood floor has also been disturbed causing gaps to appear between the planks. See the plan above to note the location of the hall.

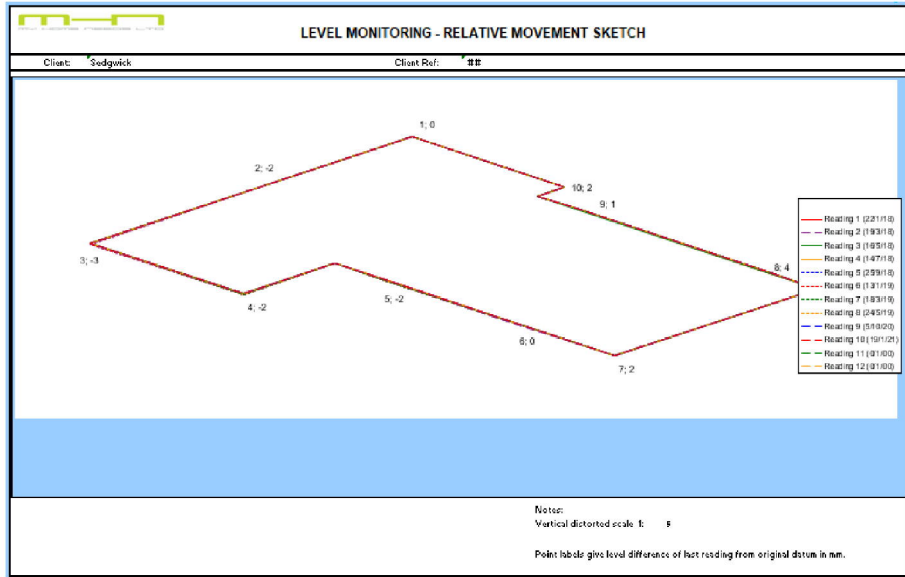
Level monitoring started in January 2018 and measured the movement on the left-hand leg of the building. Point 3 represents the front left corner of the property, the point closest to the Poplar.

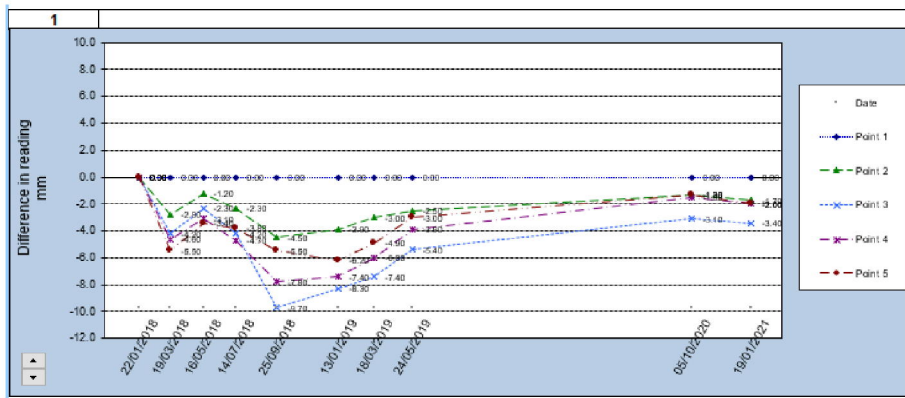
The chart above shows the movement recorded at points 1 to 5, which are on the left-hand side of the leg, the points closest to the Poplar. Downwards movement of approximately 10mm was recorded at point 3 to September 2018 followed by a recovery of over 4mm to May 2019. It can be seen that downwards movement started soon after the stations were established in January 2018. The pattern demonstrates cyclical movement over the summer of 2018 which in our opinion has been caused by the Poplar. No further readings were taken until October 2020 at which point the front left corner closest to the Poplar showed 3mm downwards movement, which was maintained through to January 2021. This shows that the building had not fully recovered to its January 2018 position which confirms the continuing influence of the Poplar.

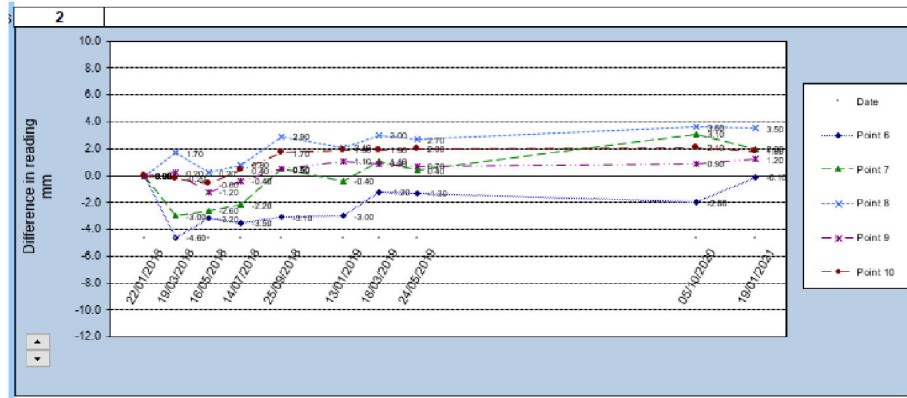
The chart above shows the movement recorded at points 6 to 10, which are on the right-hand side of the leg, the points furthest from the Poplar but closest to the Lime. Points 6 and 7 are at the front of the building and suffered downwards movement of approximately 5mm and 3mm respectively to March 2018 followed by a general overall recovery which has continued to date. We consider that if the Lime tree was the cause of the movement then downwards movement to this section of the building would also have continued to September 2018 because the Lime is closer to this part. However, this was not the case.

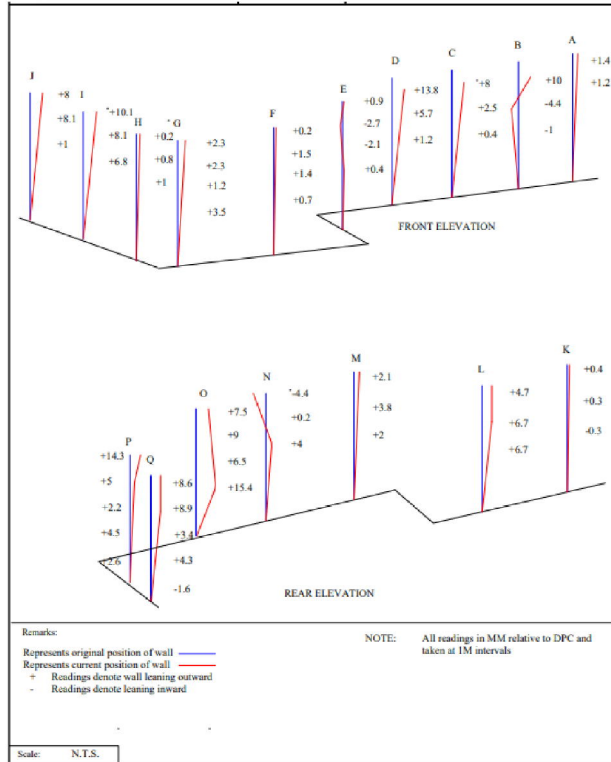
The chart above shows a tilt towards the front, i.e. towards the Poplar of 9.3mm at the front left corner over the full height of the wall.
