**TECHNICAL REPORT ON A SUBSIDENCE CLAIM**

Kenham Property Company Limited  
Flat 2  
1F Oval Road  
NW1 7EA

[REDACTED]  
**SUBSIDENCE CLAIM**

31<sup>st</sup> December 2019

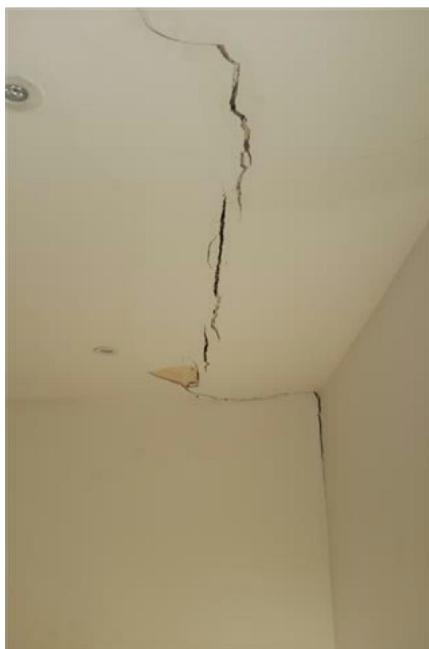
Cracking in ceiling at junction of rear outrigger with main

The most significant damage occurs in Bedroom 1 in the rear single storey outrigger. There is cracking across the ceiling approximately 15mm in width with pieces of plaster falling away. This cracking tracks down the side wall diminishing towards floor level. There is no damage to the adjacent en-suite bathroom to Bedroom 1 but this is in the two storey section.

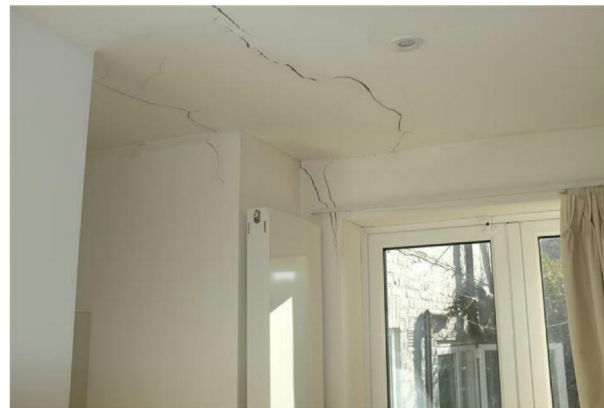
Separation cracking in rear outrigger at junction with two storey section

The mechanism of movement indicated by the damage is a slight rotation of the right hand area of the two storey section towards the tree located in the right hand neighbour's front parking area, with dislocation occurring to the right of the window as depicted. A more significant rotation of the rear single storey outrigger has occurred towards the trees located in the rear garden.
