12 Keats Grove London NW3 2RN

Project No. 1168 12KG

For Planning **RIBA Stage Timber Condition** Survey - Rear Elevation

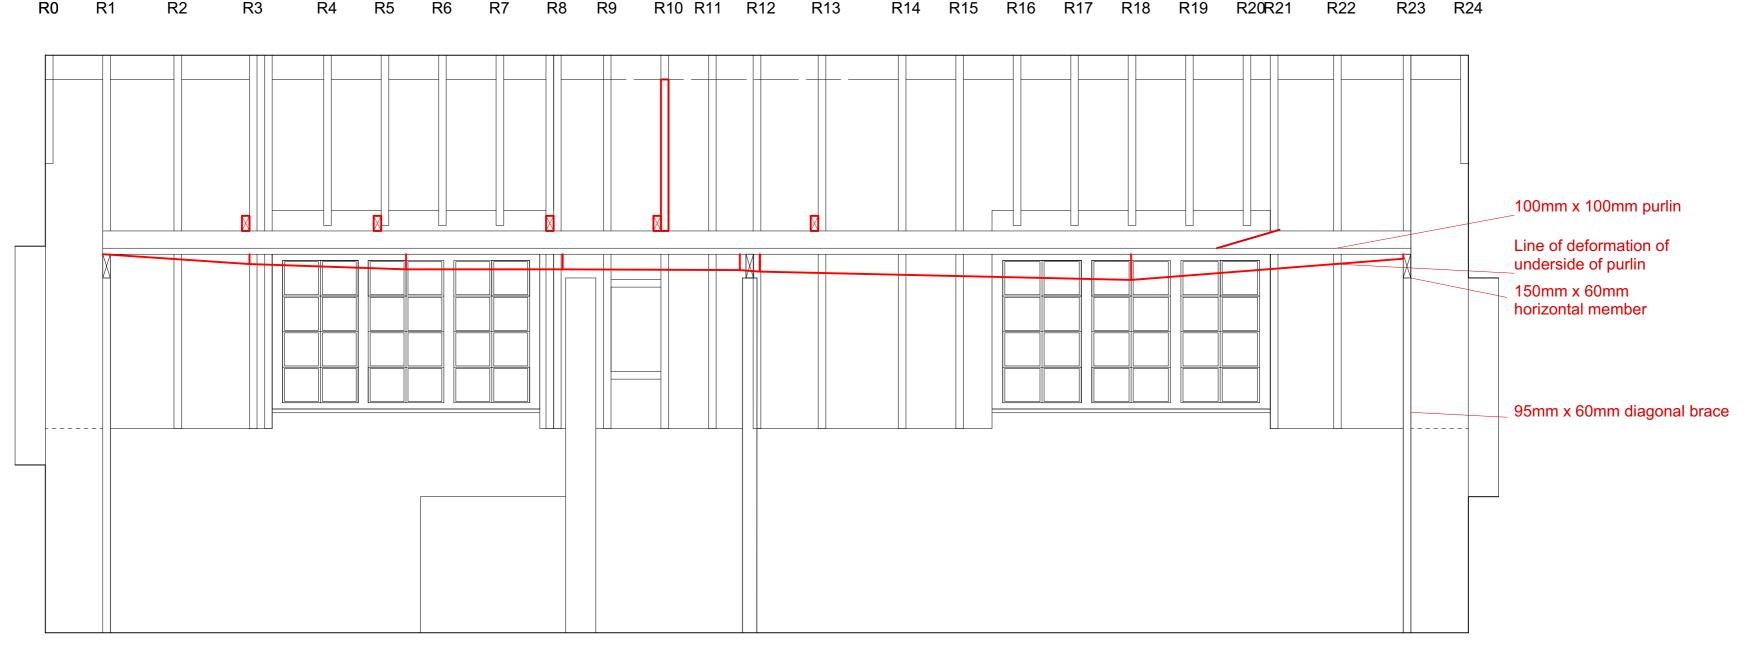
R13 R15 R16 R17 R18 R19 R20R21 R22 R23 R24

R0: 100mm x 50mm modern timber with 100 x 50 timber noggin at ridge beam

R1: 90mm x 60mm original timber

R2: 95mm x 70mm with 25mm firring on top

R3: 95mm x 60mm with 40mm firring on top with 100 x 50 modern timber tie above purlin

R4: 95mm x 60mm with 50mm firring on top

R5: 80mm x 60mm with 55mm firring on top with 100 x 50 modern timber tie above purlin

R6: 100mm x 55mm with 60mm firring on top

R7: 85mm x 60mm with 60mm firring on top

R8: 80mm x 60mm with 55mm firring on top with 100 x 50 modern timber tie above purlin level

R9: 100mm x 70mm notched over puhrlin

R10: 100mm x 70mm cut and trimmed for rooflight with 15mm firring, with 100 x 50 modern timber tie above purlin level from which a vertical strut to the ridge beam has been added.

R11: Rafter fractured and missing at the top. 95mm x 60mm

R12 100mm X 65mm over spine wall.

R13: 100mm x 60mm with 30mm firring on top and 100 x 50 modern timber tie.

R14: 100mm x 60mm original timber, with 45mm firring on top

R15: 100mm x 60mm with 70mm firring on top

R16: 95mm x 70mm with 90mm firring on top with 100 x 50 modern timber tie above purlin level into end framing

R17: 95mm x 60mm with 90mm firring on top

R18: 95mm x 75mm with 100mm firring on top.

R19: 100mm x 60mm with 95 mm firring on top

R20: 95mm x 75mm with 80mm firring on top.

R21: 120mm x 60mm, over fractured purlin with 65mm firring on top

R22: 90mm x 105mm abive purlin and 100mm x 50mm below purlin.

R23: 95mm x 65mm with no firring braced

R24: 95mm x 60mm

Historic damage has been revealed caused by introducing the dormers and removing the original in-plane diagonal bracing.

The cutting of the bracing has removed the original truss action in the roof structure and increased loading on the existing perlin.

This has caused them to creep over time and required the addition of significant firrings in the recent past.

To form the dormers the bracing and rafters were cut and as a result the purlin is undersized for its current use.
