# 12 Keats Grove Existing Roof

## Structural Inspection Report

Job Number: **28412**

Date  
March 2021

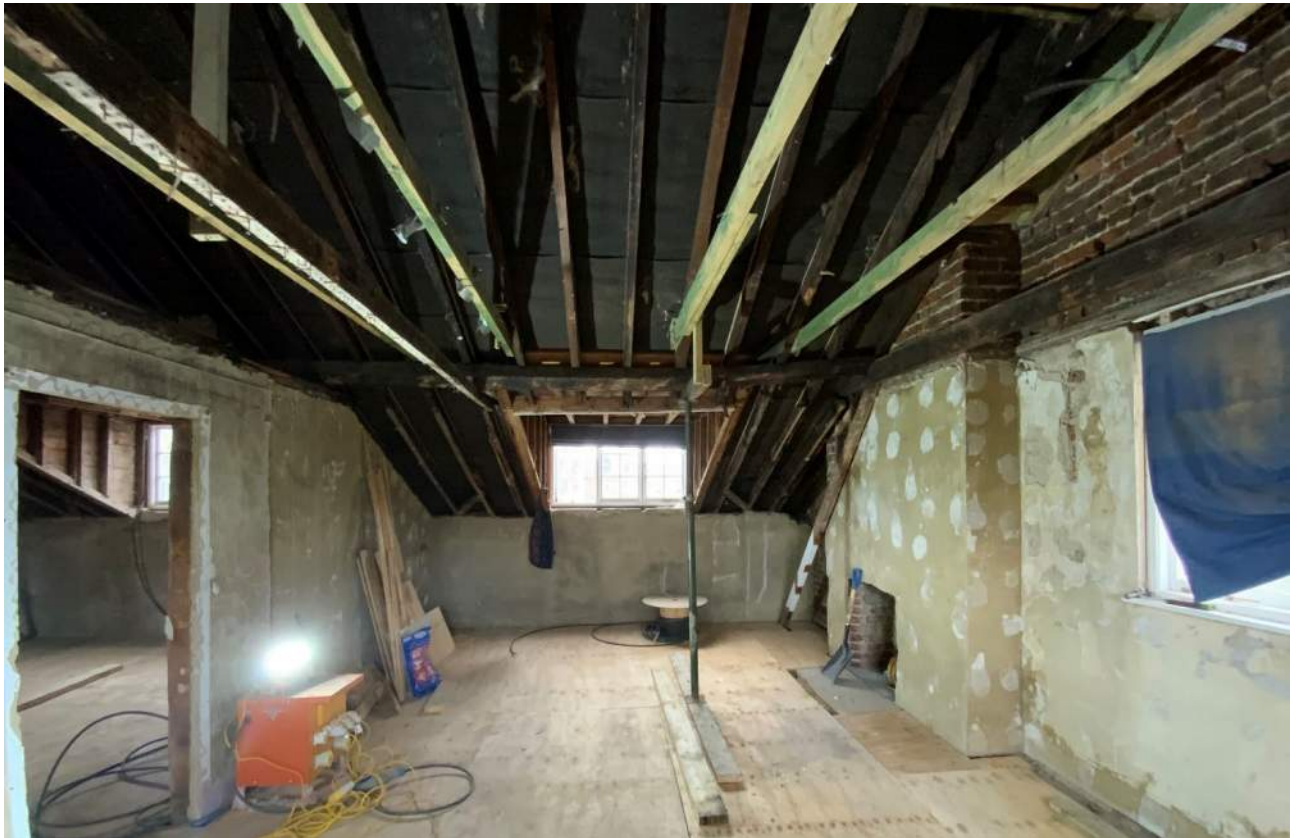
General view of the roof space looking south on the western side of the house, showing fractured purlin and modern timber roof elements.

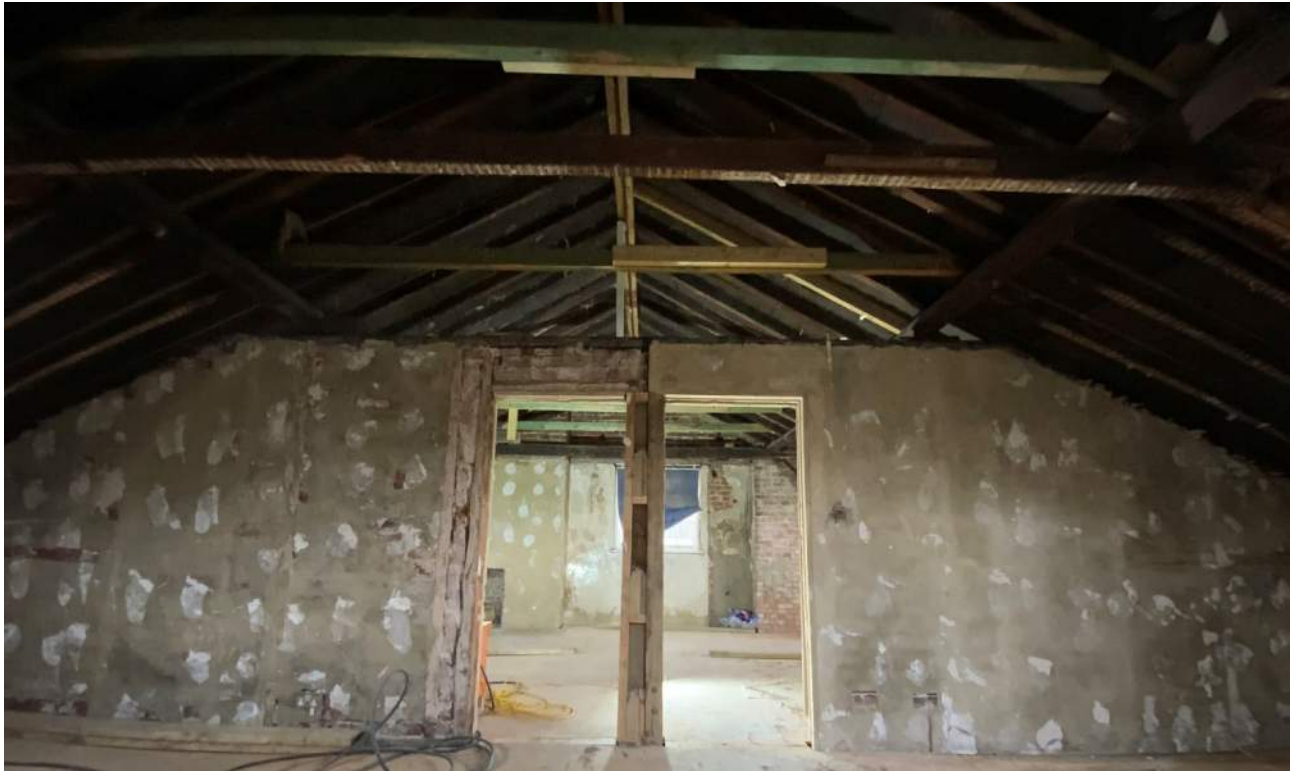
View of the roof space looking east along the central axis of the roof at the central partition and eastern gable wall beyond.

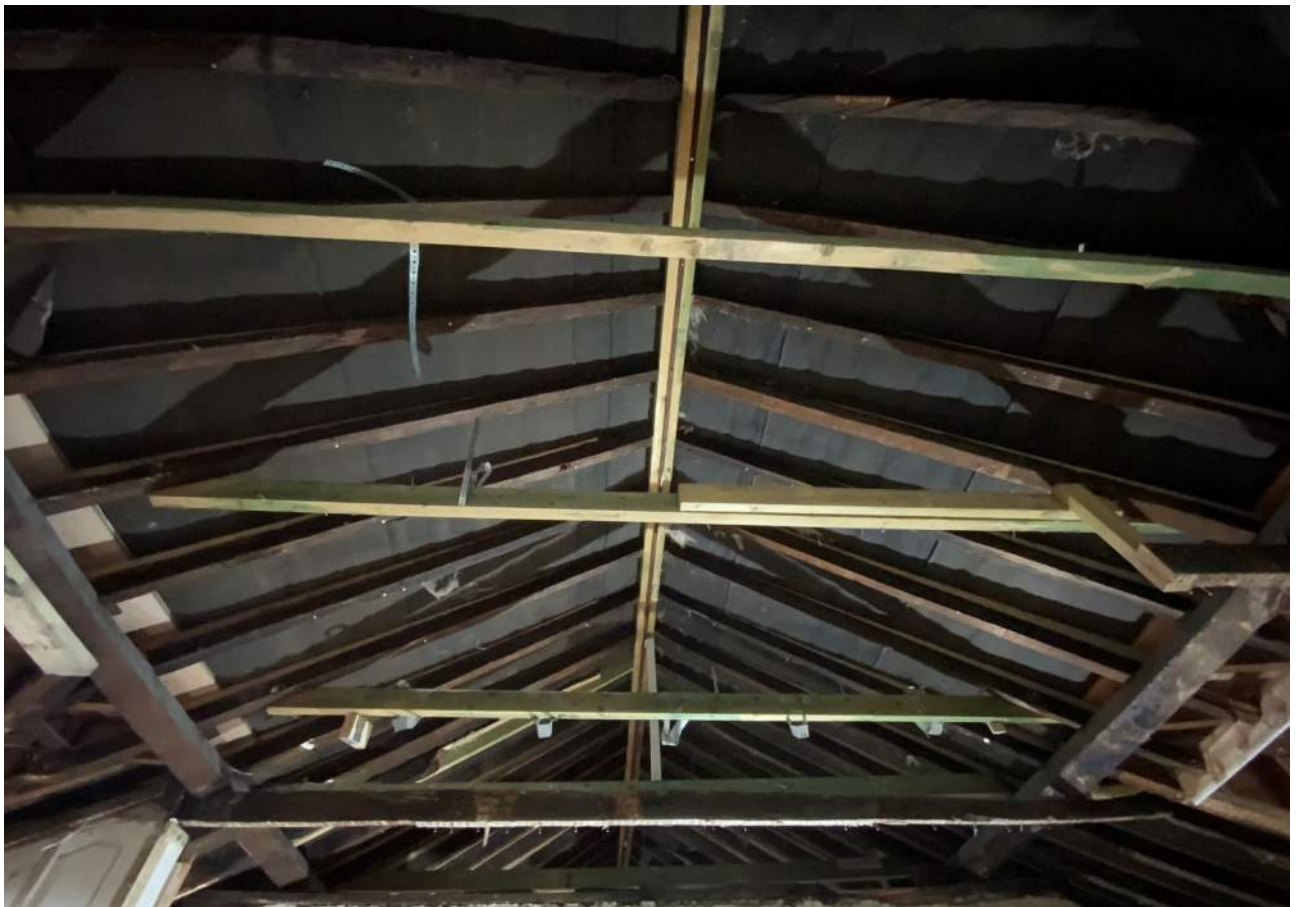
View of the upper roof space looking east along the central axis of the roof.

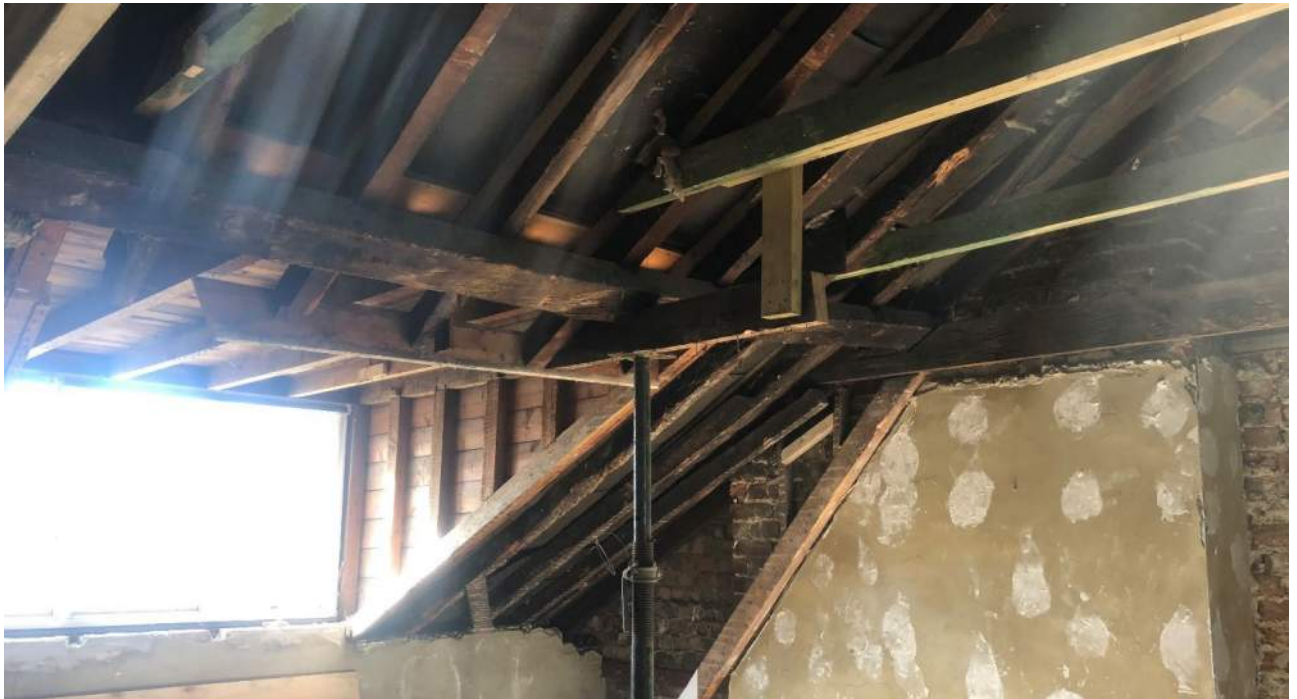
The existing rafters appear to be contemporary with the construction of the original house in the early 19th century. The rafters are generally 100mm deep and 60-70mm wide and are in continuous lengths from the wall plate to the ridge.

View of timber rafters

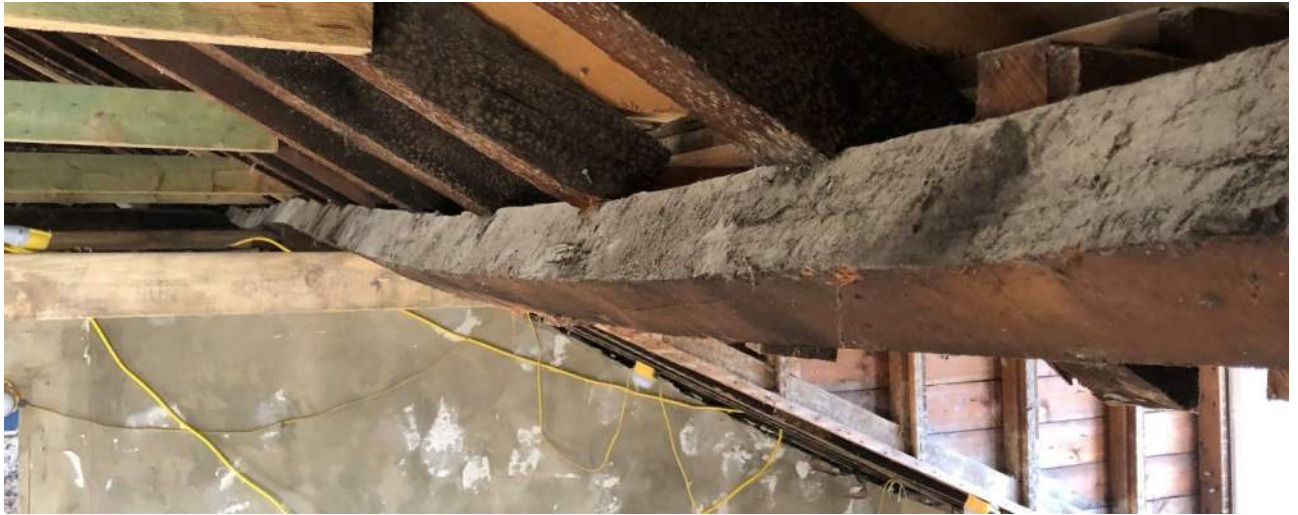
Both the front and back purlins have significant deflection of over 100mm. They both have diagonal fractures through their full thickness. The deflections of the purlins are shown on the survey drawing in the Appendix along with the sizes of the timber elements of the roof.

View along north purlin looking west showing continuity over spine wall and deflection at dormer heads.

The existing purlin is undersized for the loads that it began to carry following the truss removal. The visible deflection is a symptom of that and has occurred by the timber creeping under high stress. Creep is gradually increasing deflection over time and occurs when timber is overstressed in bending.

The existing purlins are both broken. They require replacement, as do elements within the supporting chimney breast frameworks which are also broken. It is not considered feasible to repair the existing purlins. They are both under sized for the load they need to carry and are too deformed to allow strengthening timbers to be spliced onto them.

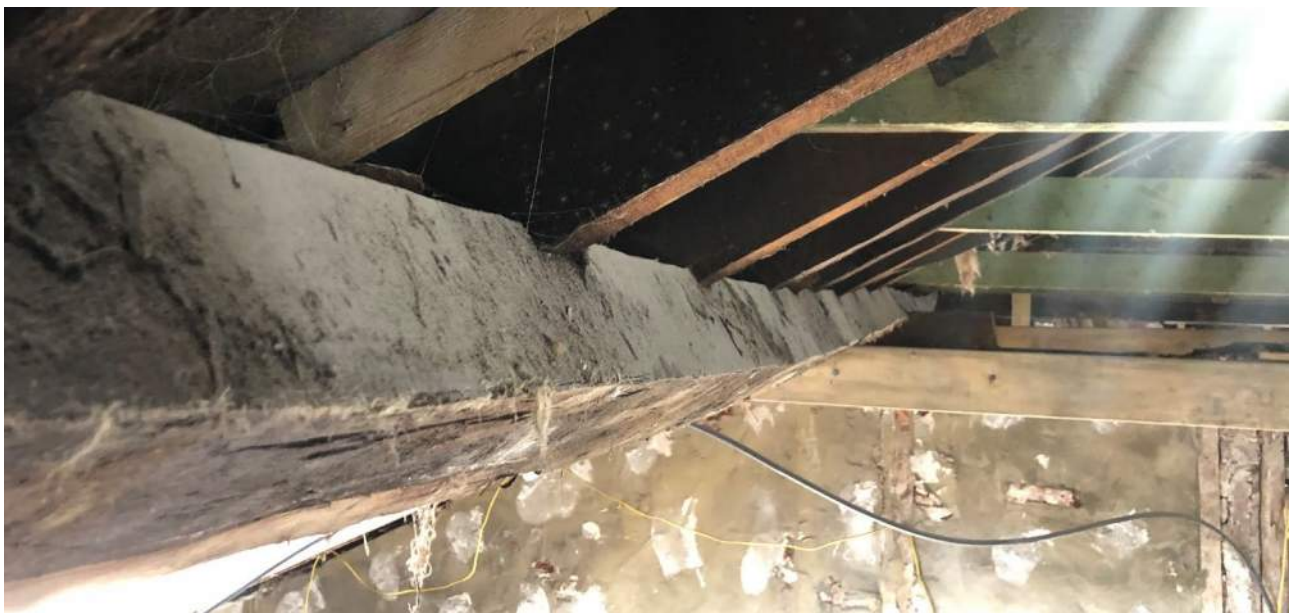
View along south purlin looking west again showing continuity and deflection.

Both the north and south purlins are fractured. The south purlin has been temporarily propped at the position of the crack.

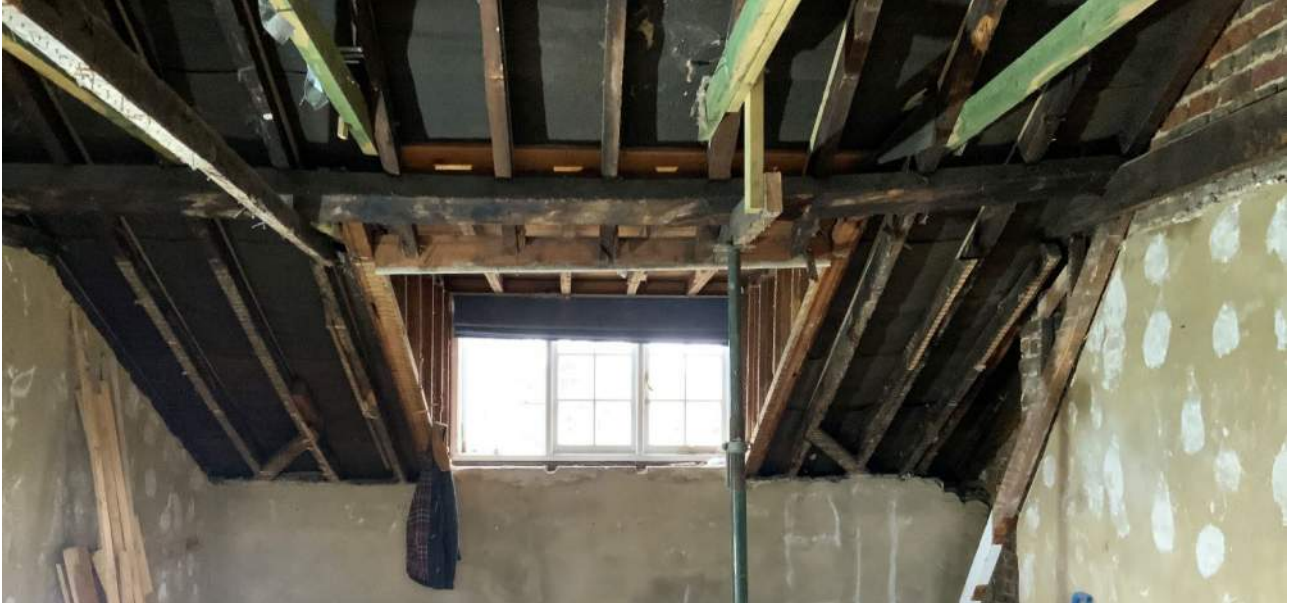
A total of four dormer windows have been cut into the existing roof. Historic photos confirm that this work was carried out after 1920. The dormers are timber framed with the side cheeks and roof of each dormer spanning from the house wall to the line of the purlins. Existing rafters have been cut and removed to accommodate the dormers.

View of dormer at south west corner of house.

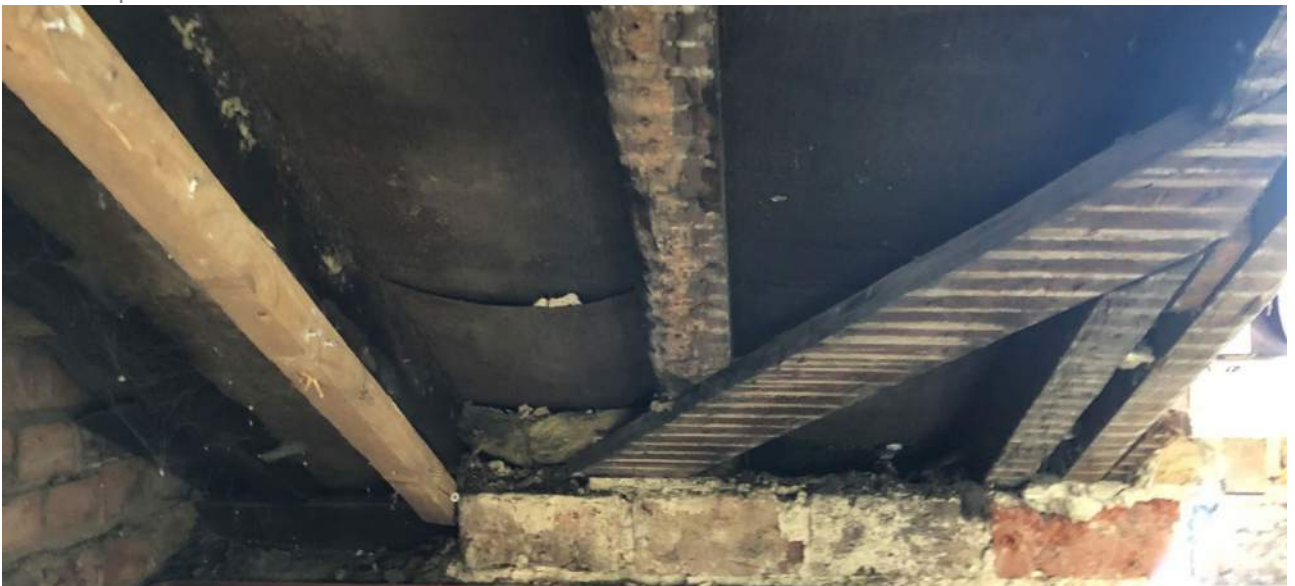
There are remains of diagonal bracing that was originally in the plane of the rafters on both sides of all four dormers. One of these diagonal timbers can be seen in the photograph below. Trimmed diagonal members and notches in the existing rafters confirm that the lower portion of the roof pitch below the purlin was trussed before the dormers were cut into the roof. The removal of the diagonals has disrupted the truss action of the roof.

View of cut diagonal roof truss member.

The diagonal bracing within the plane of the roof should be reinstated on either side of the dormer windows to restore the in-plane stiffness of the roof and allow the rafters to work as originally conceived. This would minimise the size of the purlin and allow a similar sized timber element to be used to that that exists in the roof at present. The roof would not require a ridge beam and would have a ridge plate of similar size and proportion to the original plate that exists between the modern ridge beams timbers.

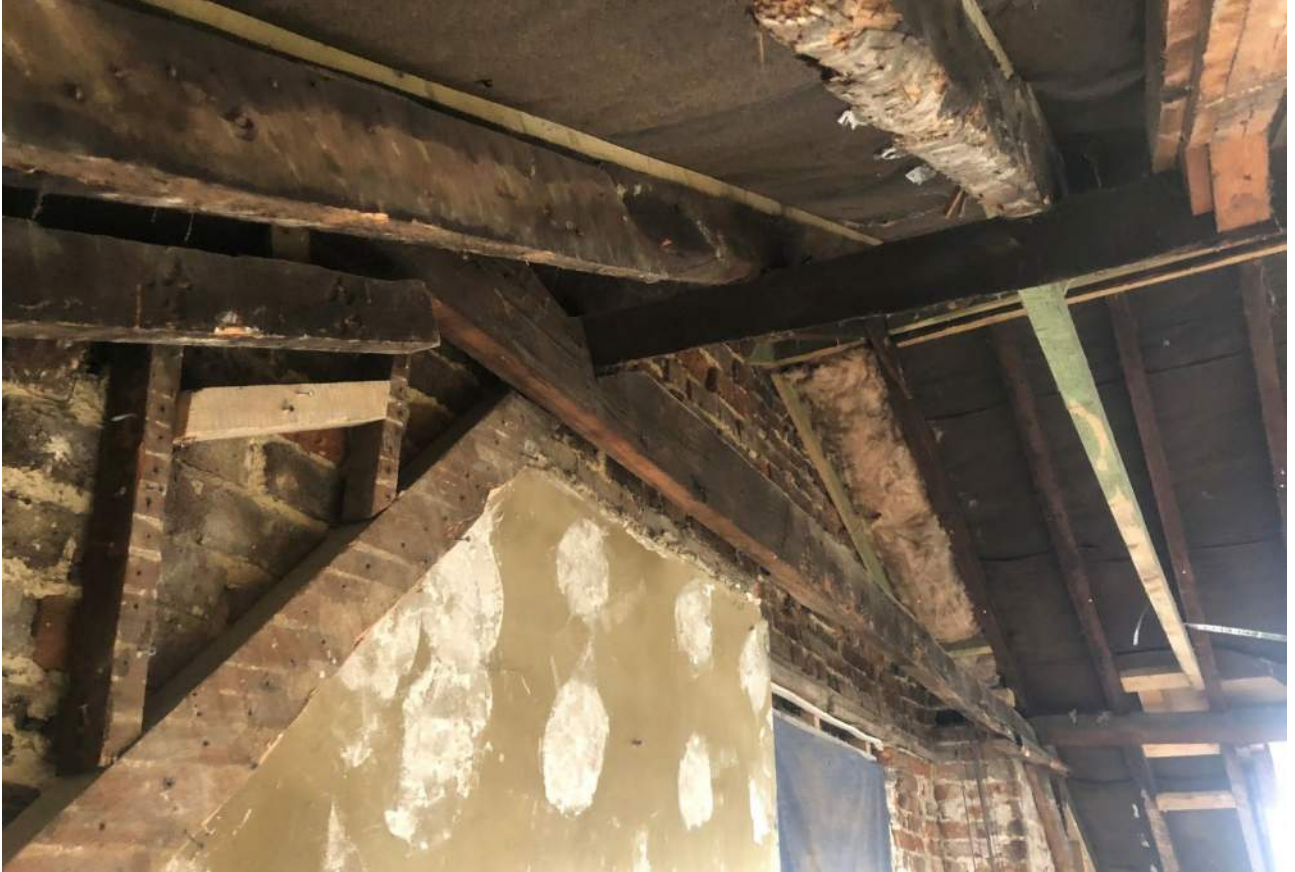
To prevent the purlin from penetrating the brickwork of the chimney breast and being exposed to fire, there is a pair of timber frames on either side of the house. These are made up of a 150x45 timber beam supported on two 100mmx60mm diagonal braces which are in turn notched into the floor joists of the second floor.

View of chimney breast frame on western gable.

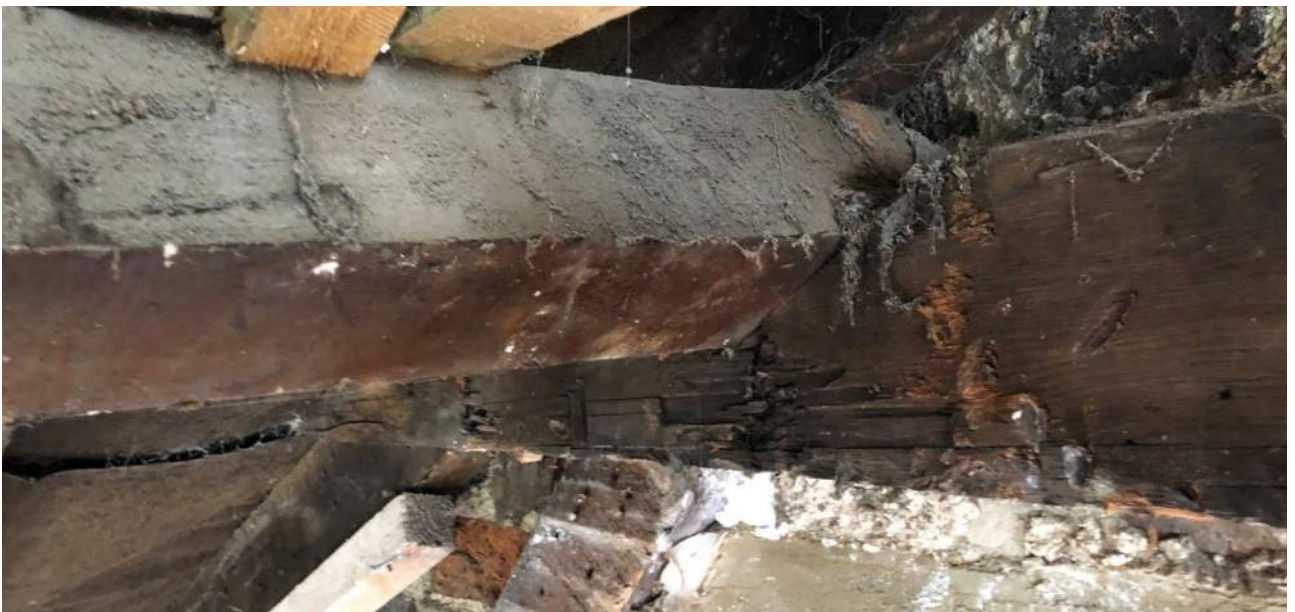
View of purlin notched into chimney breast beam.

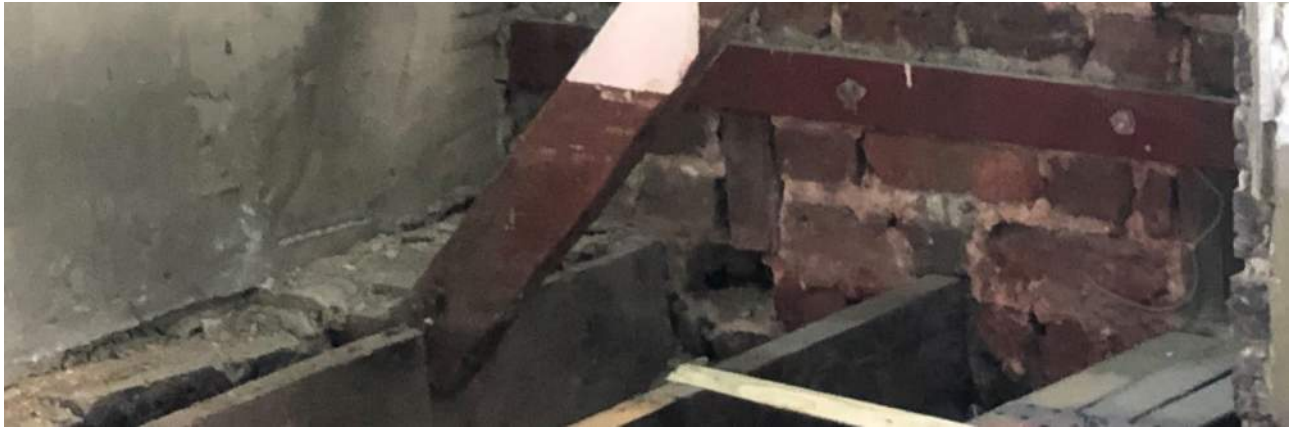
View of diagonal member of chimney breast frame work notched onto floor joist.

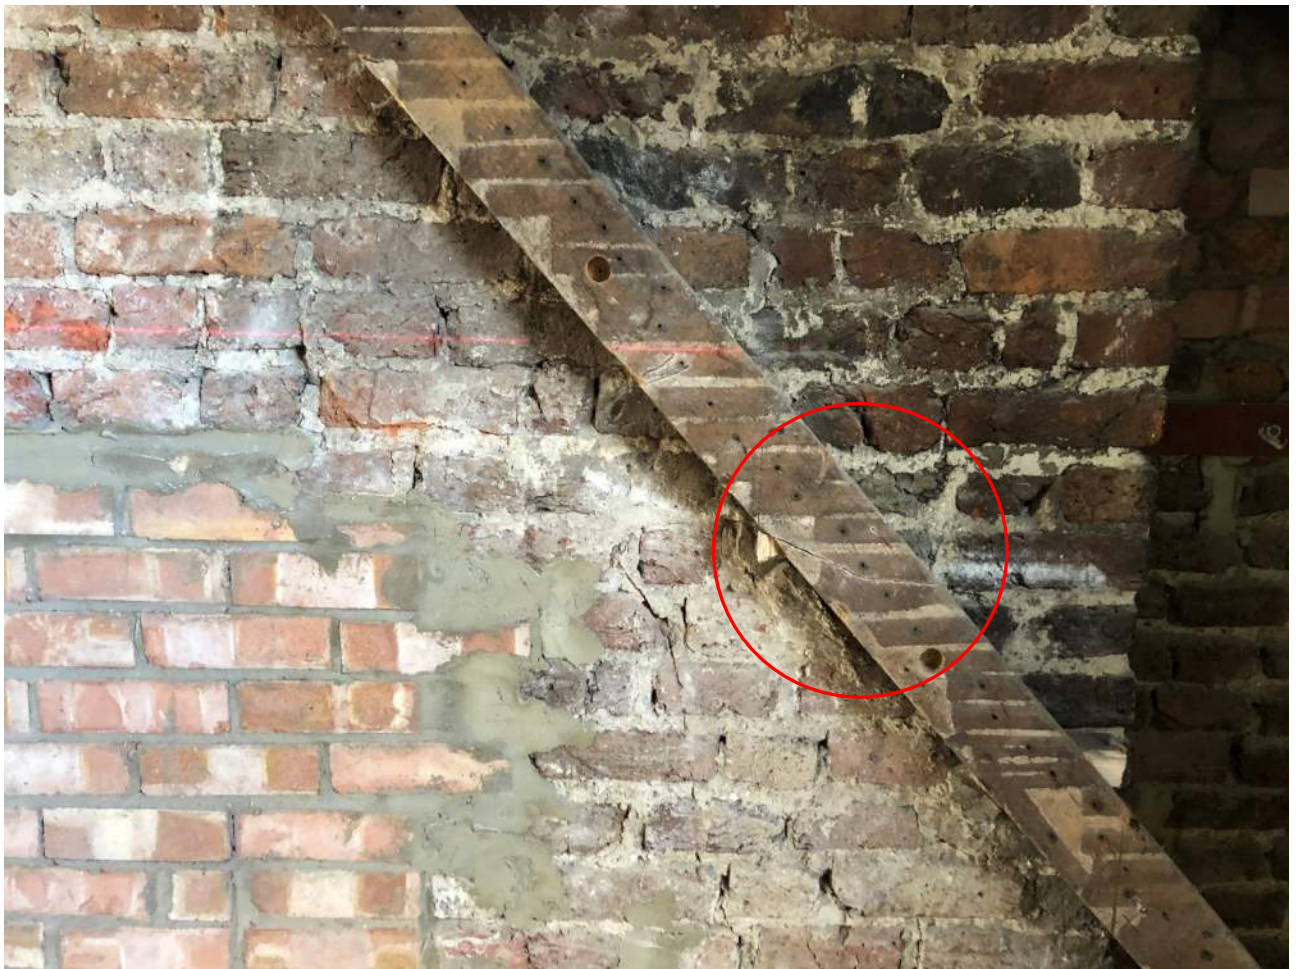
The diagonal brace at the north west corner of the house has a fracture through it and an attempt to restrain it to the adjacent brickwork has been made in the past.

Fracture in diagonal brace

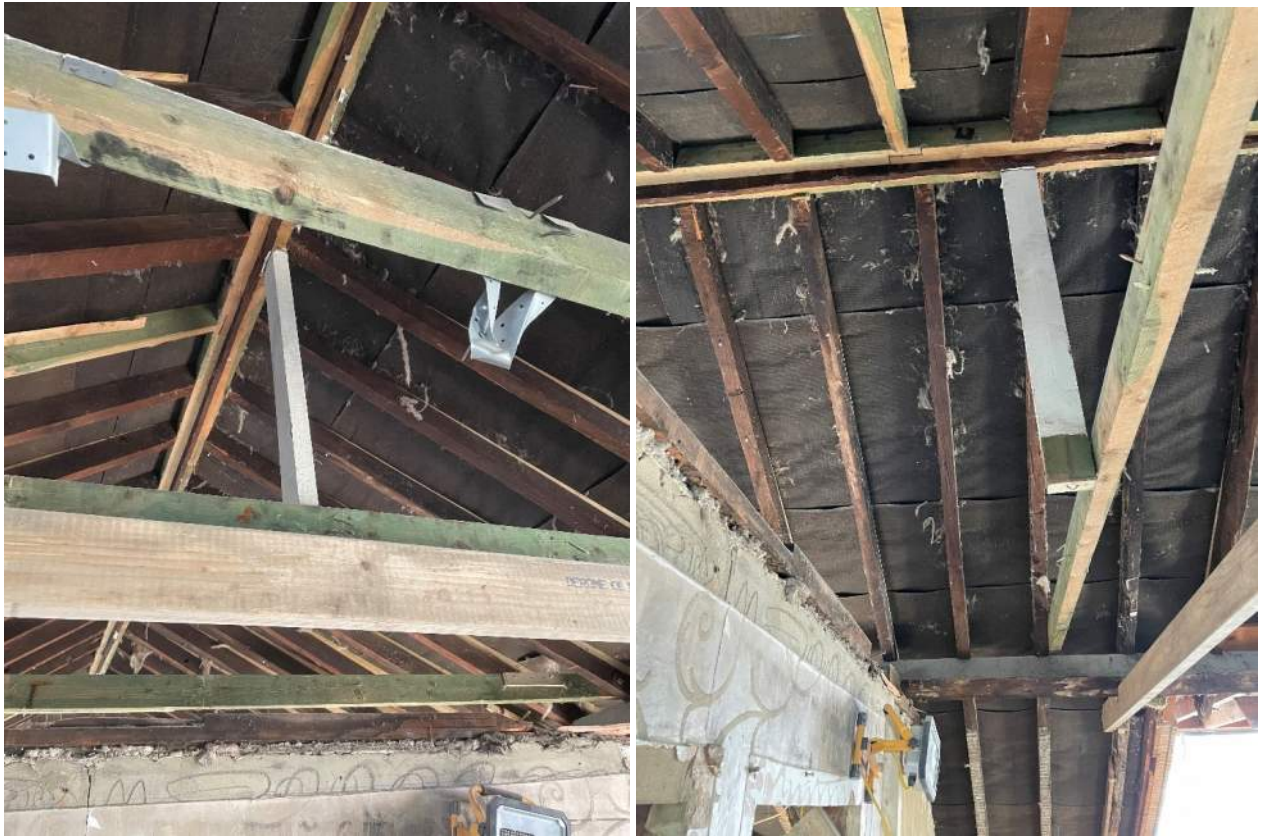
The original ridge plate of the roof has been augmented by two 150mm deep x 50mm wide modern timbers. The original timber plate is in place but has been made structurally redundant by the new timbers. The original rafters have been but back to fit against the new ridge beam and a central strut under the ridge beam connected to a modern tie beam forms a rudimentary truss.

View of new ridge beams and central strut/truss.

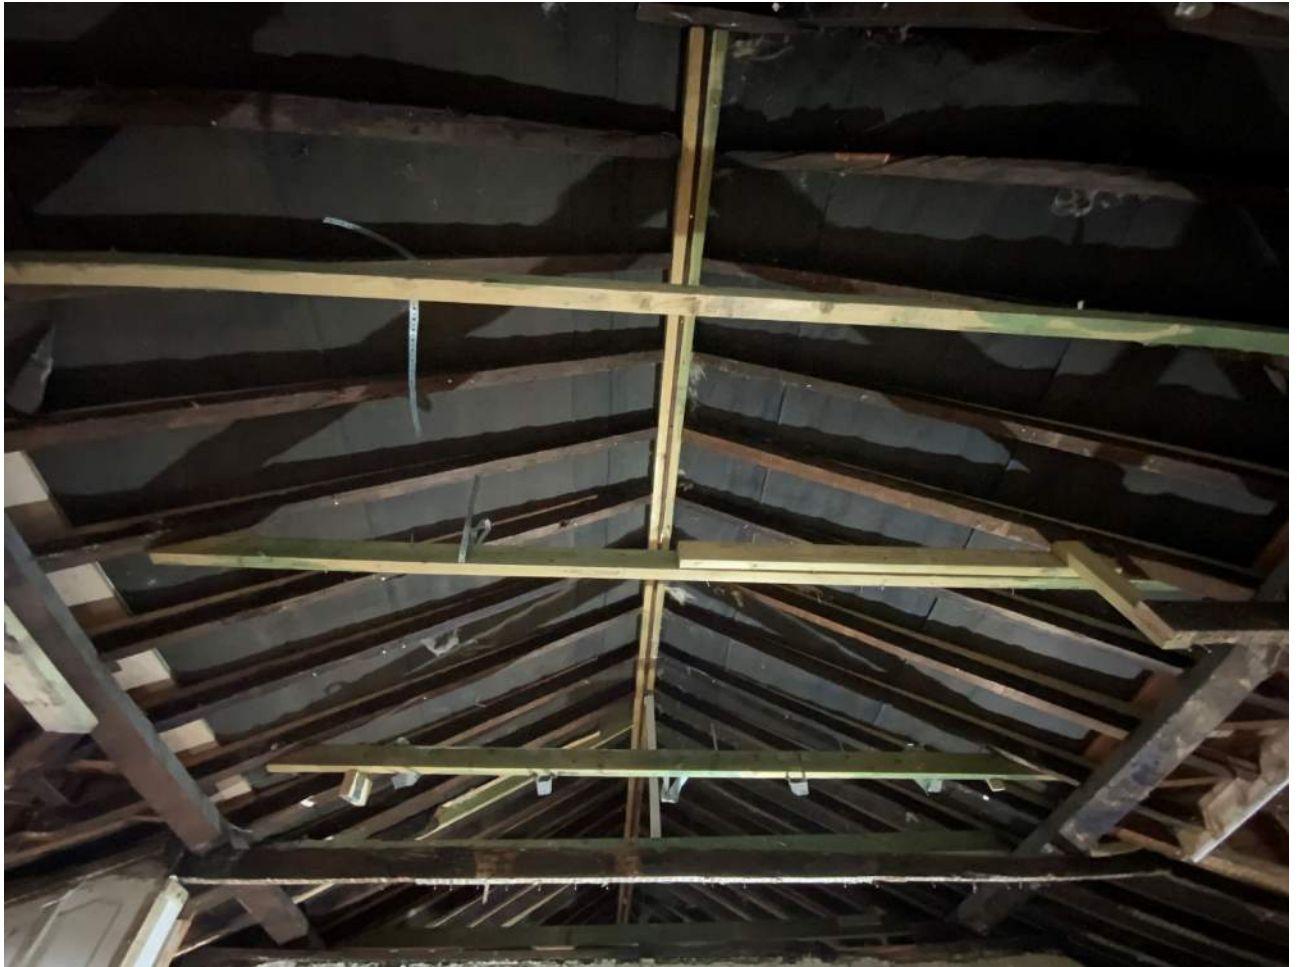
View of modern tie beams across the roof and firring pieces on top of the rafters

The size of the firring pieces indicates that the rafters have a deflection of around 100mm along their 5m length.

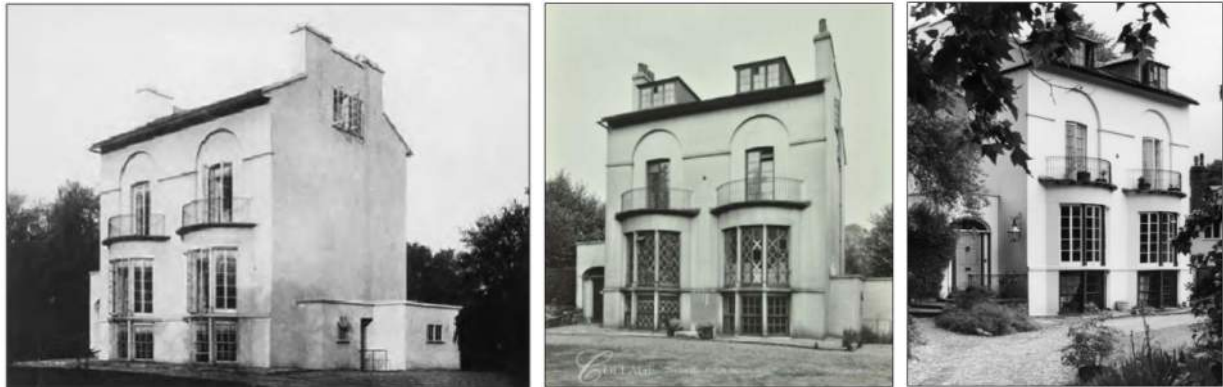
Historical photos confirm that the dormer windows were added into the roof between 1920 and 1943. This is consistent with the appearance of the dormer timber work.

Photographs of the house taken in 1920, 1943 and 1967 showing introduction of dormer windows.

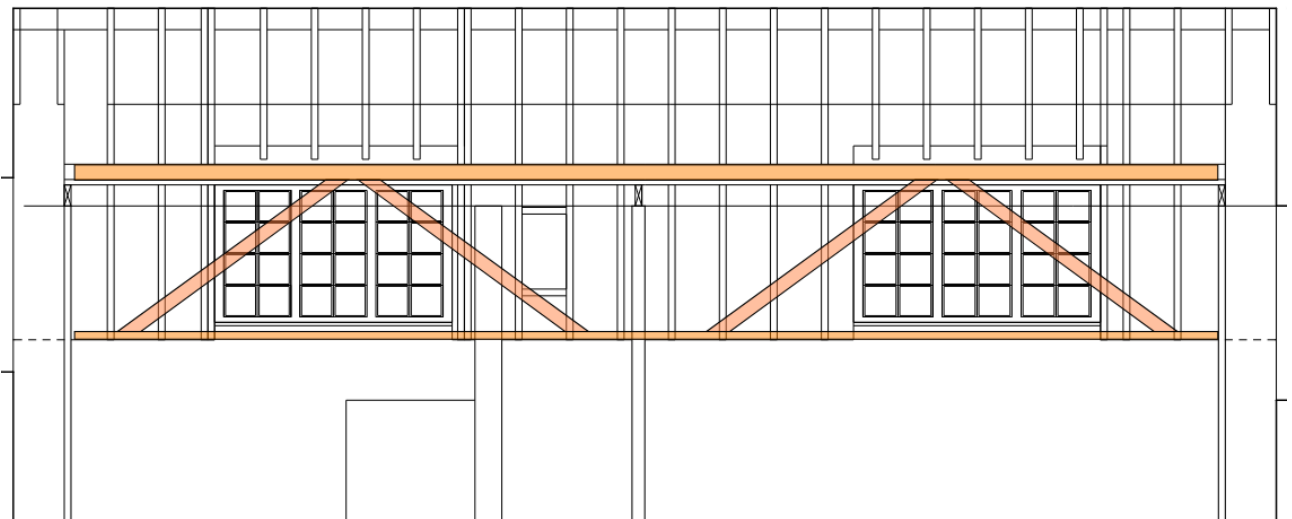
Diagram showing original trussed rafter arrangement of the structure.

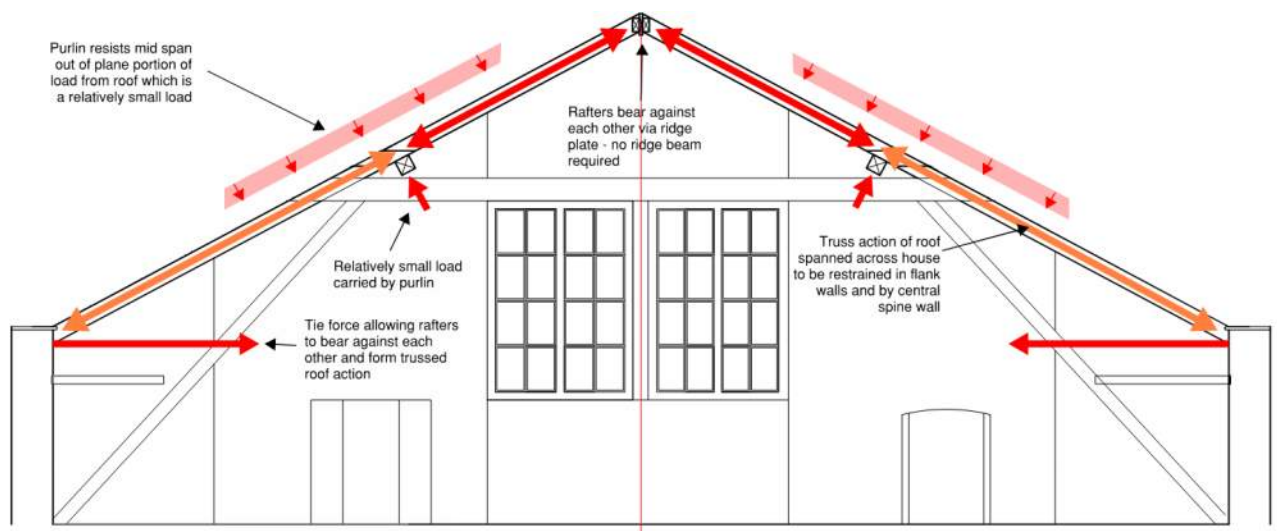
Structural flow of forces in original roof

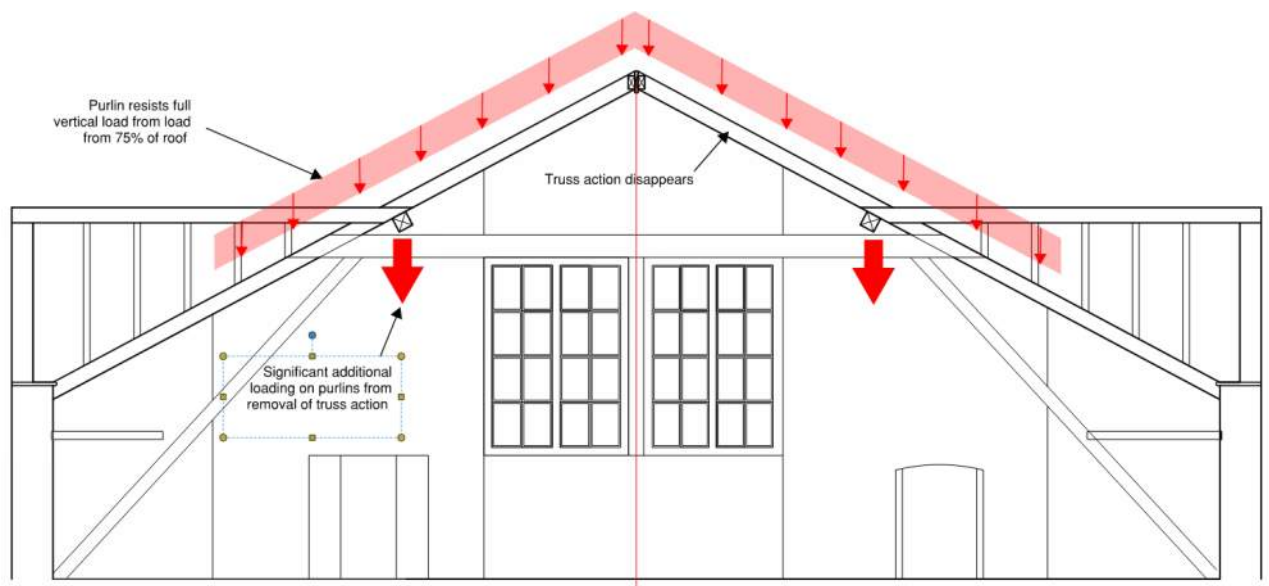
Alteration of load path with removal of truss members

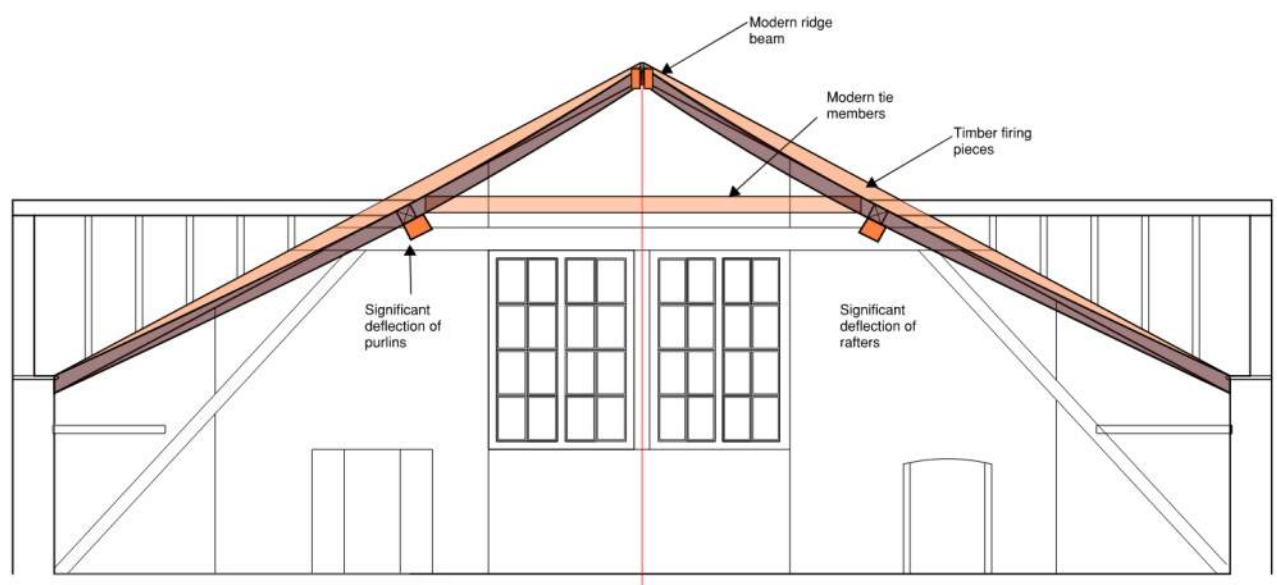
Deflected form following removal of truss action.

The trussing members in the roof were removed sometime after 1920 and before 1943. The impact of this was to significantly increase the loading on the purlins. The purlins as a result have deflected by over 100mm which is a large deflection. The existing rafters that are fixed to them have also dropped down with this deflection and appear to have deflected along their length also.

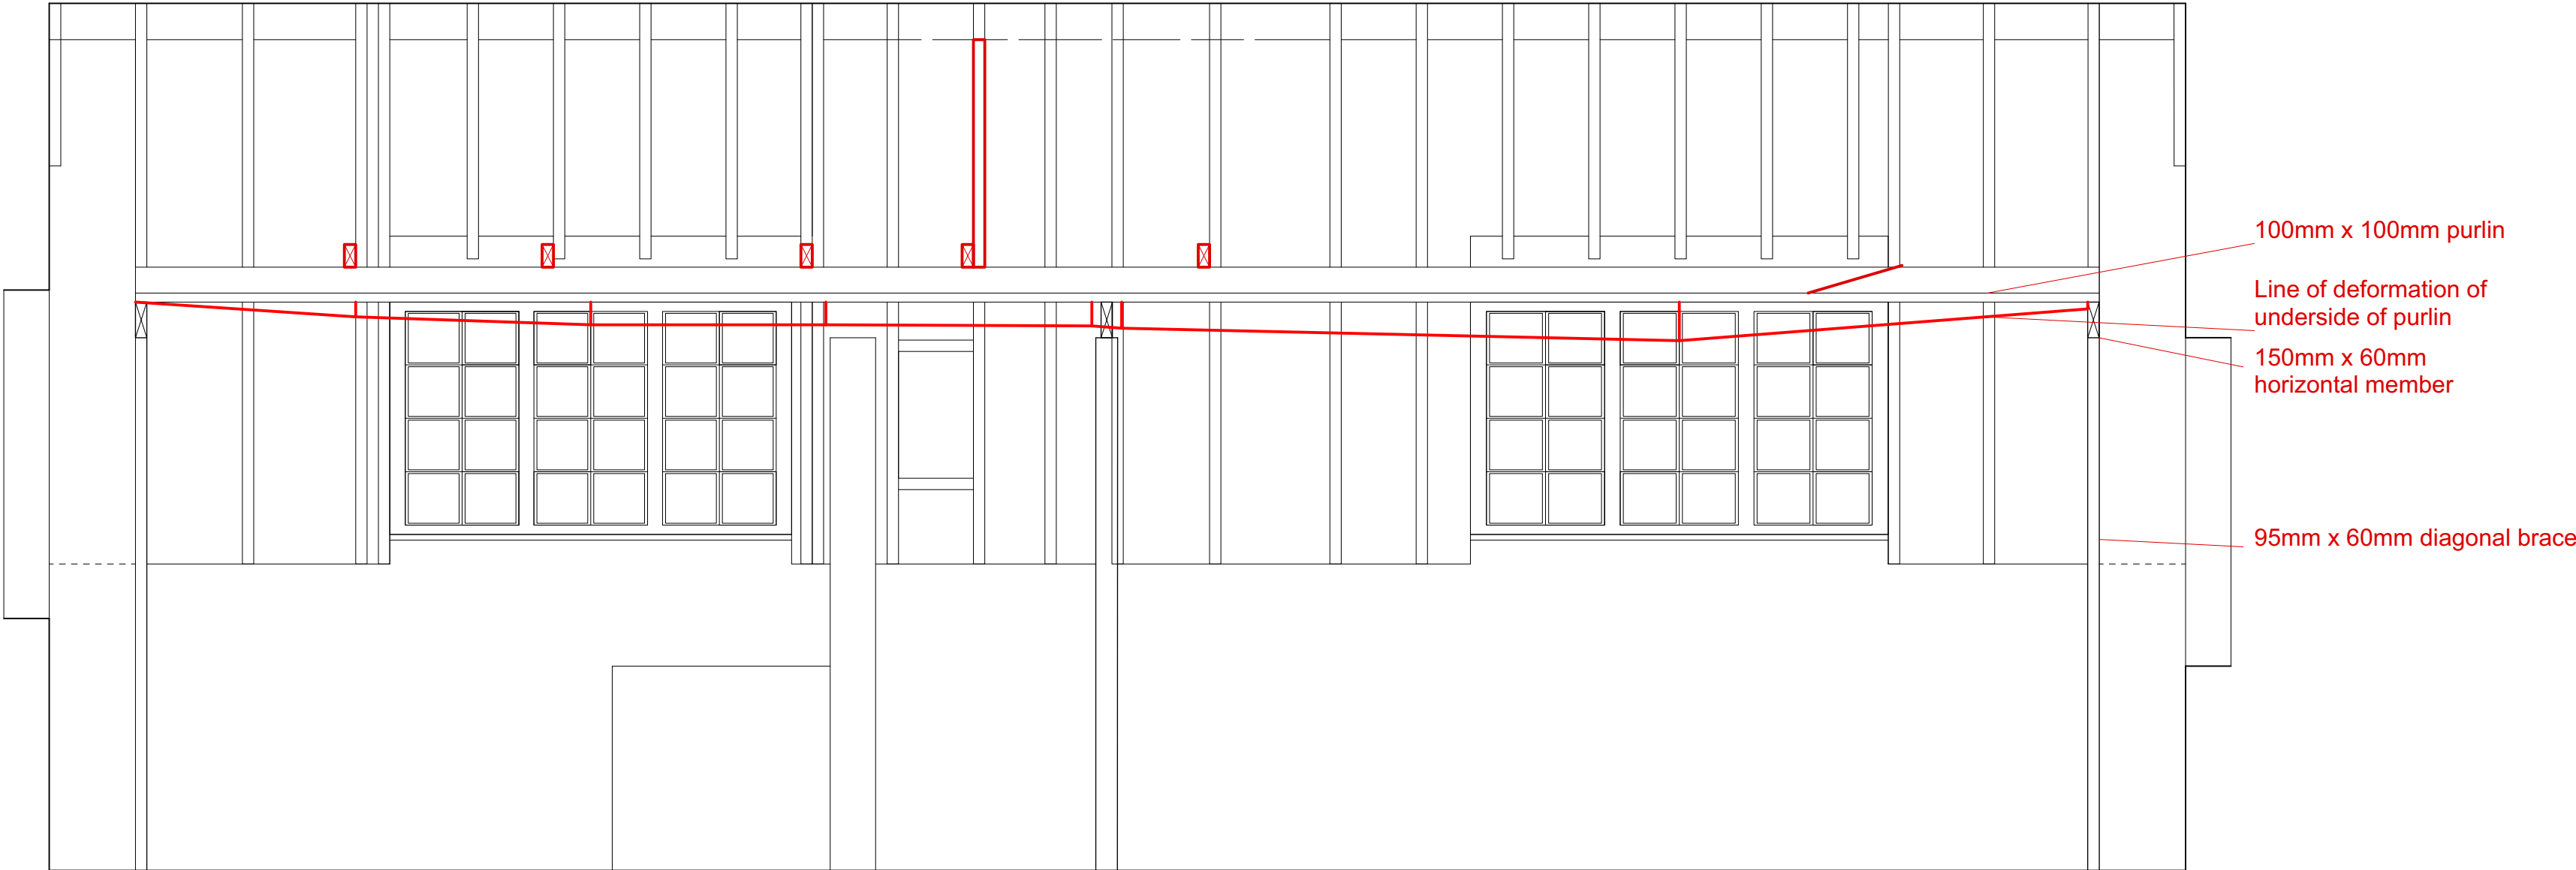
For Planning  
RIBA Stage  
**Timber Condition  
Survey - Rear Elevation**

Historic damage has been revealed caused by introducing the dormers and removing the original in-plane diagonal bracing.

The cutting of the bracing has removed the original truss action in the roof structure and increased loading on the existing perlin.

This has caused them to creep over time and required the addition of significant firrings in the recent past.

To form the dormers the bracing and rafters were cut and as a result the purlin is undersized for its current use.

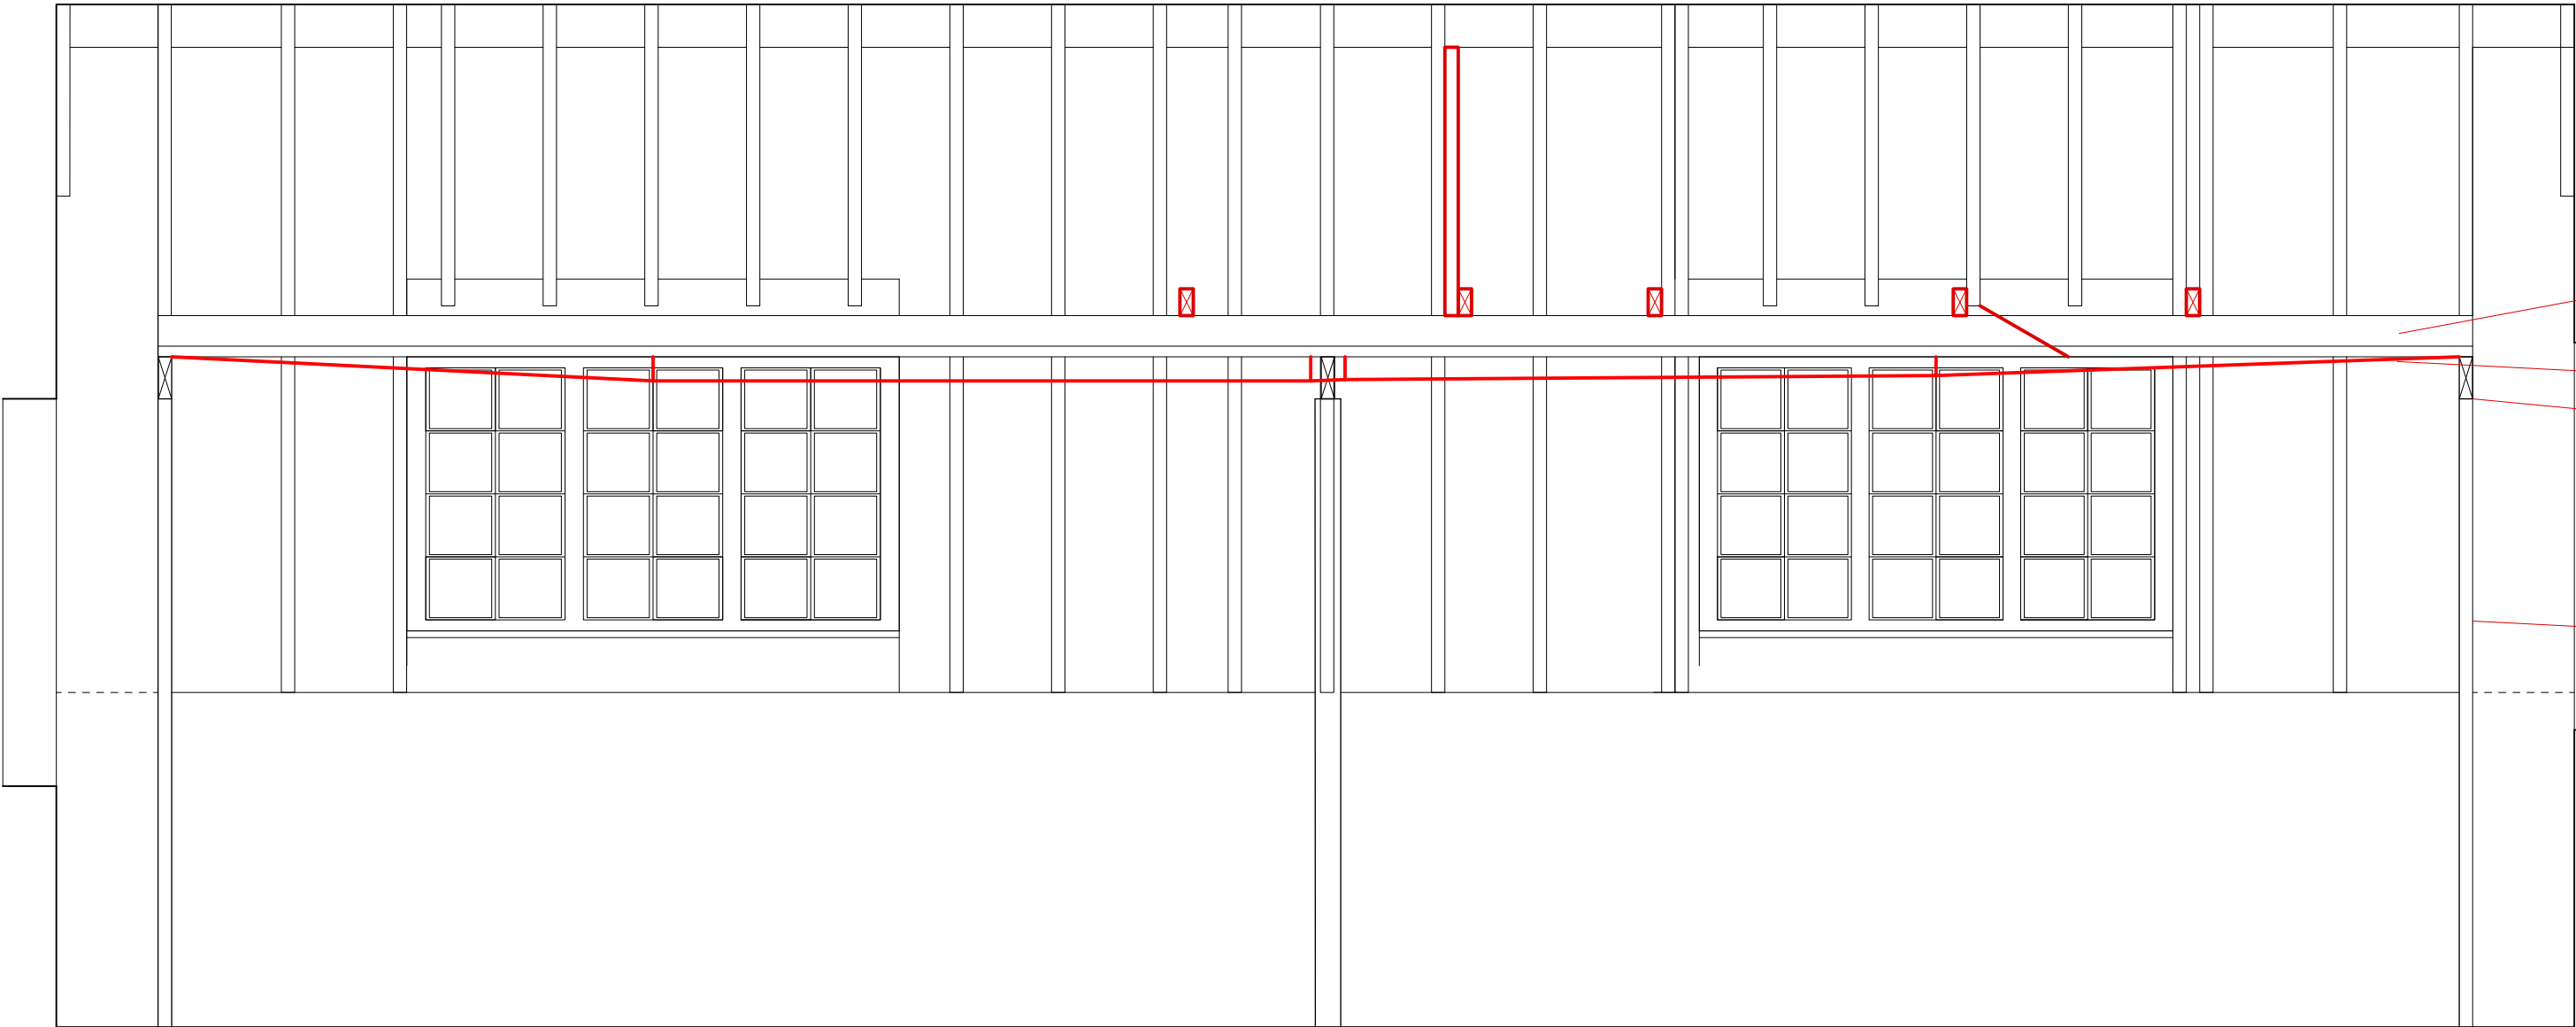
For Planning  
RIBA Stage  
**Timber Condition  
Survey. Front Elevation**

Line of deformation of underside of purlin
