82 Fitzjohn Avenue
Photographic walkthrough

External Photographs

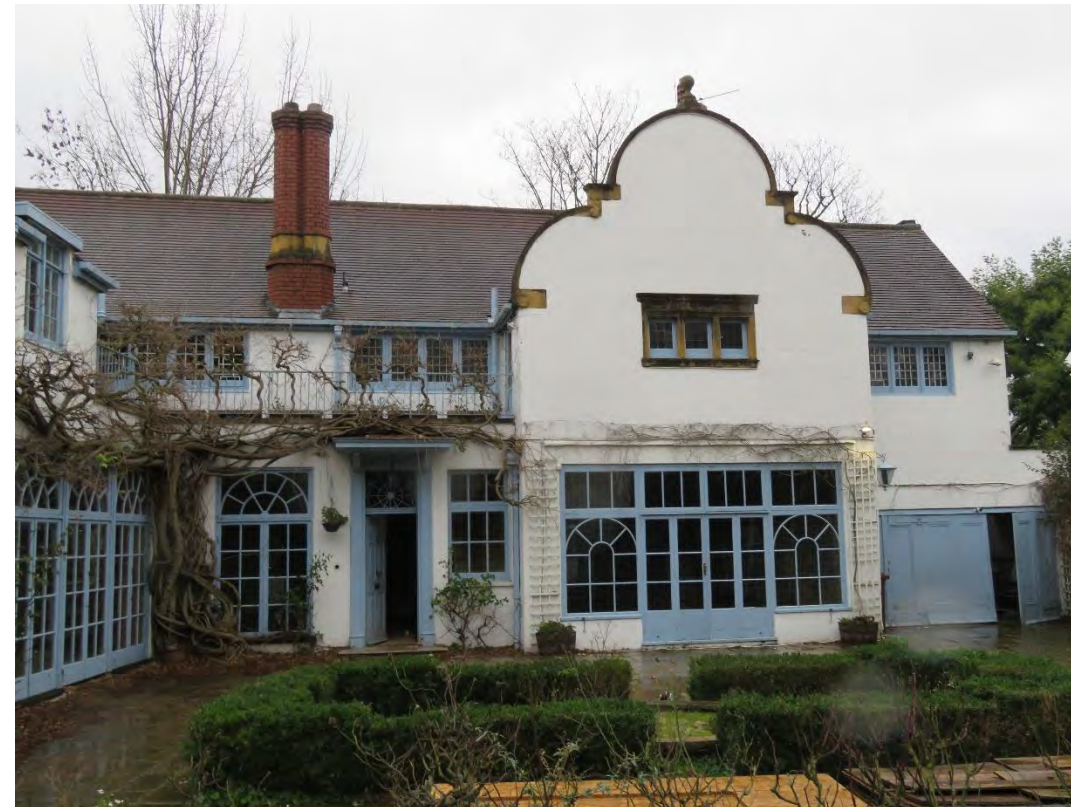
Figure 1: West Elevation of the main house. Note the original gable, chimney stacks and led windows (first floor)

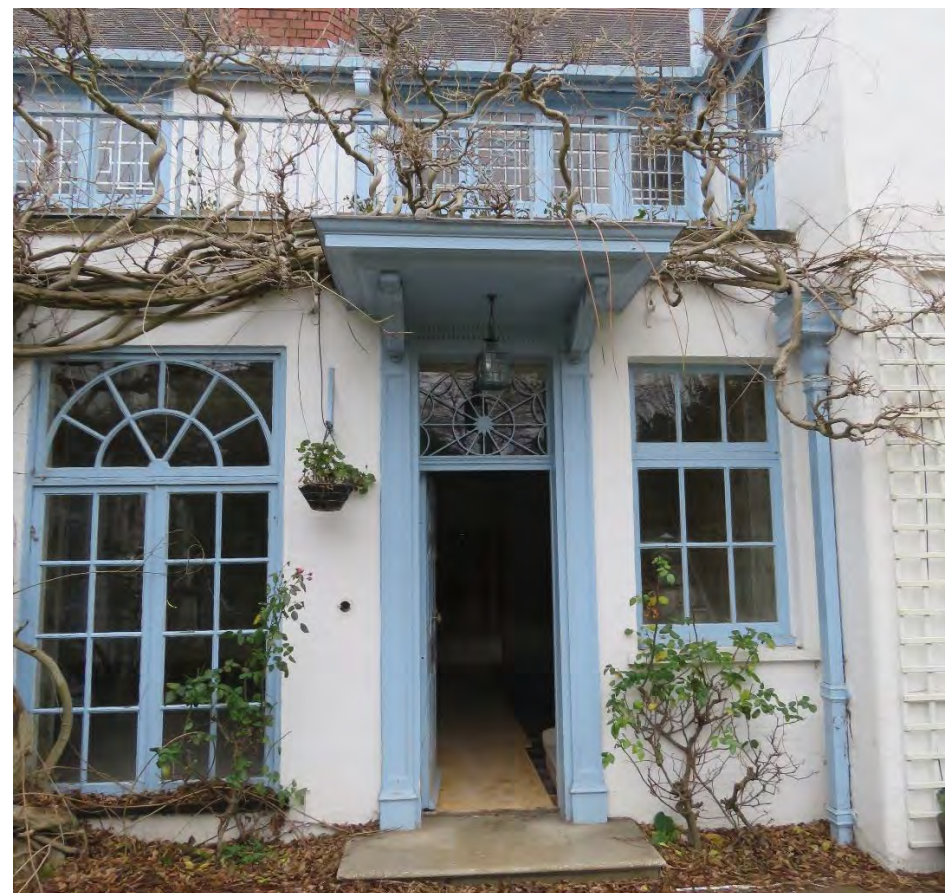
Figure 2: Detail of the front door and flanking fenestration. Note that the wall in this location was brought forward in the c.1960s. The door and windows are not original to the building.

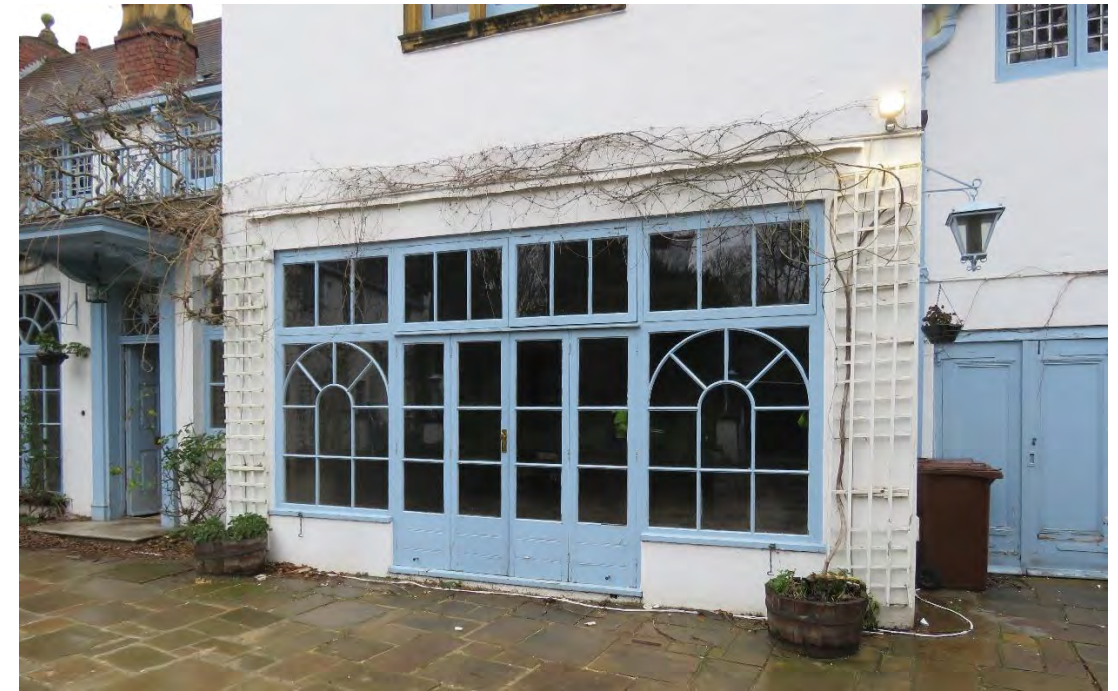
Figure 3: View of the conservatory style glazed French doors at the ground floor. This is a later intervention and replaced the original fenestration in this location during the c.1960s works.

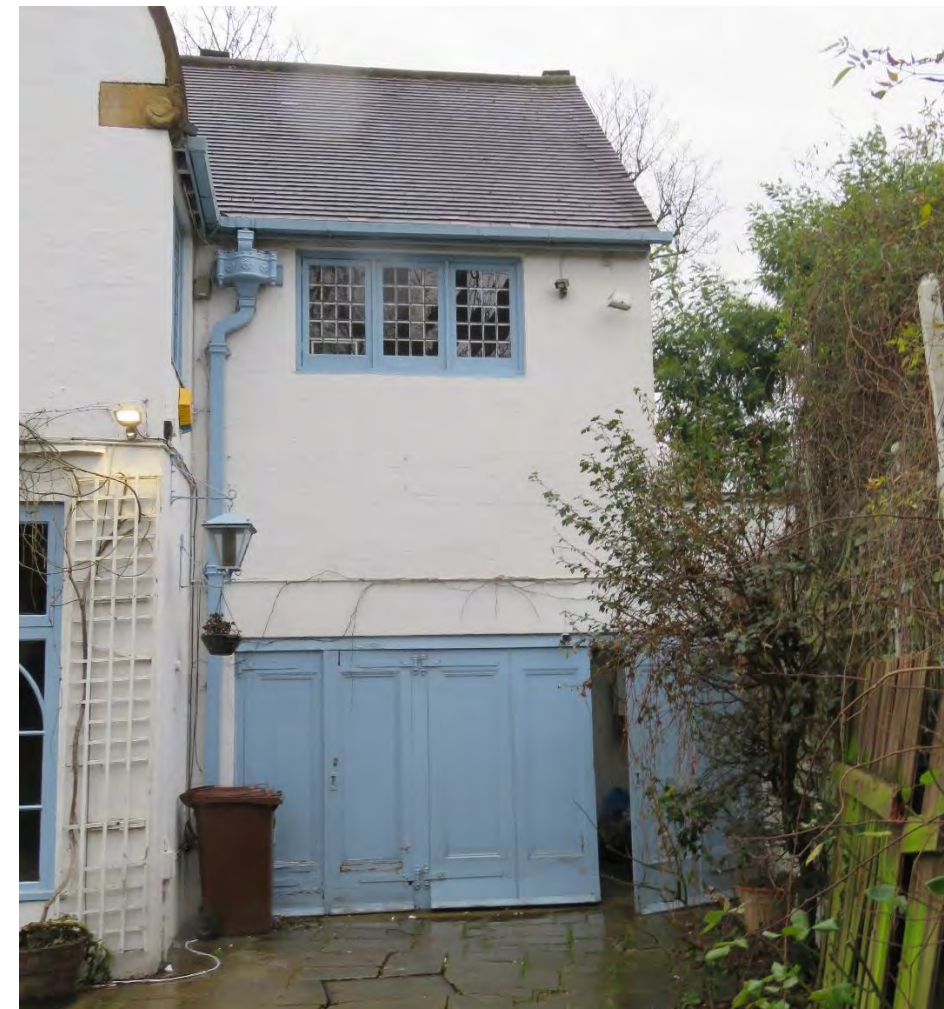
Figure 4: The garage extension to the south side of the house. This two-storey extension is not original to the building and was likely inserted in c.1960s.

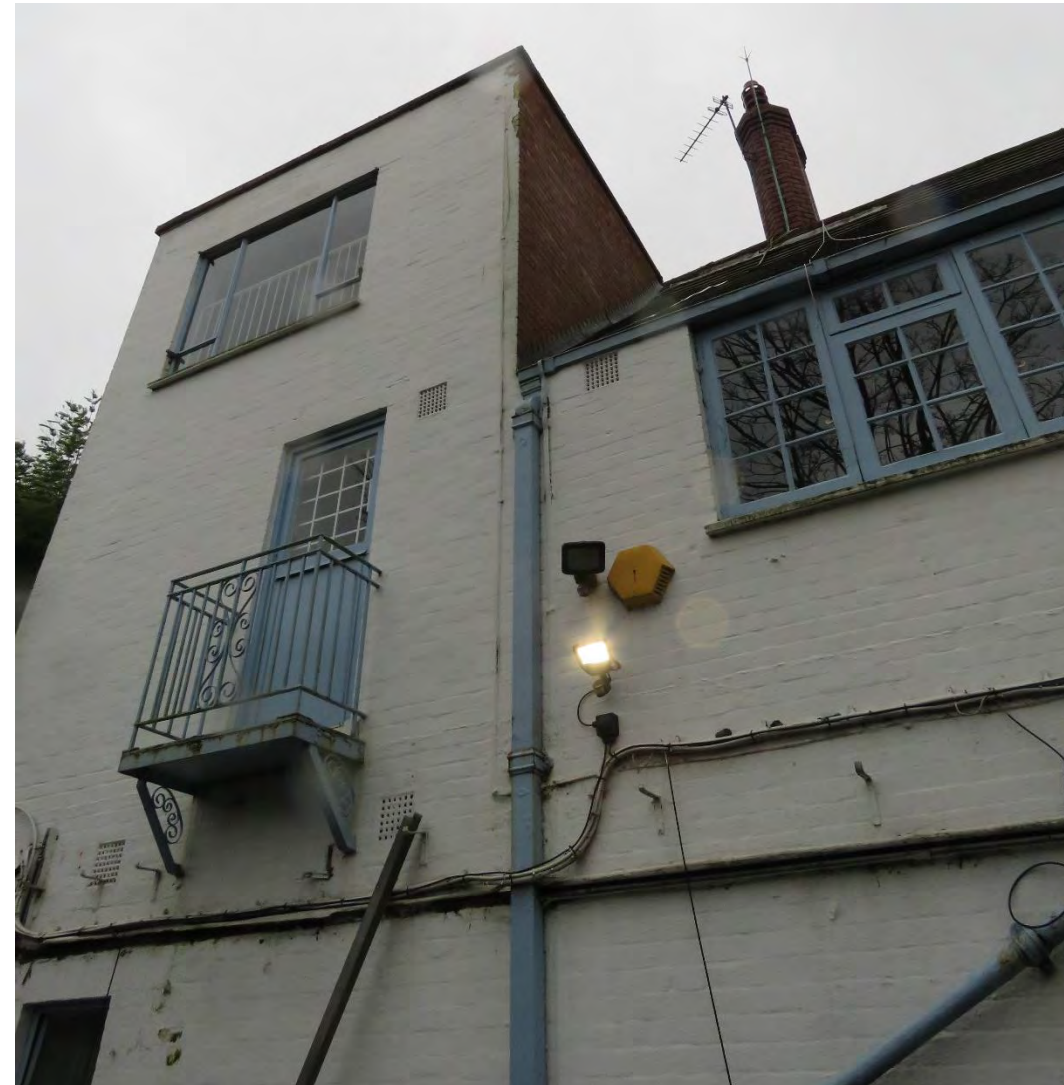
Figure 5: East elevation showing the garage extension to the left (south) with the additional (second storey). The window to the right appears to be a c.1960s addition.

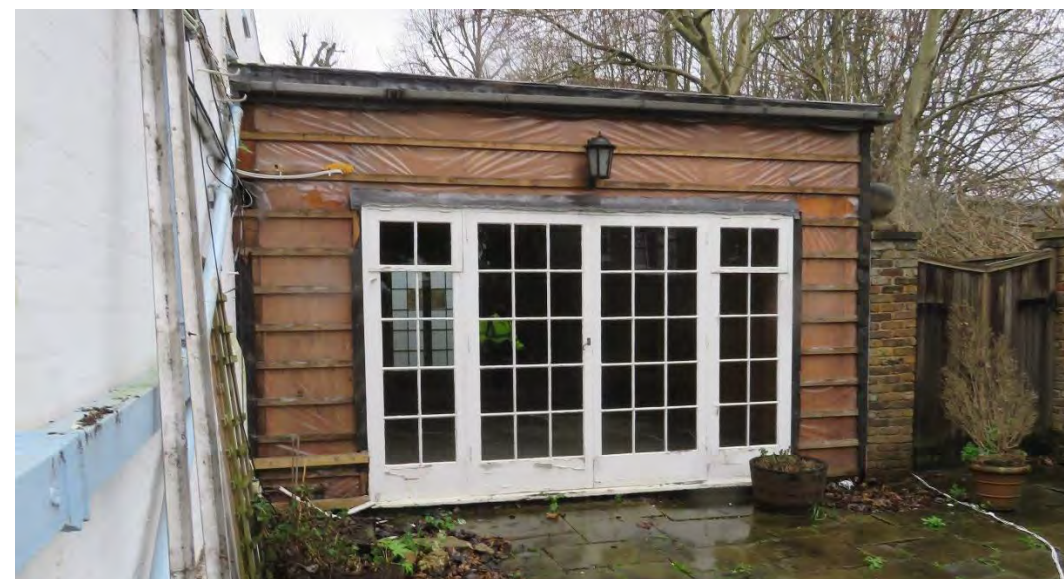
Figure 6: The c.1969 library extension to the east of the main house.

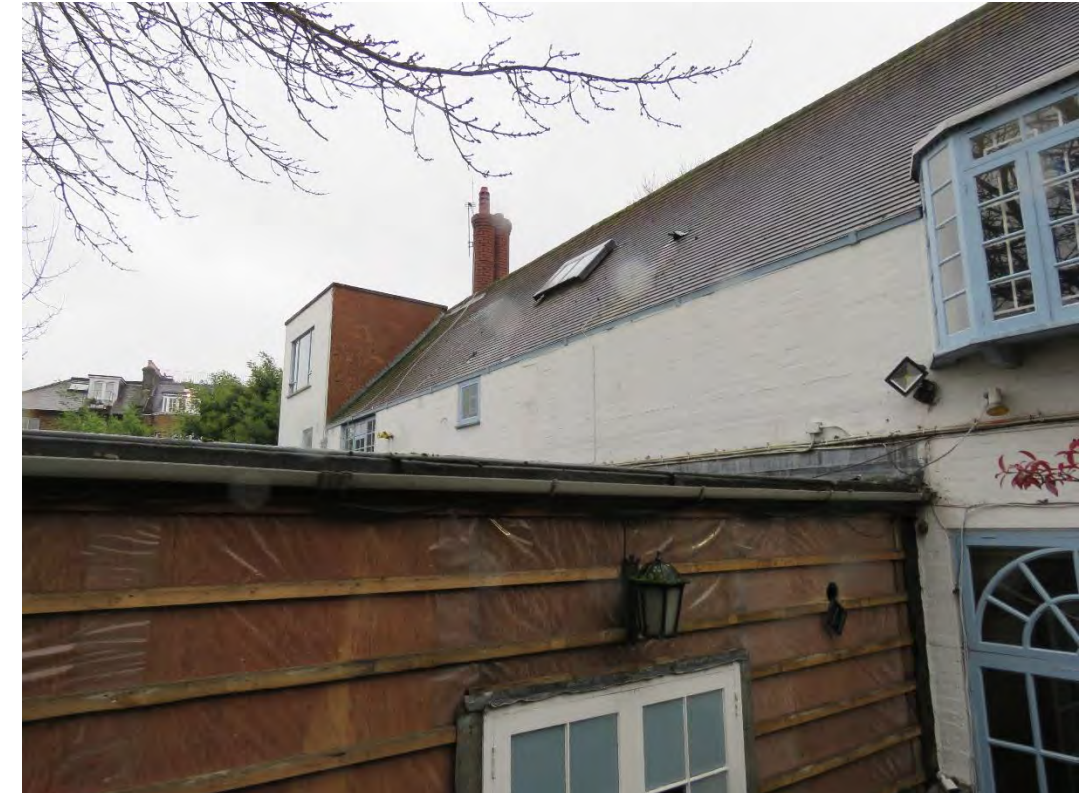
Figure 7: View of the East elevation of the house showing the library extension in the foreground. The second storey extension within the roof is seen in the background (far left) and the first floor bay window is seen to the far right.

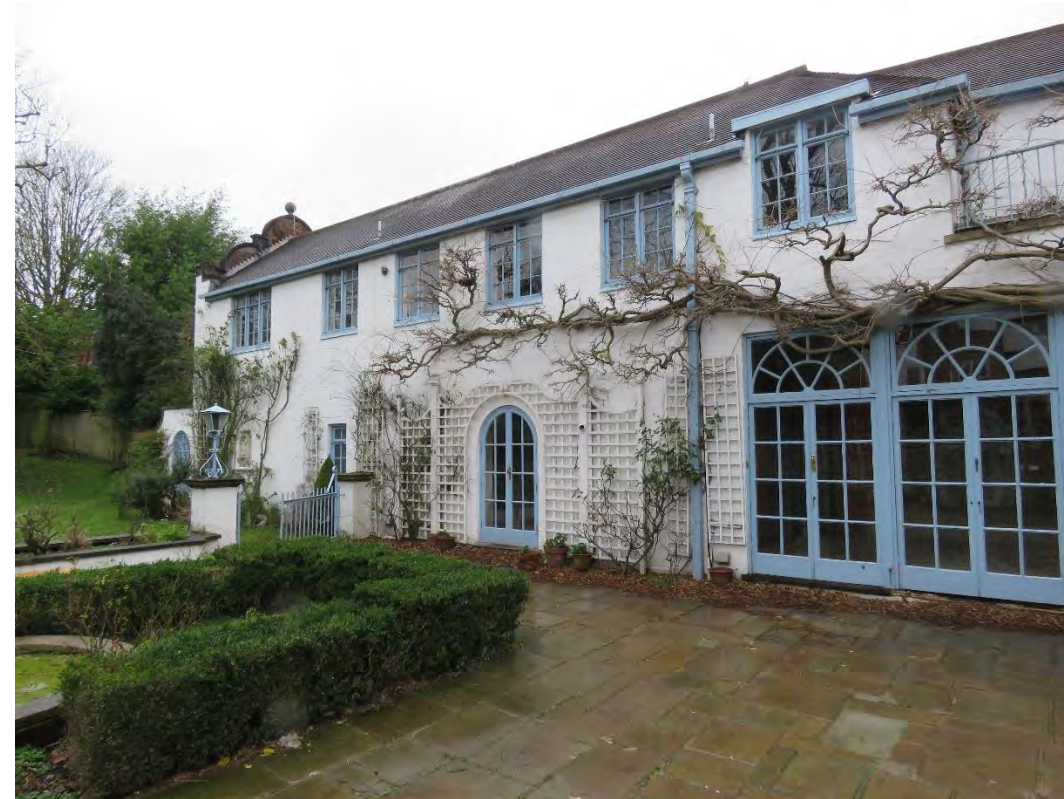
Figure 9: General view of the south elevation of the 1955-65 wing.

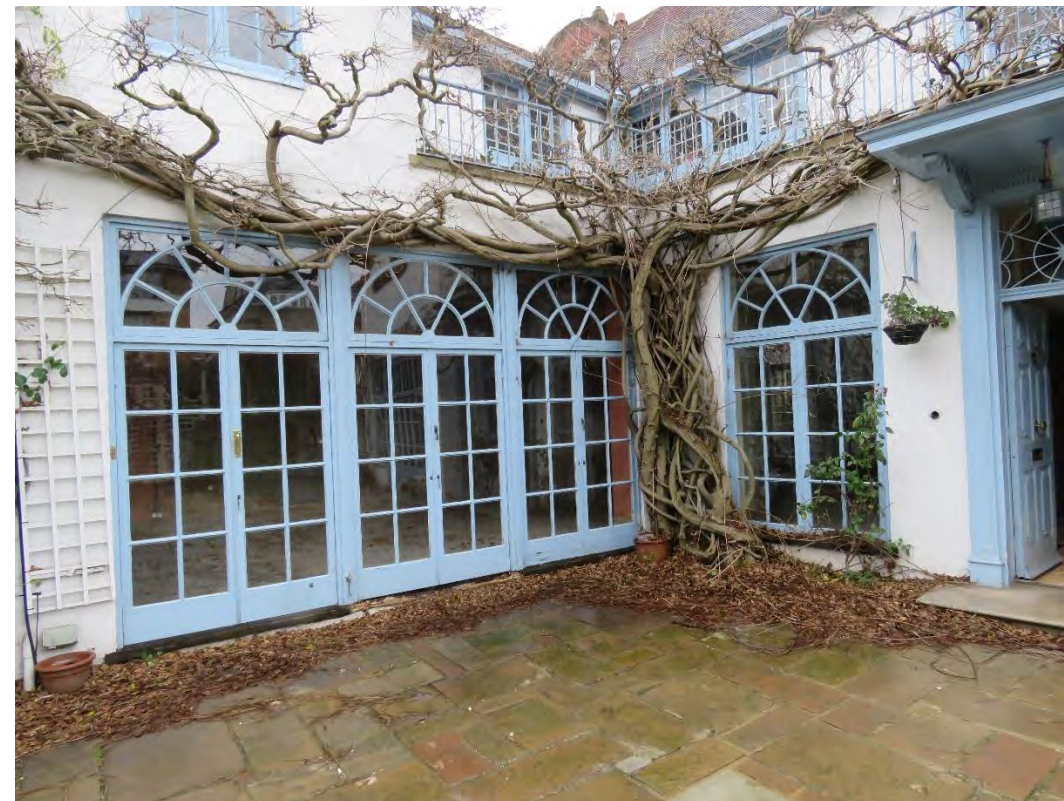
Figure 10: Connection between the 1955-65 wing and the main house. Note the large glazed doors at ground floor and the balcony at first floor.

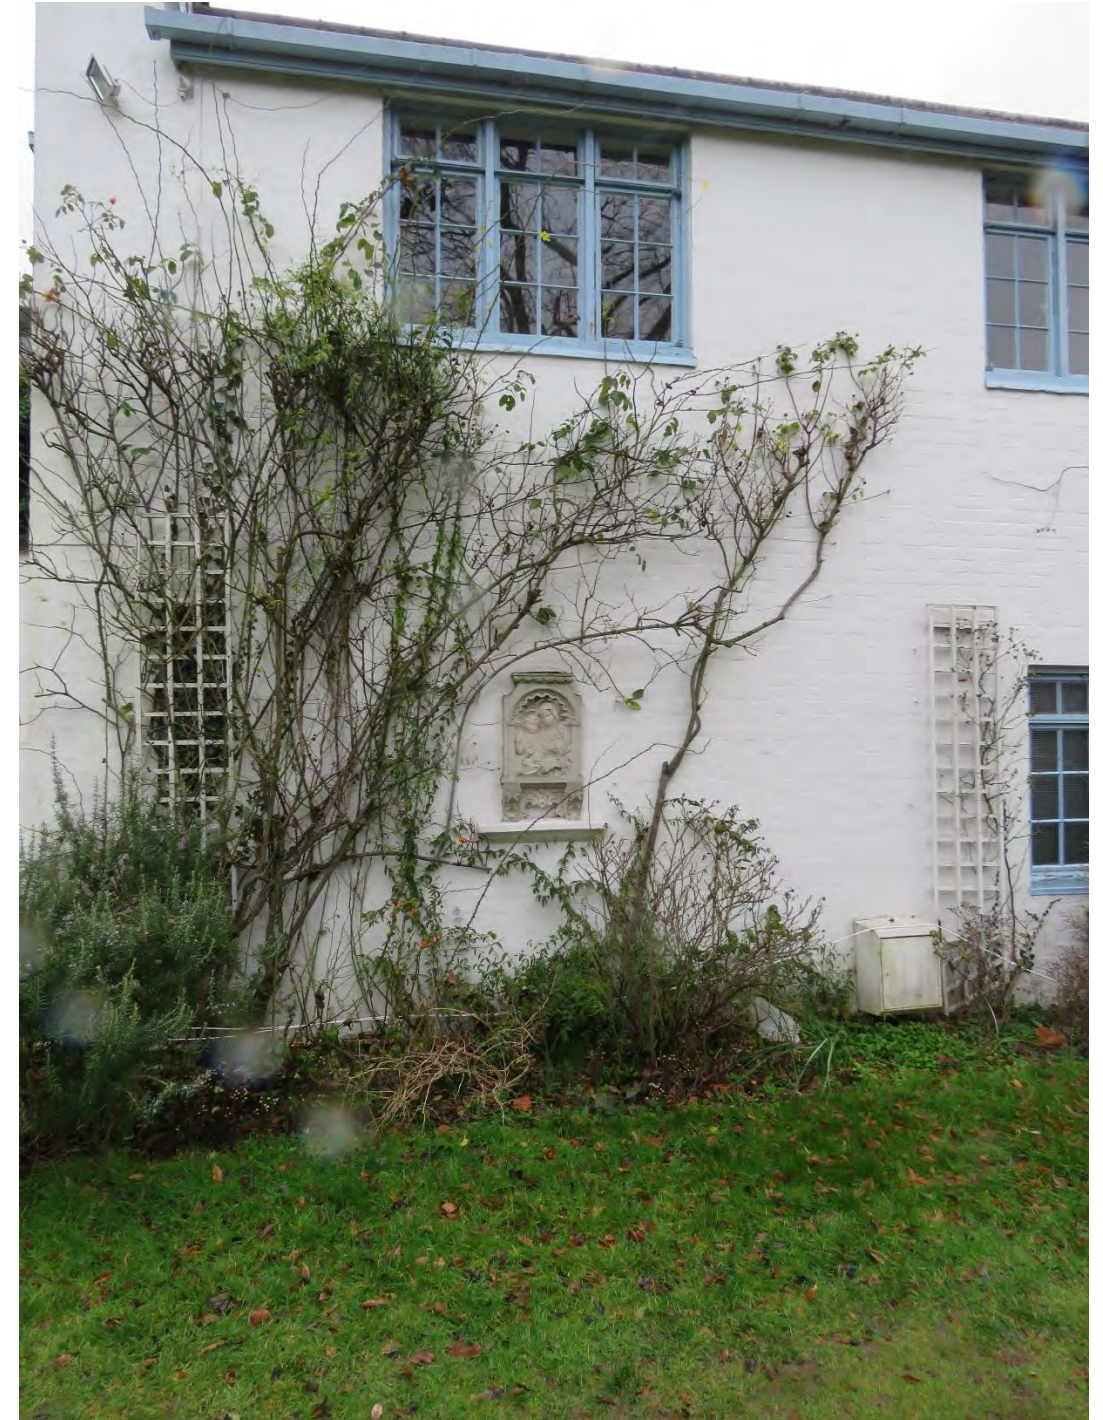
Figure 11: View of the south elevation of the 1955-65 wing. Note the timber casement windows.

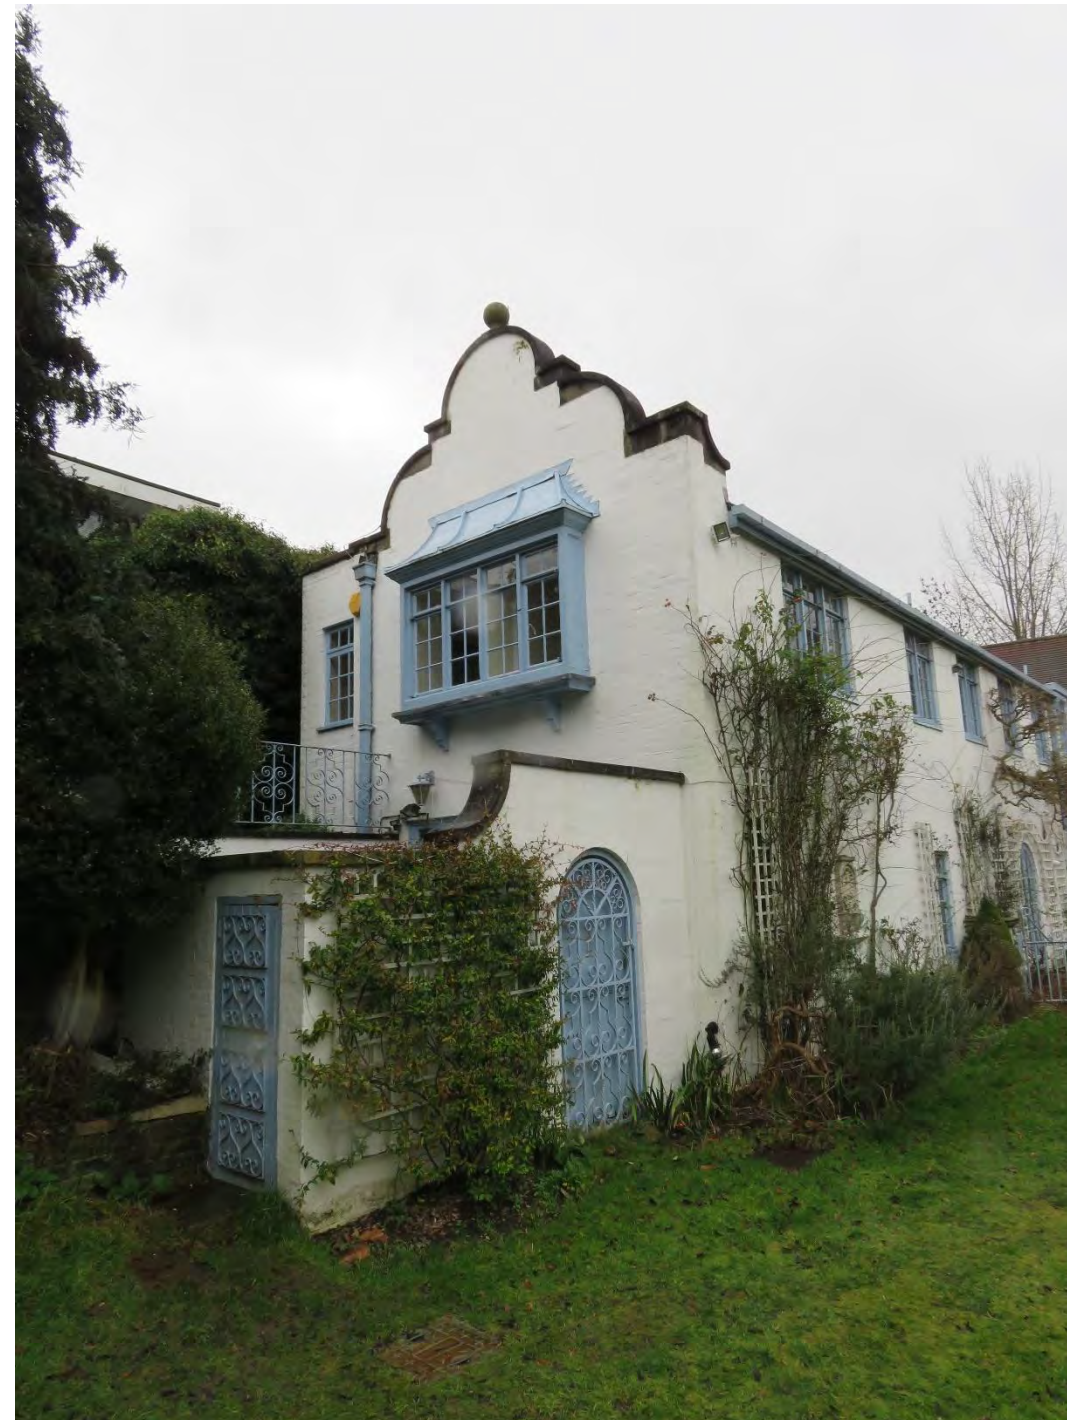
Figure 12: View of the west front of the 1955-65 wing. The gable 'apes' the original gable of the main house but the level of detailing is poor. The rectangular bay window with a small led roof is of poor-quality design. The projecting enclosure at ground floor further detracts from any meaningful reading of this elevation.

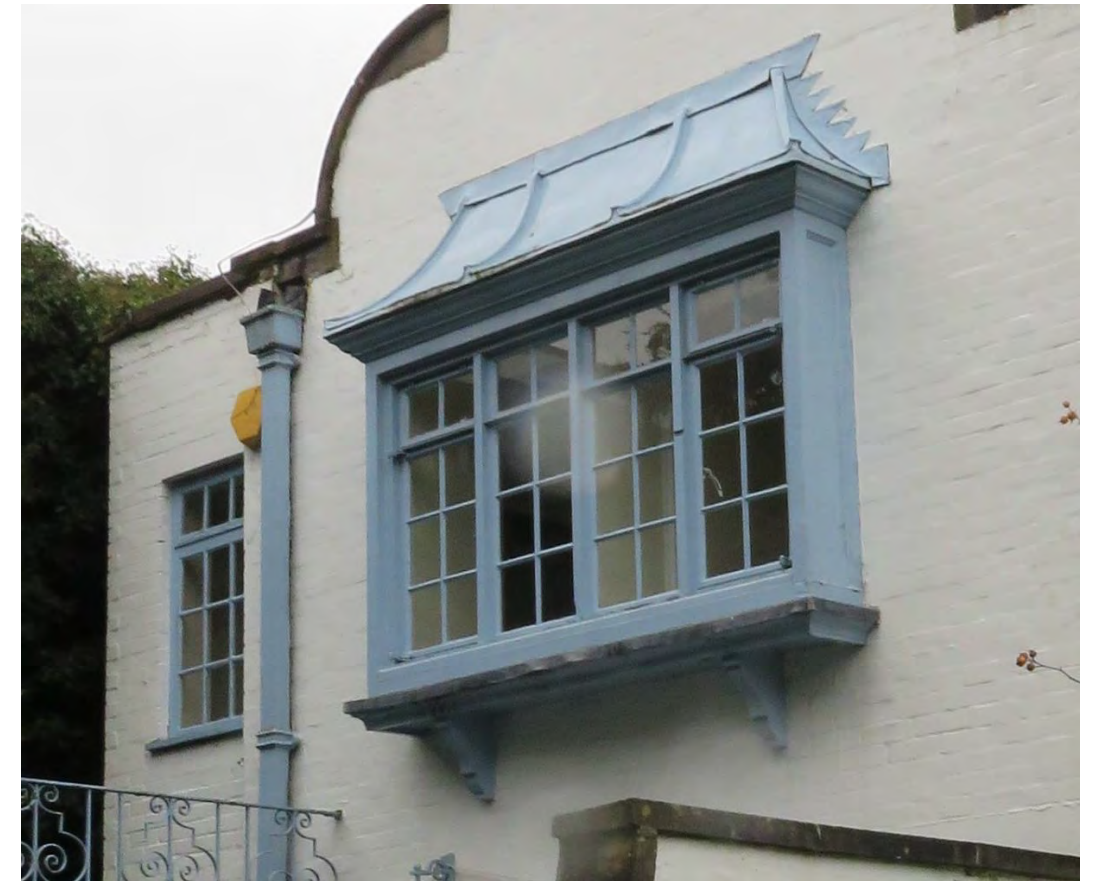
Figure 13: Detail of the first-floor bay window on this elevation. Note the poor quality of design and detailing.

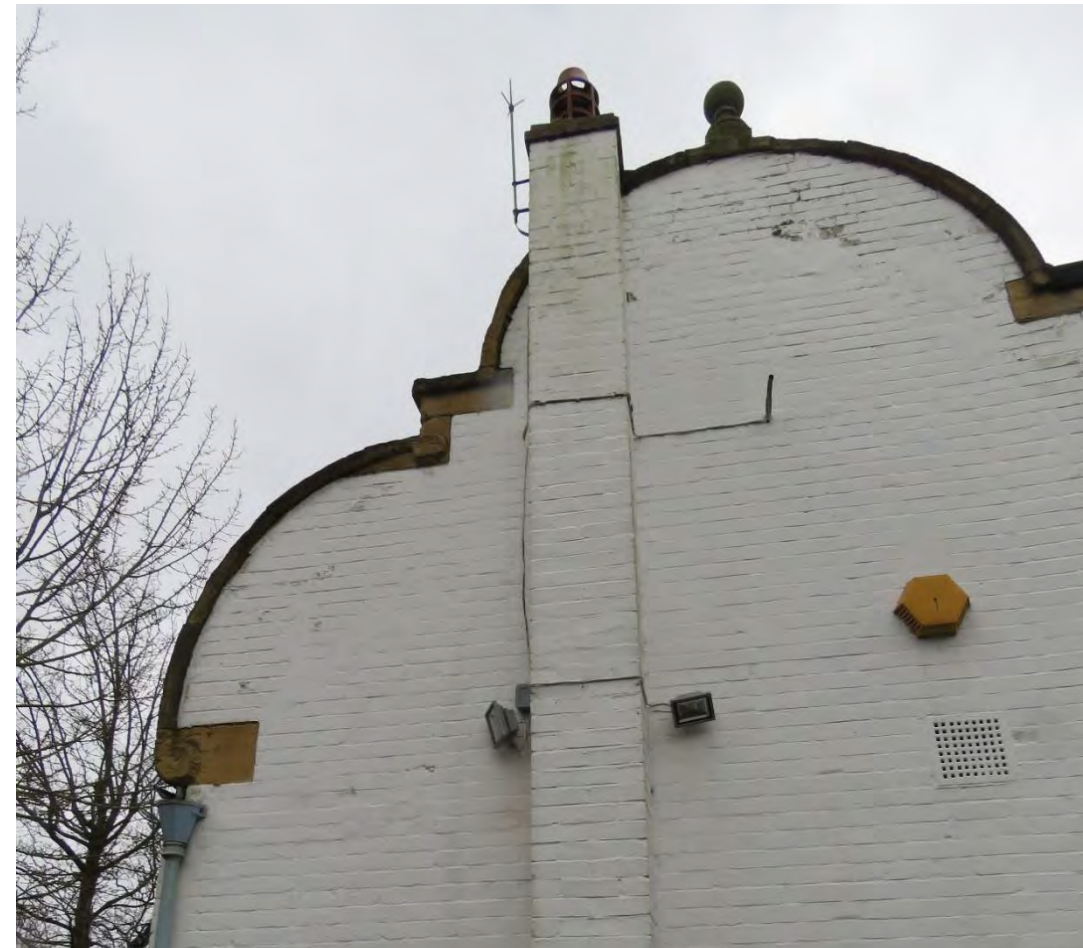
Figure 14: View of gable on the east end of the north elevation

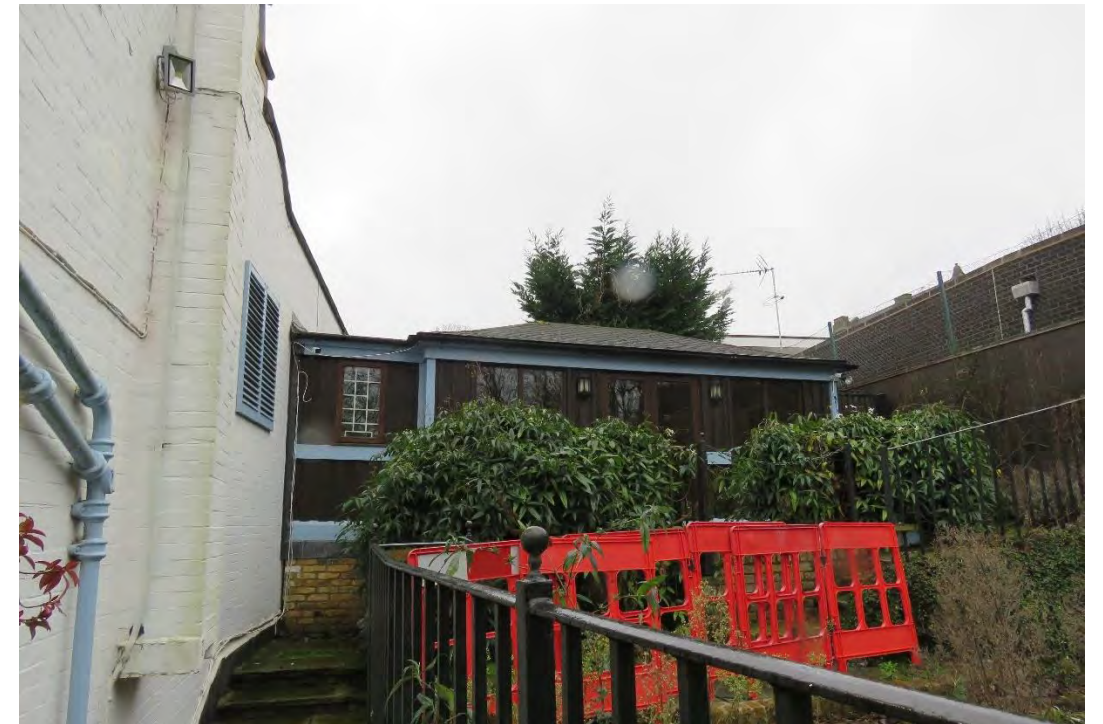
Figure 16: View of the pool house along the north elevation

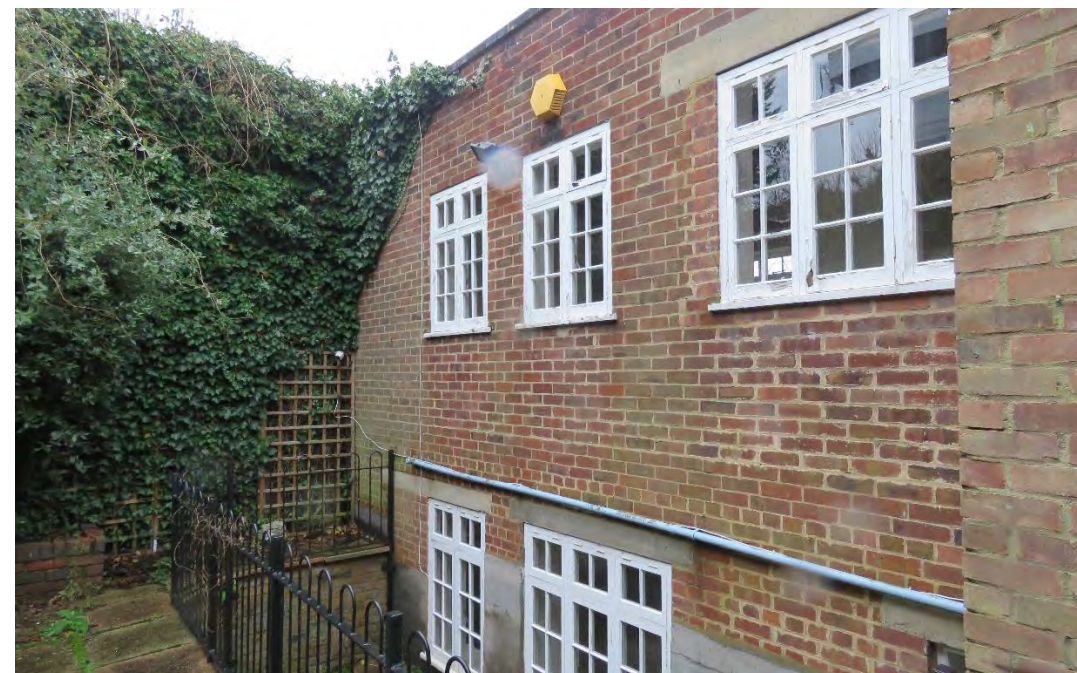
Figure 15: View of 1955-65 wing wall west end of the pool house

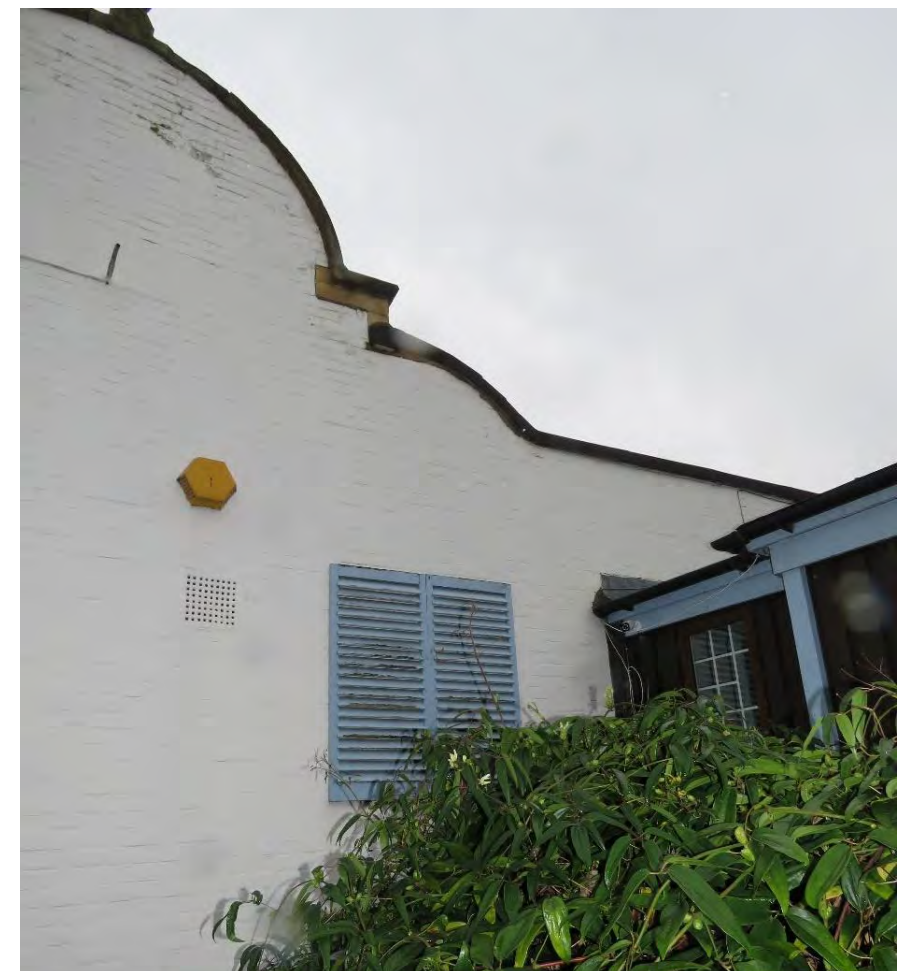
Figure 17: View of part of the gable and the connecting section to the pool house

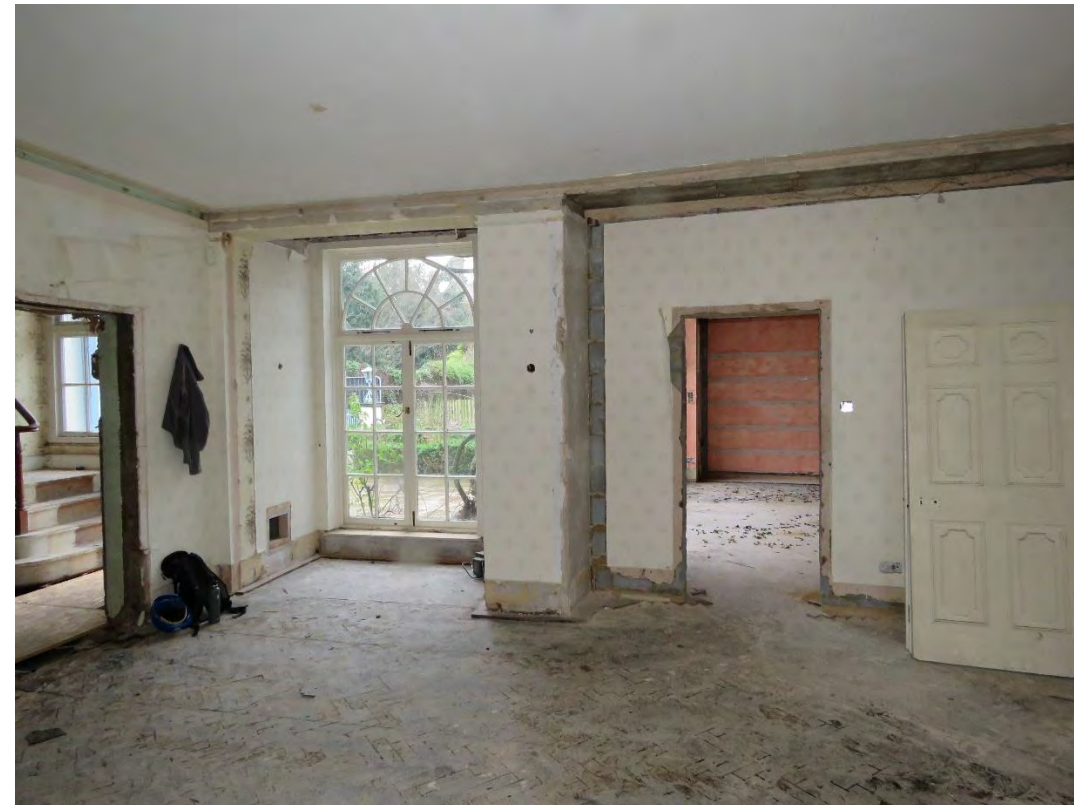
Figure 18: View of ground floor dining room. Note the original extent of the building line and the c.1960s extension with the French door (extended outwards)

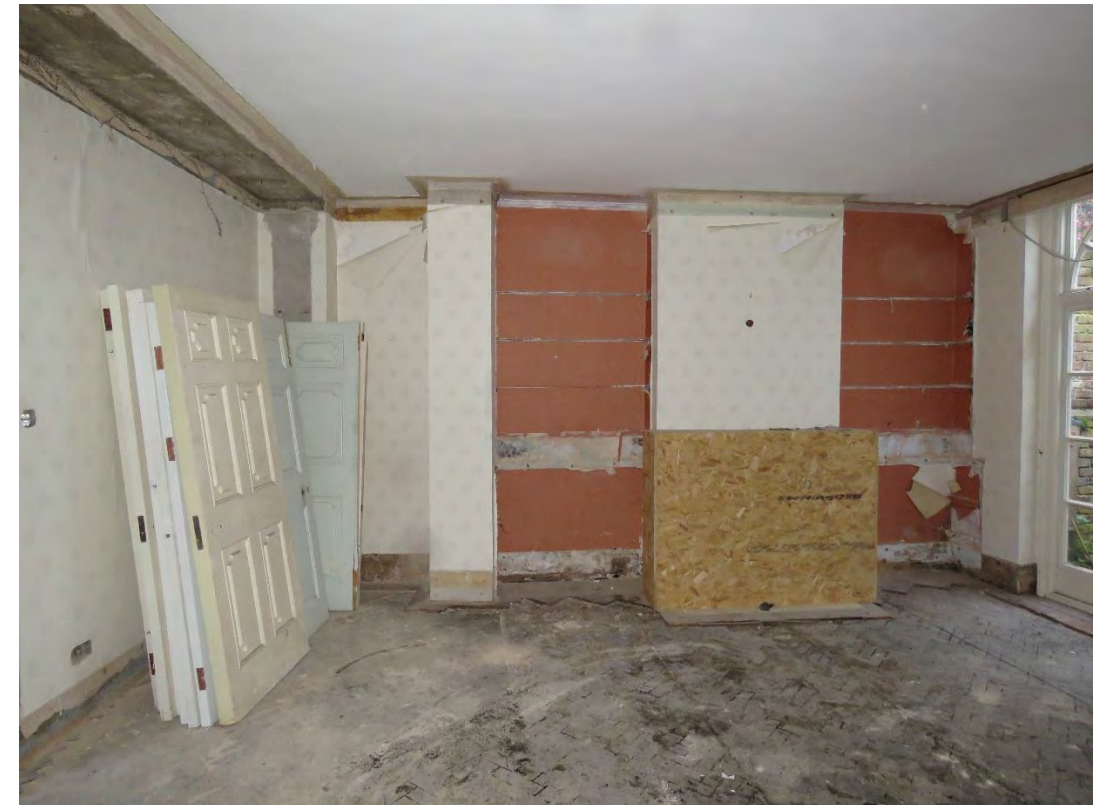
Figure 20: View of north wall showing the original chimney breast and the fireplace (protected in situ)

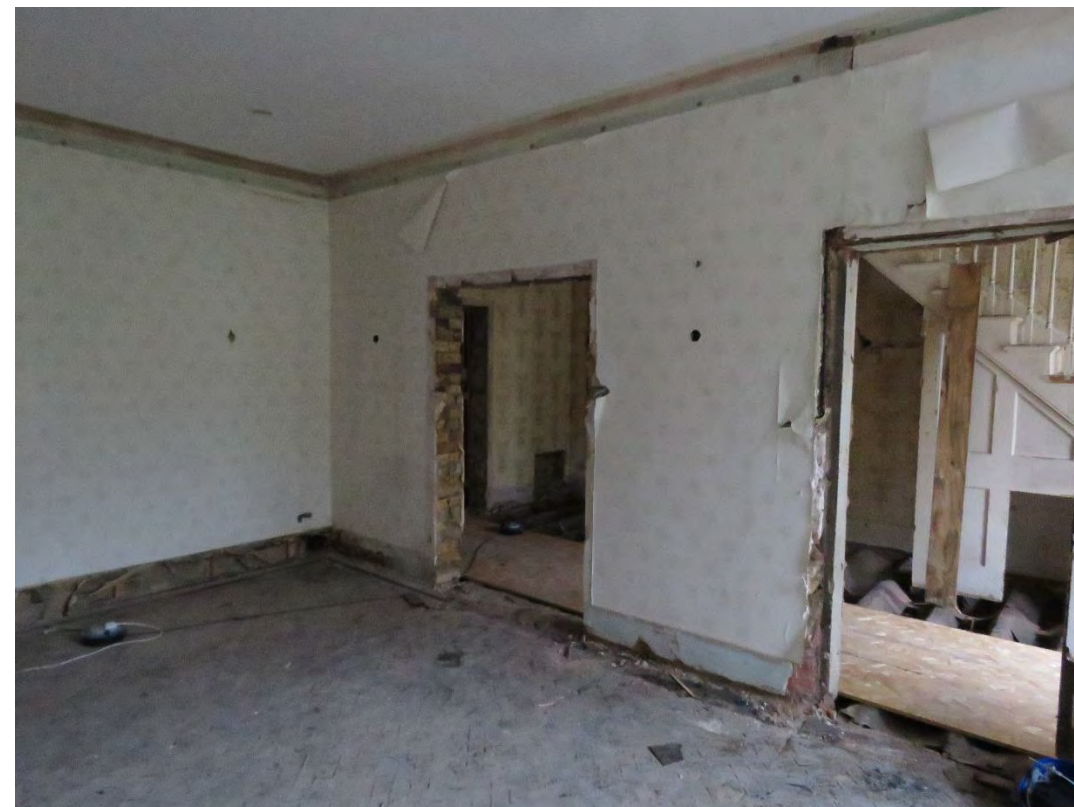
Figure 19: View of two doorways leading from the main entrance hall to the dining room. The door lintels are composed of channel sections, indicating that these were created at a later date.

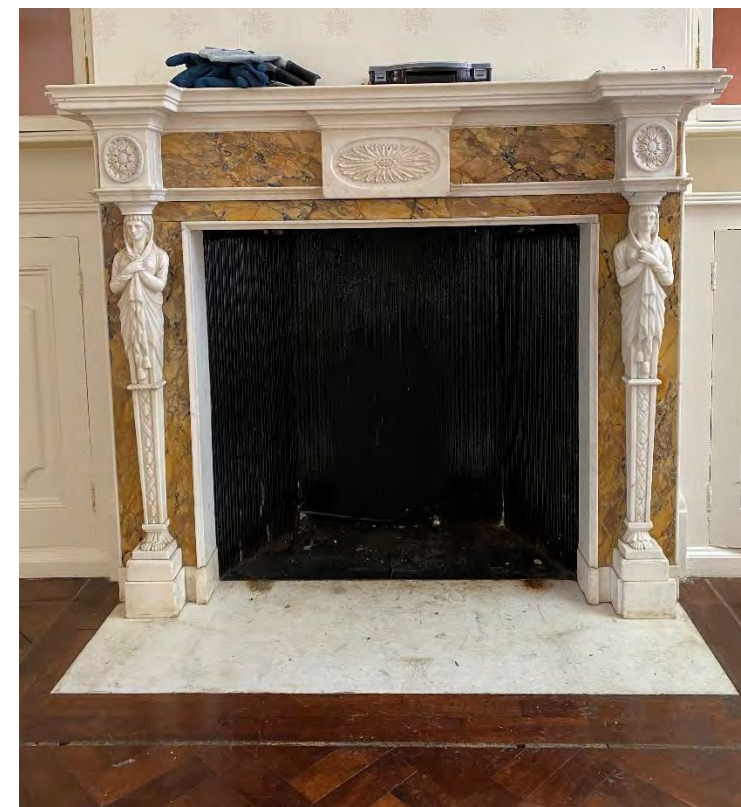
Figure 21: View of fireplace that is currently protected in situ.

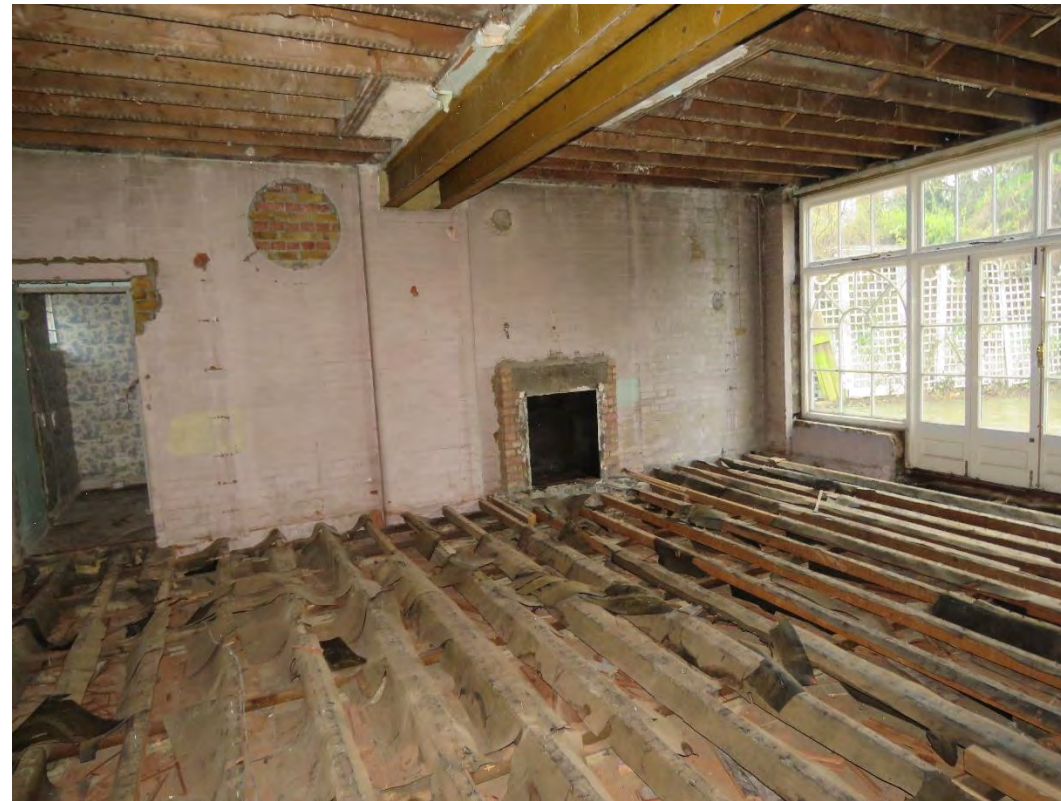
Figure 22: View of the reception room, looking south. Note the later 'fireplace' on the south wall, blocked bulls eye window. The steel I sections spanning the room and supporting the timber joists may be a later intervention necessitated by intrusive structural works in this area. The conservatory style glazed French doors to the right are modern.

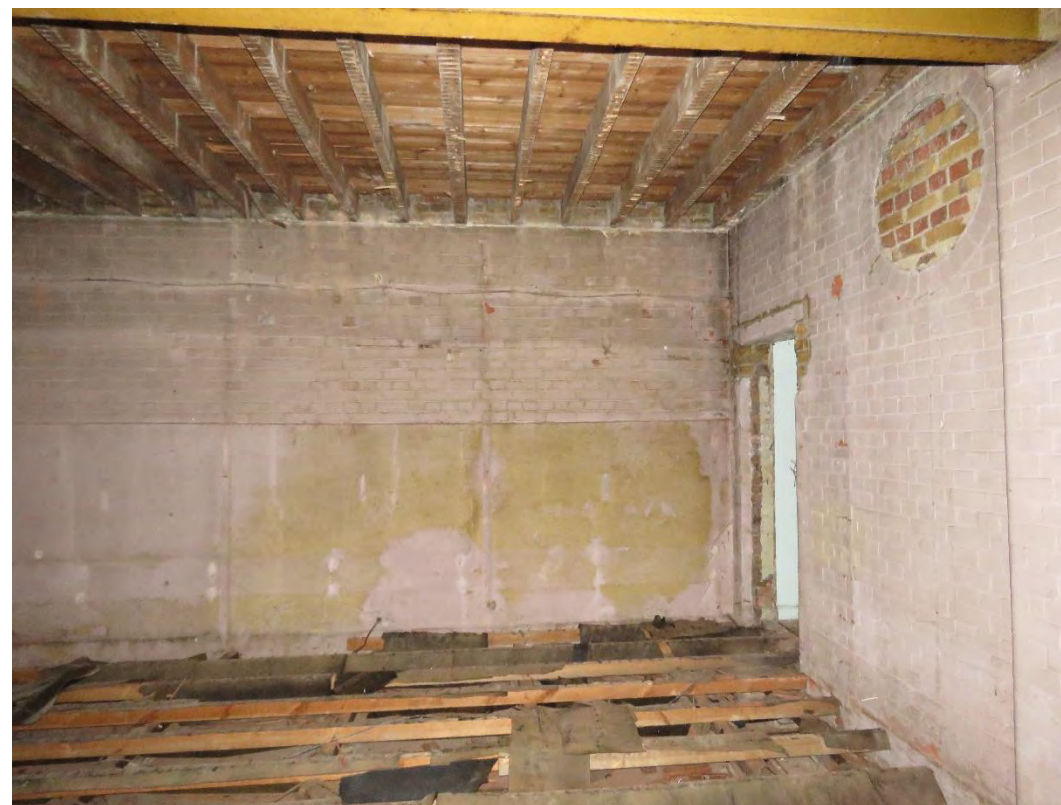
Figure 23: View of the reception room, looking east. Note the modern doorway leading to the WC.

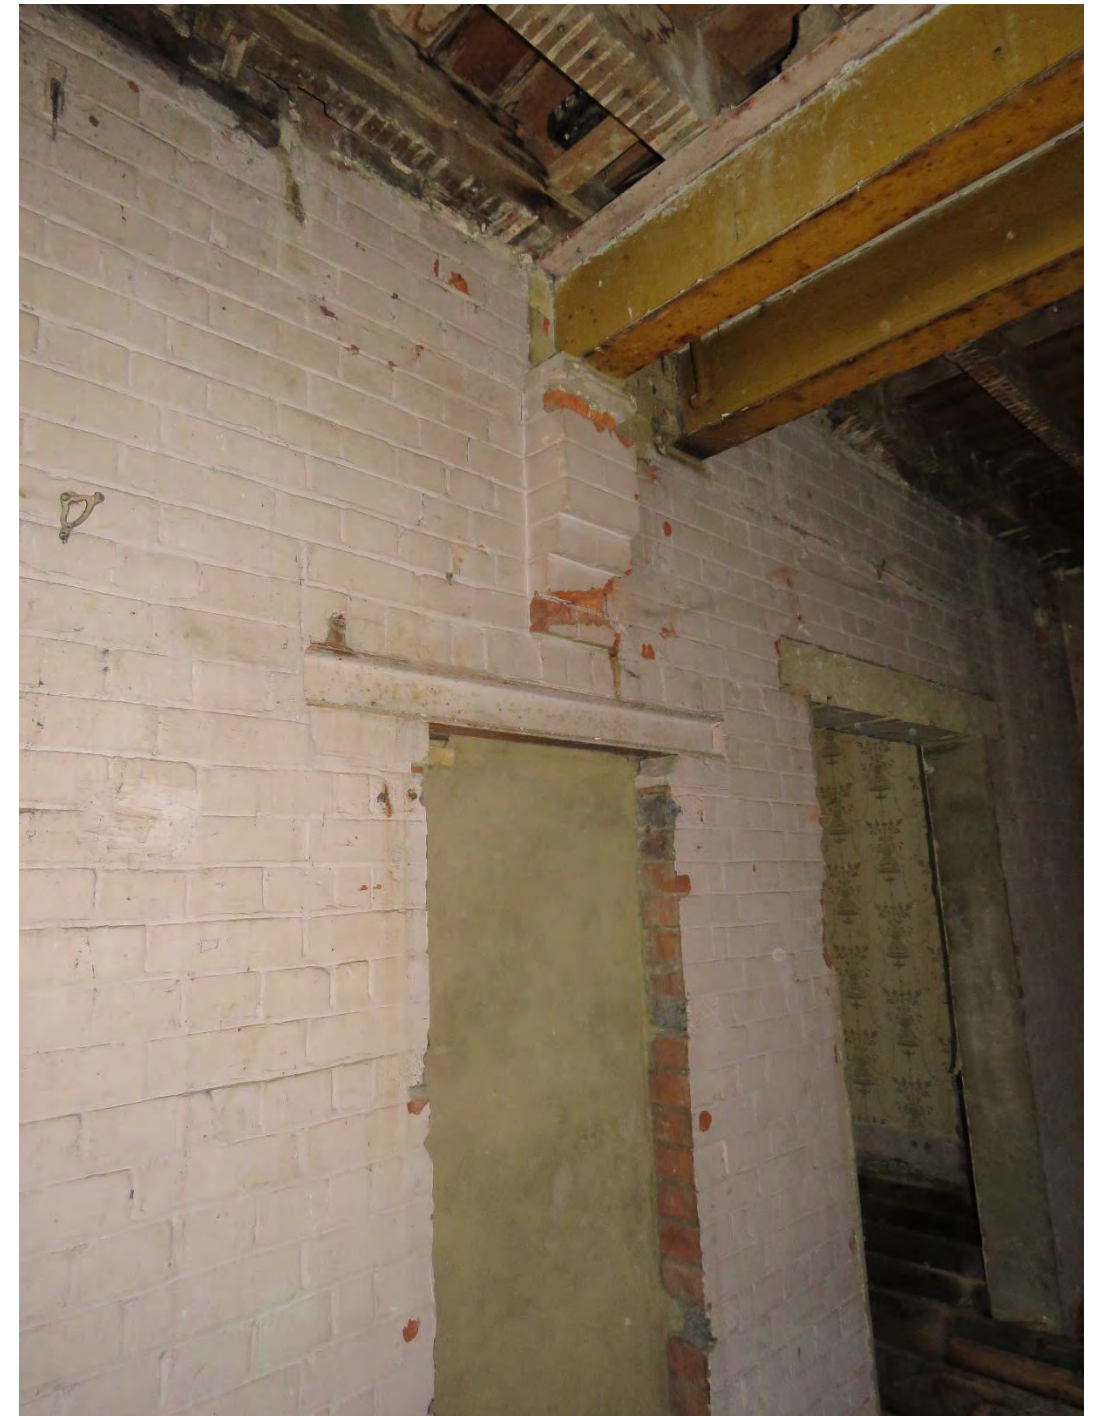
Figure 24: View of the two doorways leading to the Reception room from the entrance hall. The opening to the left (with a C channel lintel) is blocked, presumably when the staircase was added in its current location behind this. The second opening to the right has an RCC lintel and is modern.

Also note the brick bracket over the blocked opening, presumably added to provide extra bearing for the structural steel beam.
