82 Fitzjohn Avenue
Photographic walkthrough

External Photographs

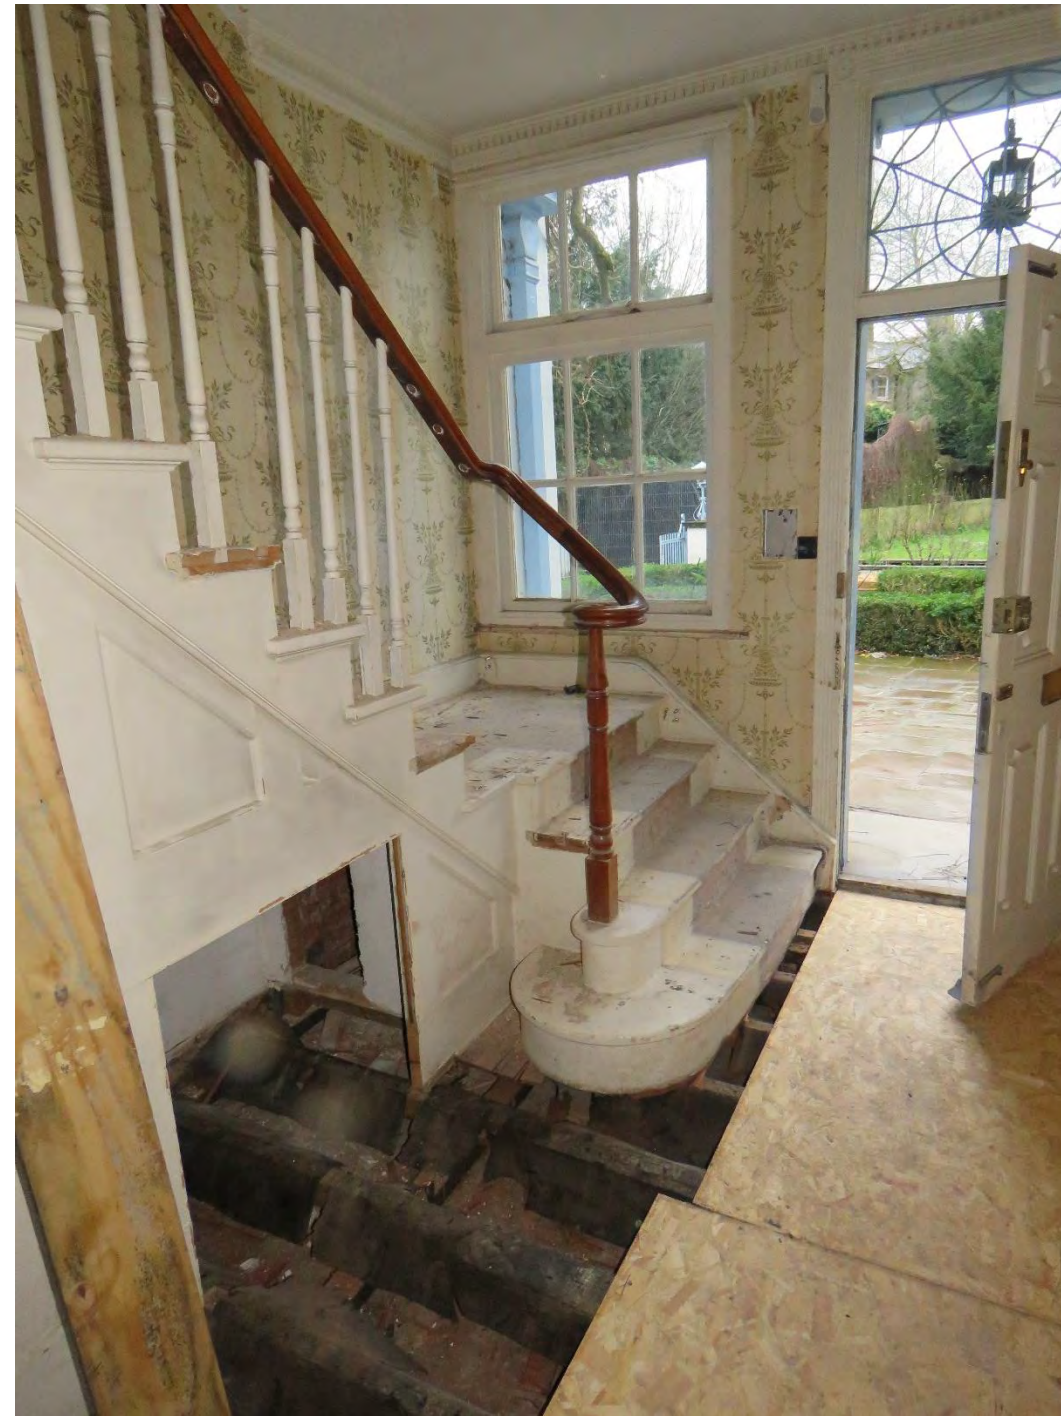
Figure 25: View of the entrance hall and staircase looking west. Though the staircase may visually be of an early-mid-20th C date, its construction detailing appears modern (**Figure 26**) and location is not original as the wall (with the window and entrance door) was brought forward during the c.1960s works. The insertion of the staircase in this location further necessitated blocking an opening from the Reception room (**Figure 24**)

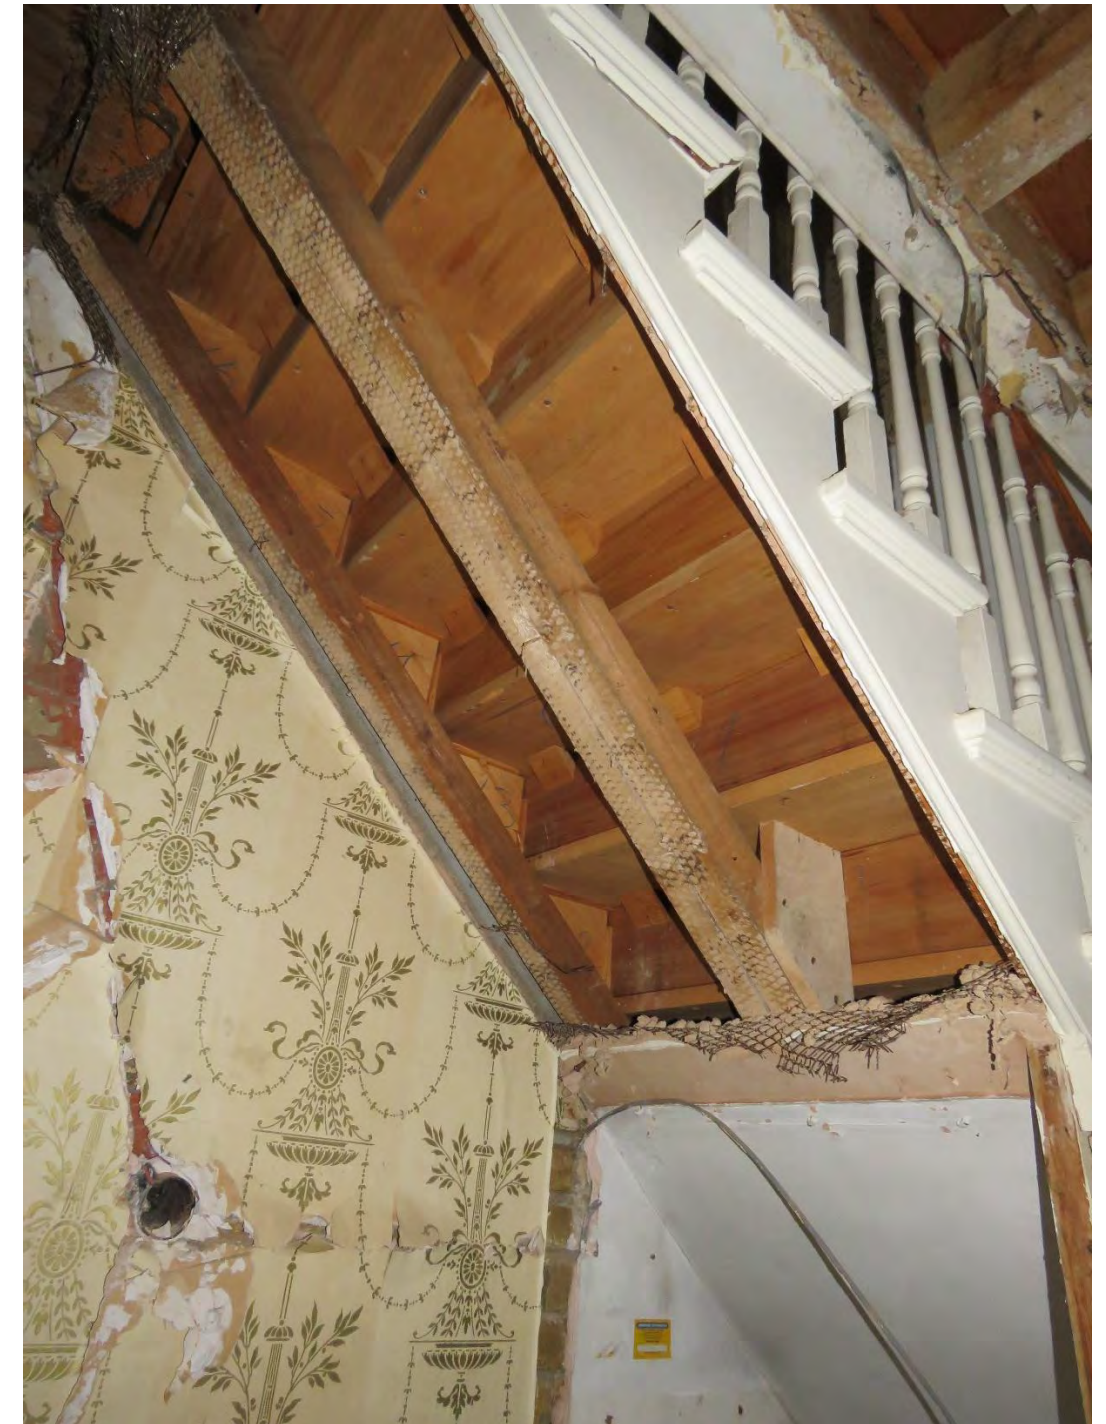
Figure 26: View of the underside of the staircase showing the modern stringer beam, treads and risers. The construction of the staircase appears to be modern.

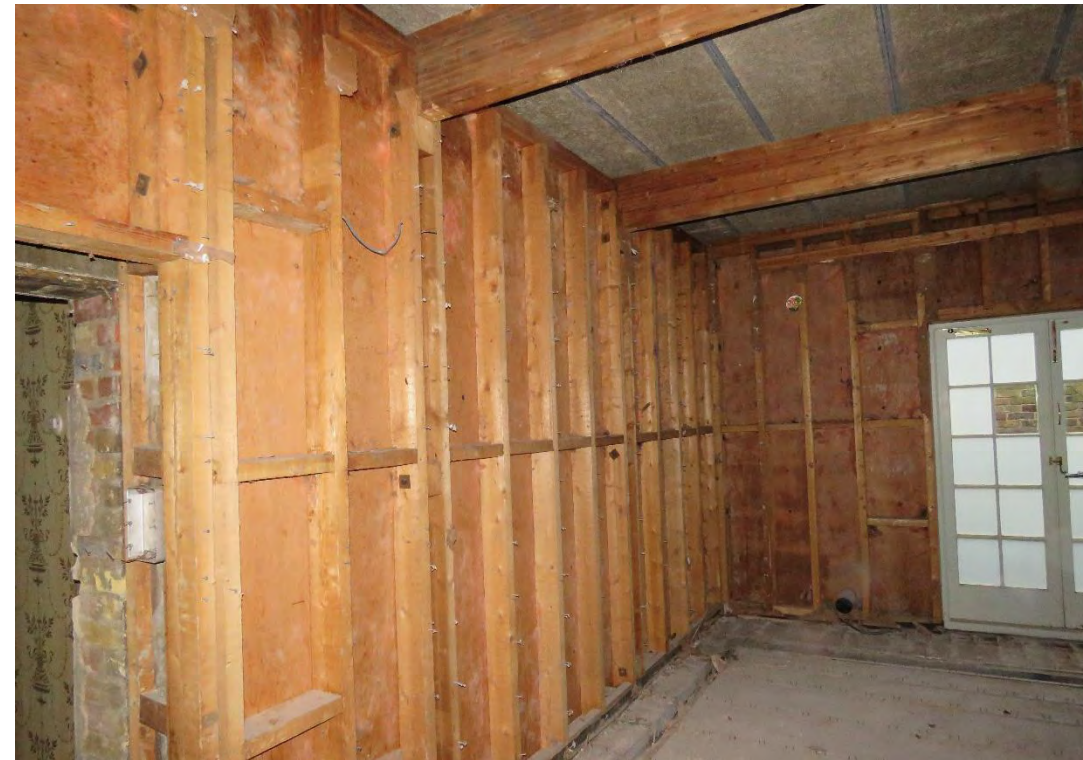
Figure 27: View of the c.1969 library extension. Note the timber studwork walls

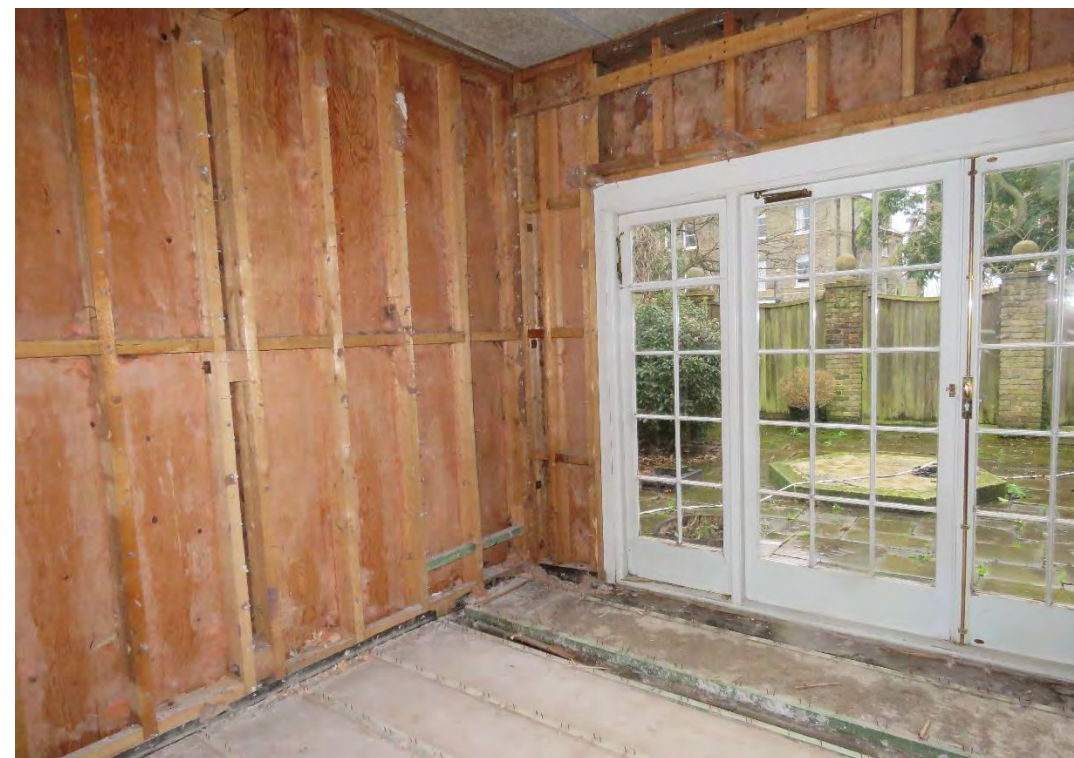
Figure 28: View of the c.1969 library extension. Note the modern glazed French doors with chunky moulded details

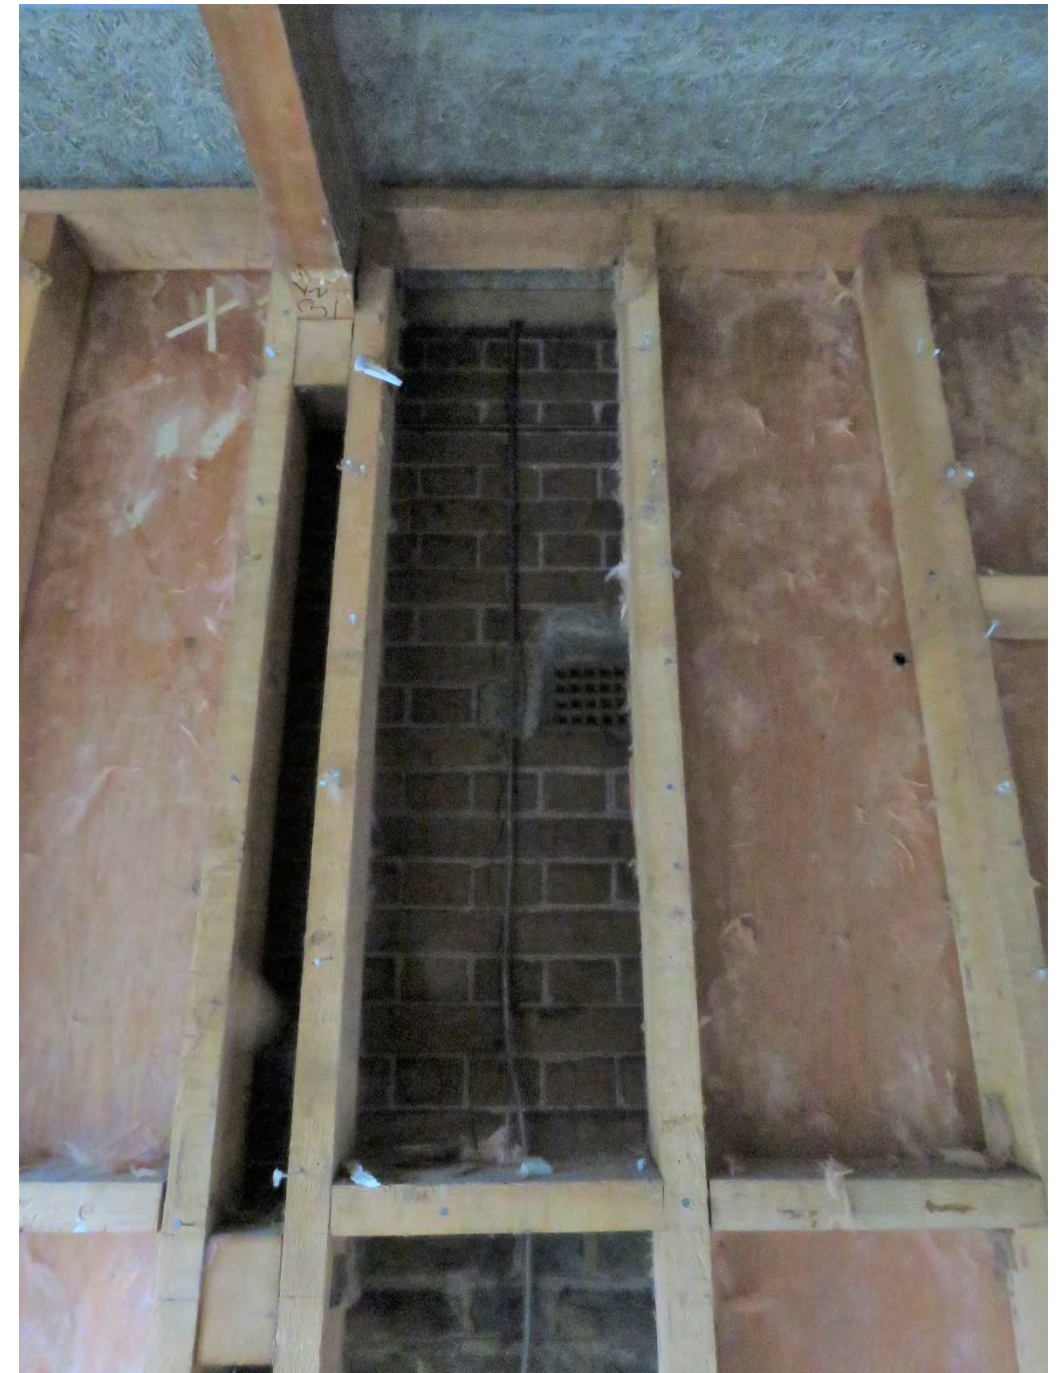
Figure 29: Detail of the timber studwork walls with plywood covering. Note the original exposed brick masonry behind. The house was originally brick faced and presumably transformed to its current 'whitewashed' form only after c.1969.

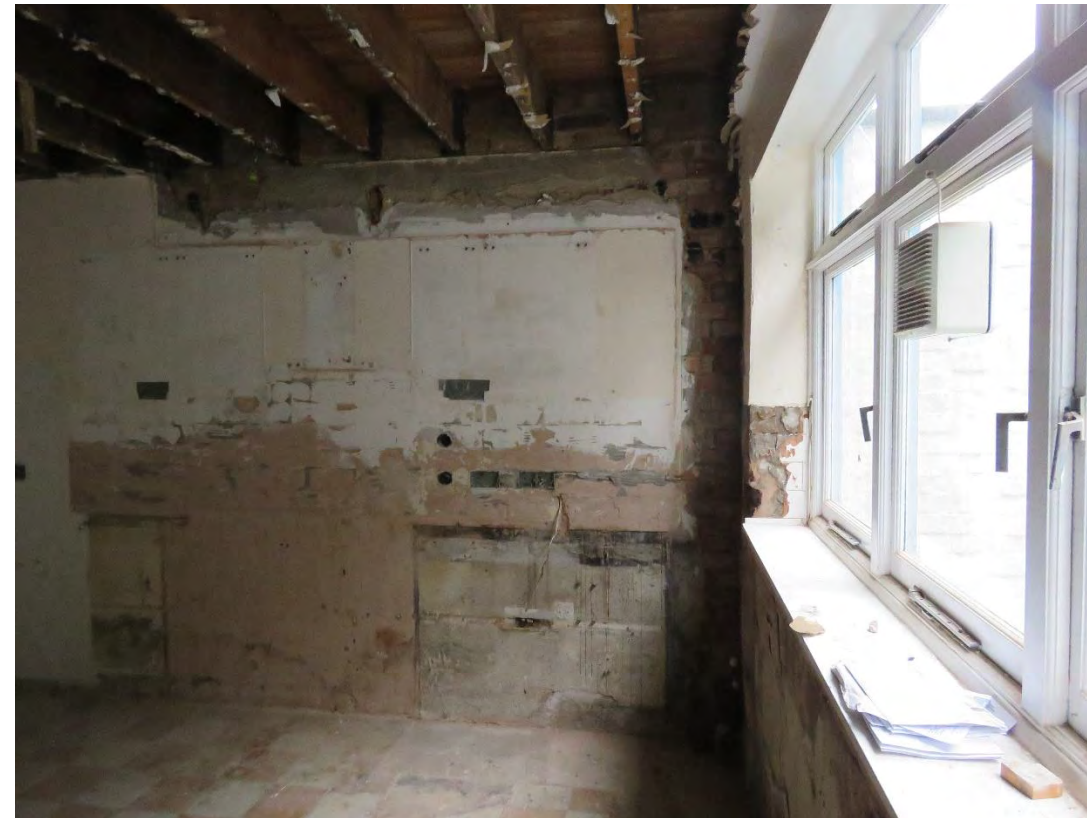
Figure 32: View of one of the rooms in the 1955-65 extension. Note the modern windows, cement plastered walls, linoleum floors and timber joist ceiling.

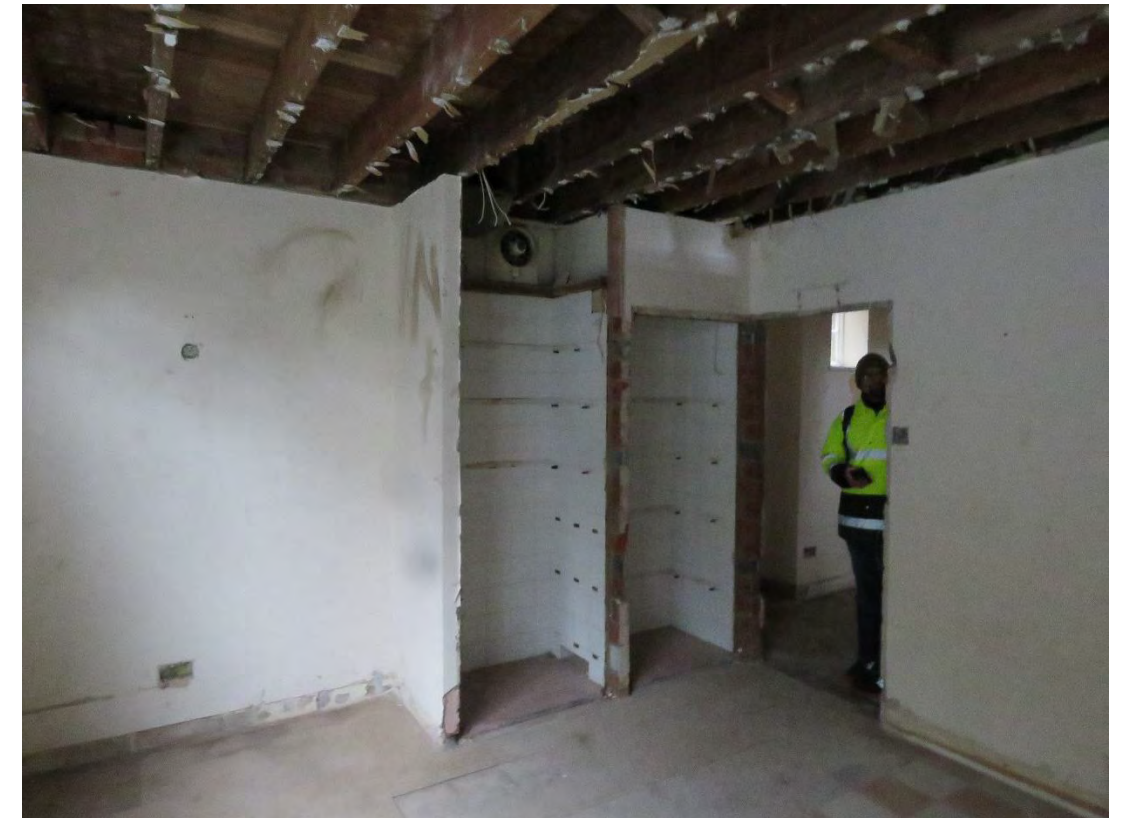
Figure 34: View of one of the rooms in the 1955-65 extension. Note the modern studwork partitions (forming the built-in furniture), half brick thick walls and linoleum flooring.

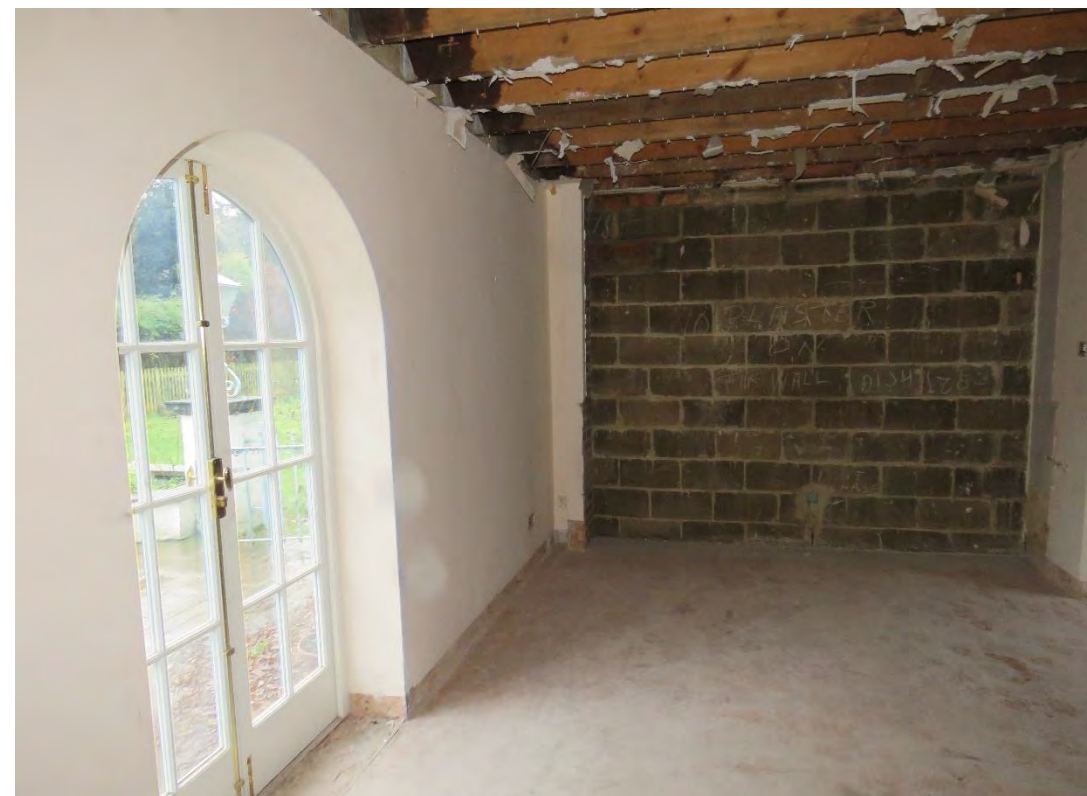
Figure 33: View of one of the rooms in the 1955-65 extension. Note the timber casement windows, modern studwork walls and cheap pine floorboards.

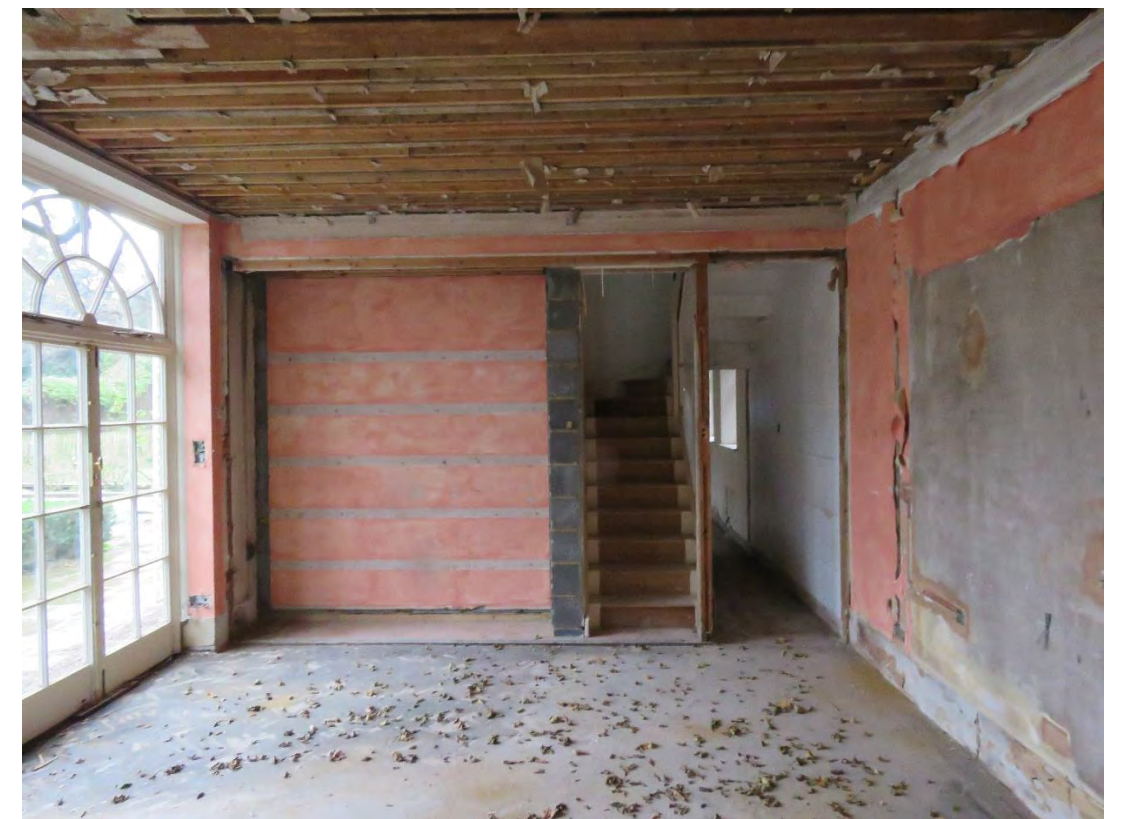
Figure 35: View of the 'Kitchen' area in the ground floor, part of the 1955-65 extension. Note the modern stairs, cement plastered walls and concrete screed floors.

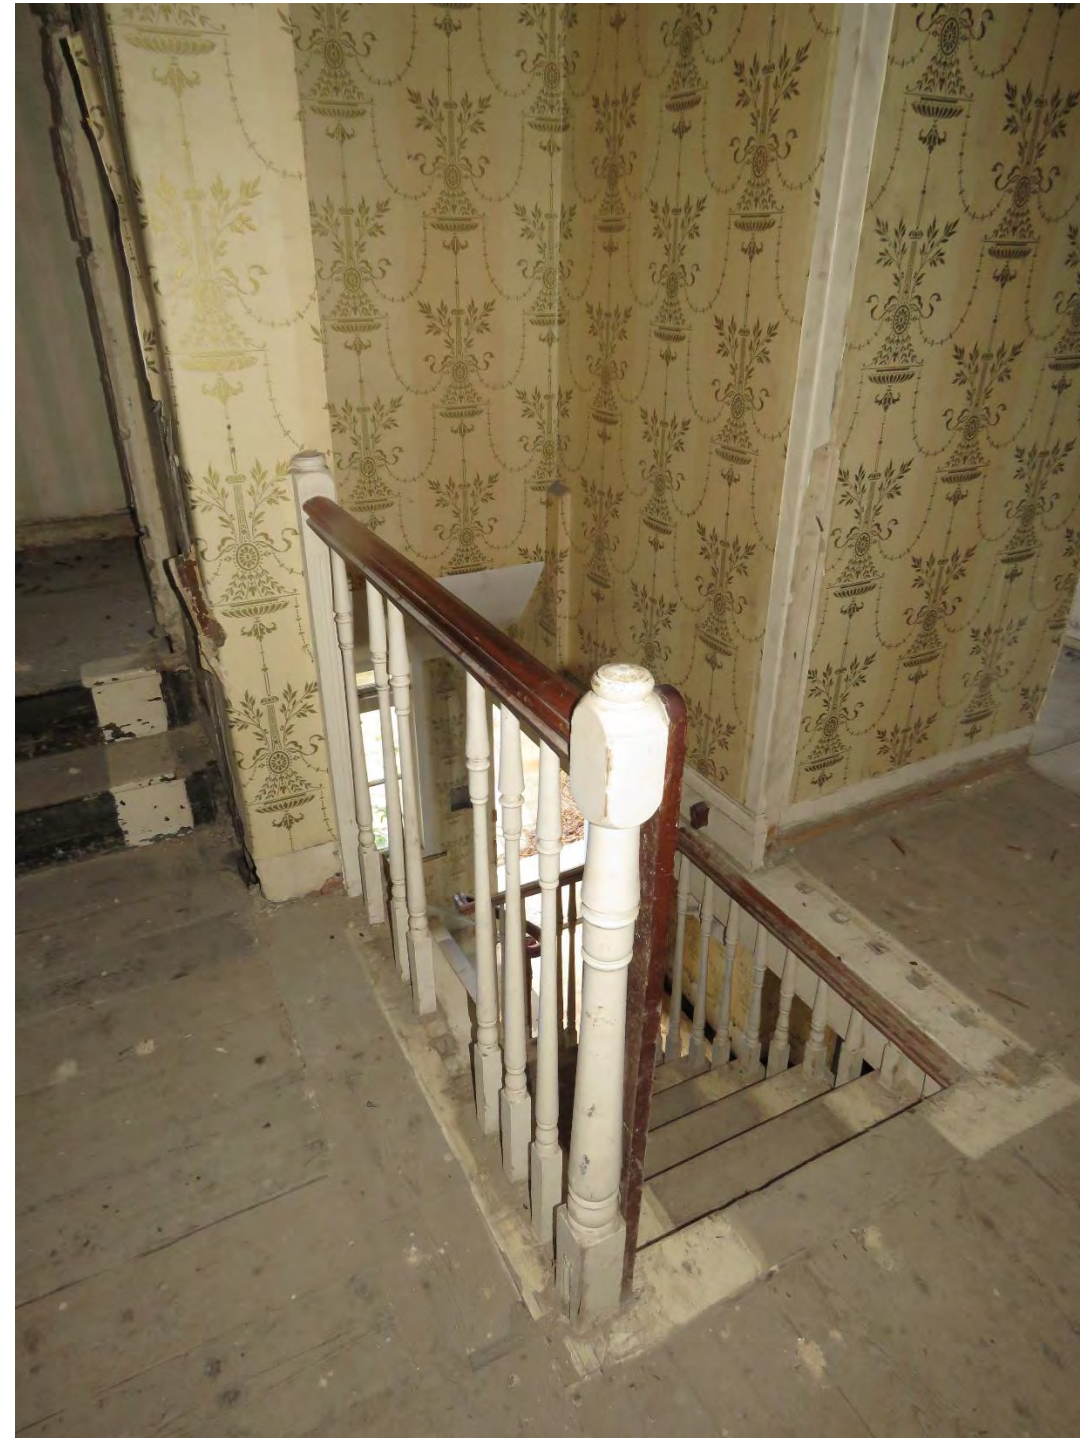
Figure 36: First floor staircase landing. This area has been heavily altered and the existing layout is not original.

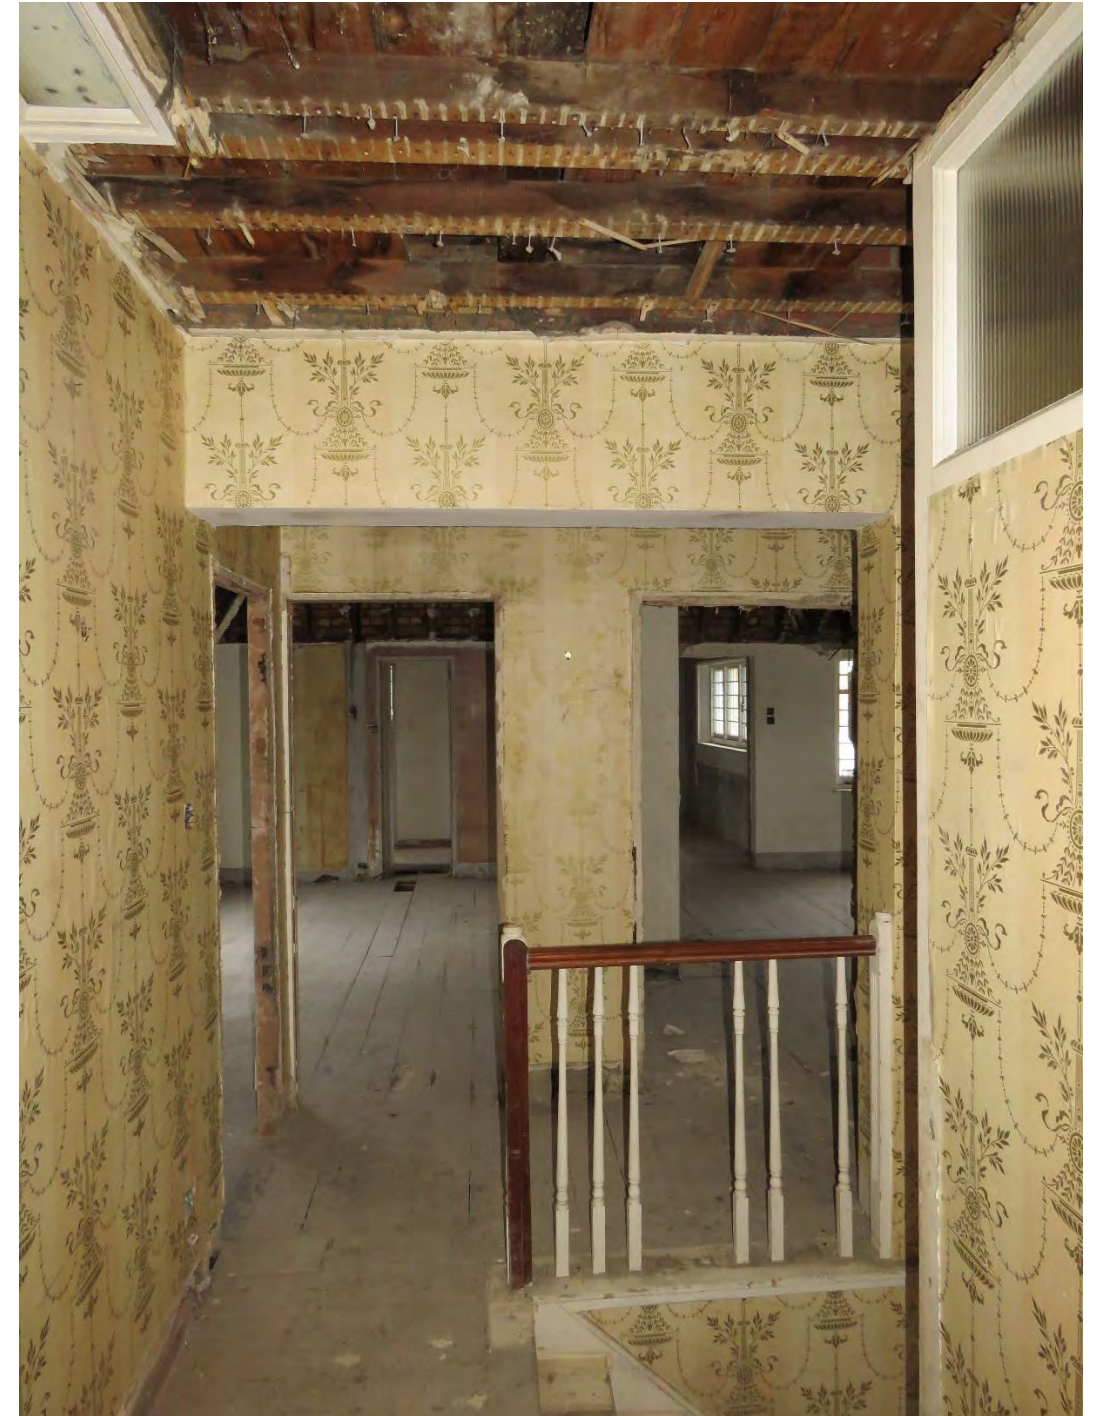
Figure 37: View of stair landing looking towards the south. The location of the original wall may be indicated by the downstand. The single brick and studwork partition with doorways leading to the bedrooms is modern. The floorboards in this area have been heavily altered.

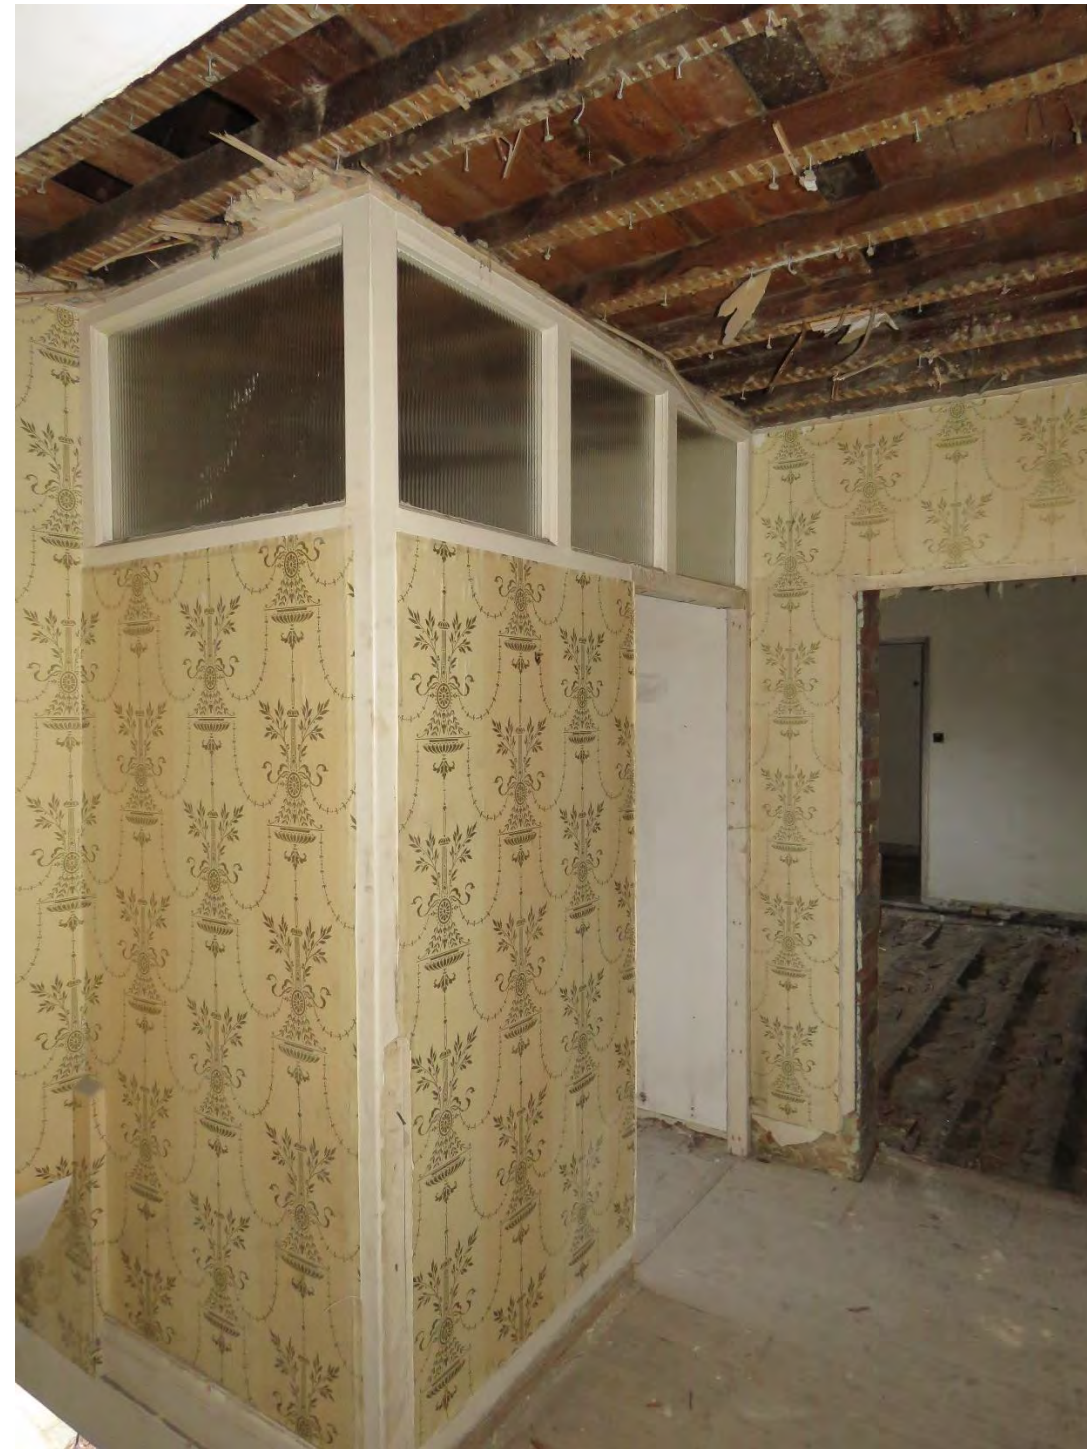
Figure 38: The modern enclosure at first floor. The enclosure is built with studwork partition walls and has glazed sections above. This view looks towards the bedroom to the north. A view of the inside of this enclosure is included in [Figure 40](#)

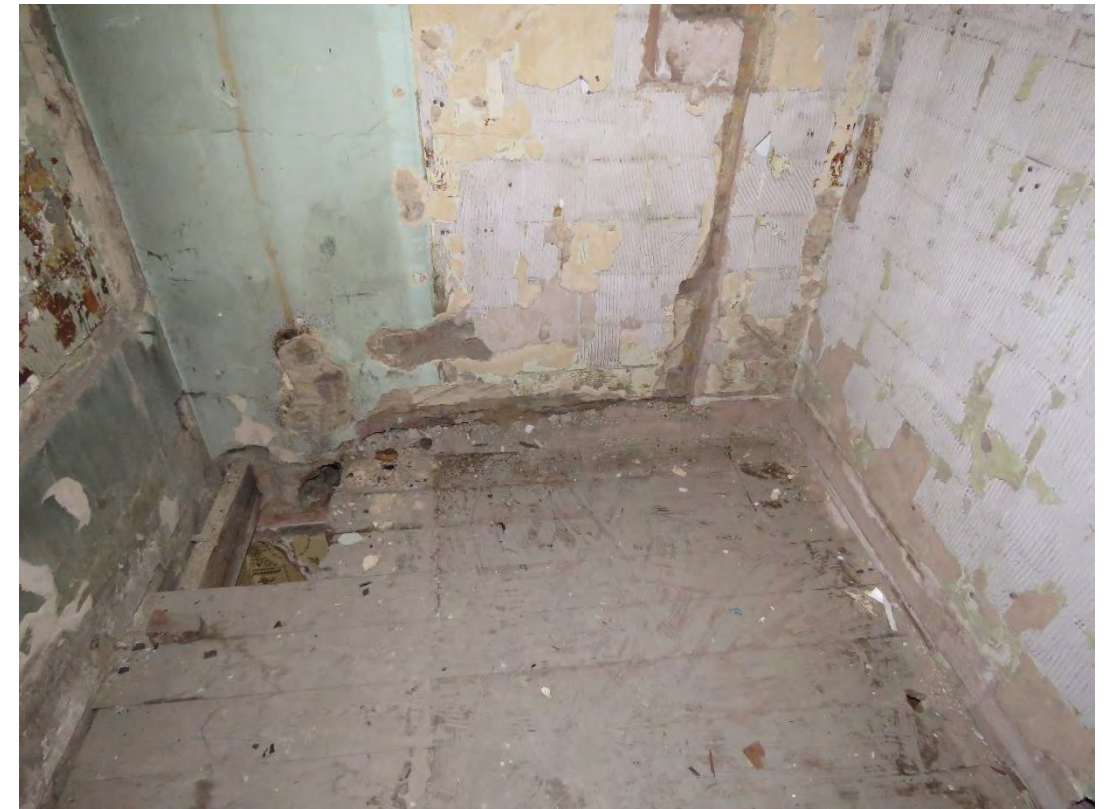
Figure 39: View of the rear wall of main building. Note the sporadic layers of construction within the walls and irregular floorboards. It appears this room has been heavily altered over time.

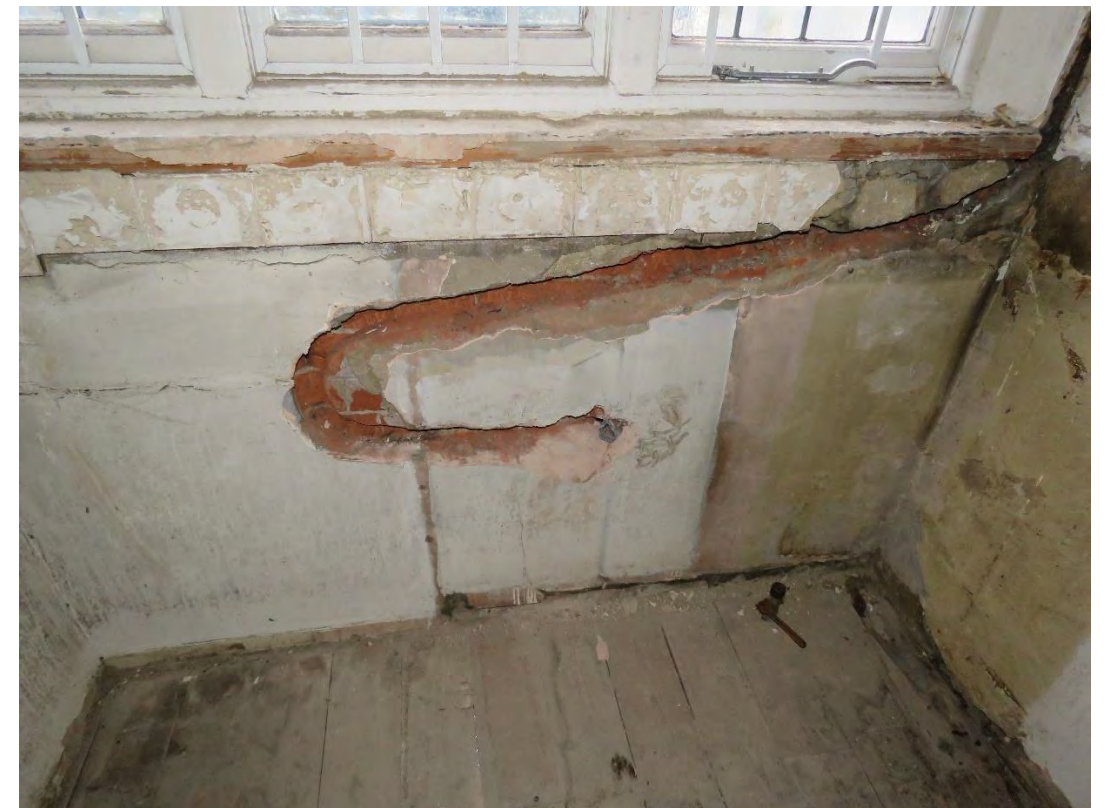
Figure 40: View of the west wall of the enclosure showing the original brick wall with chased plumbing (removed) and part of the windows. This area preserves no original finishes or details.

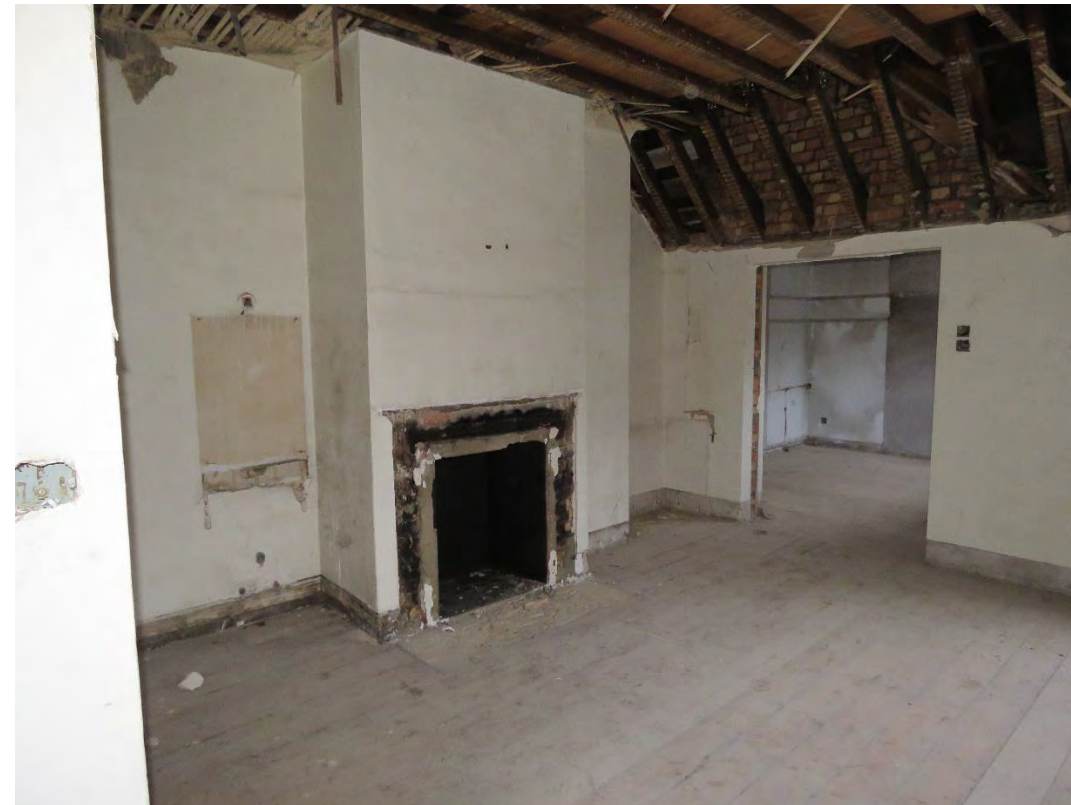
Figure 41: View of Bedroom 1 showing the chimney breast. Note the altered opening in the background. Some floorboards in this room appear to have been altered when the north wall was changed.

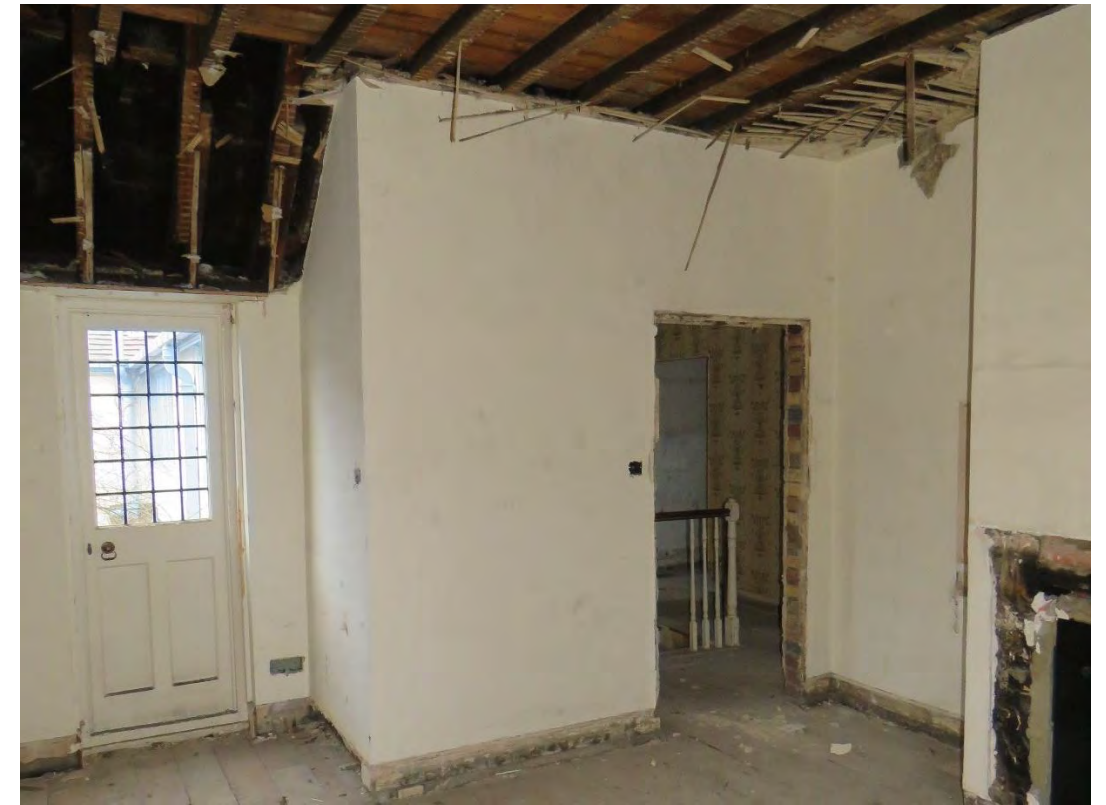
Figure 43: View of the room looking north. Note the door leading to the balcony (created during the c.1960s works) to the left and the doorway leading to the stair landing to the right.

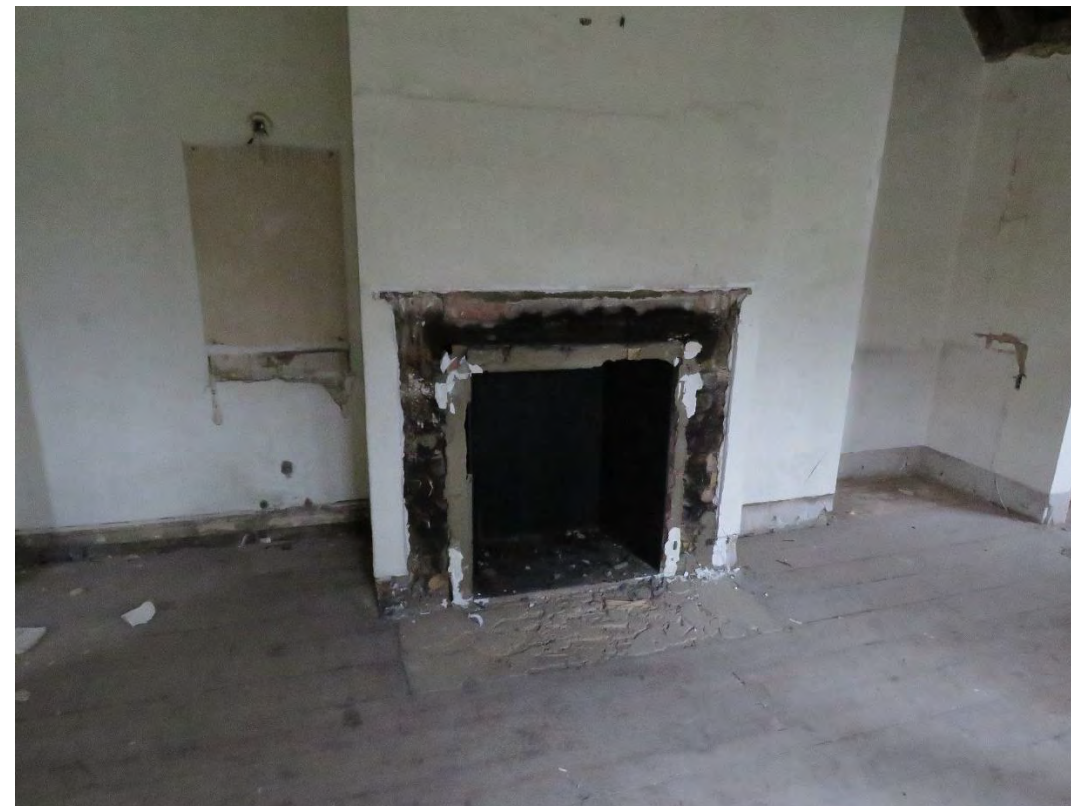
Figure 42: Close up view of the chimney breast showing the location of the fireplace (removed).

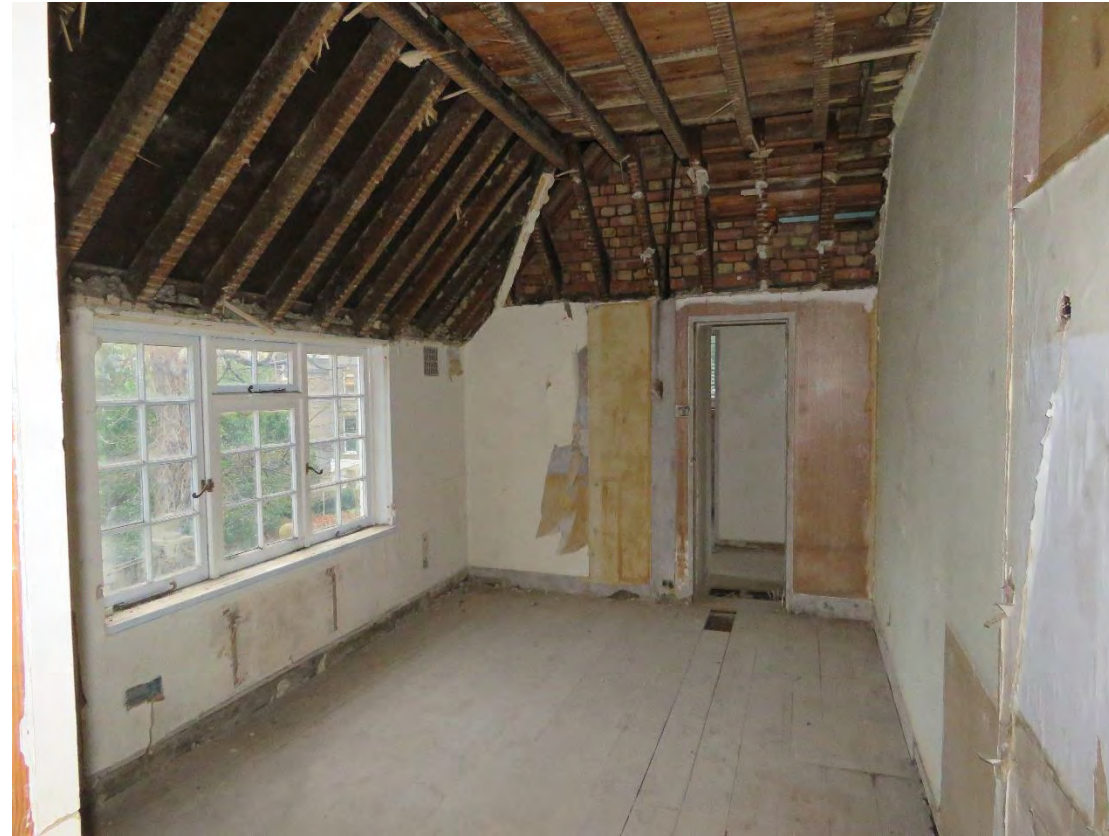
Figure 45: View looking south. Note the c.1960s windows on the east (rear) wall, modern narrow door openings and cement plastered walls. Floorboards in some areas are missing.

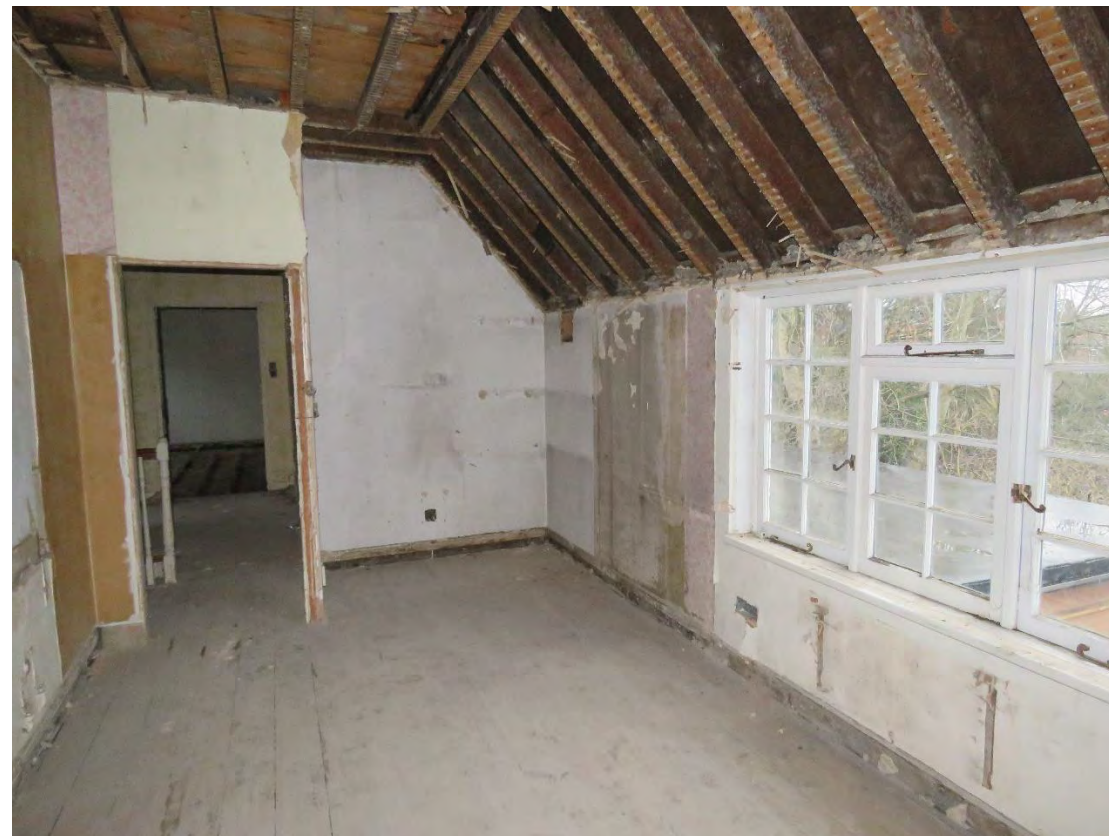
Figure 46: View looking north towards the stair landing. Note the modern studwork partition wall with the door opening. The c.1960s windows are seen to the right.

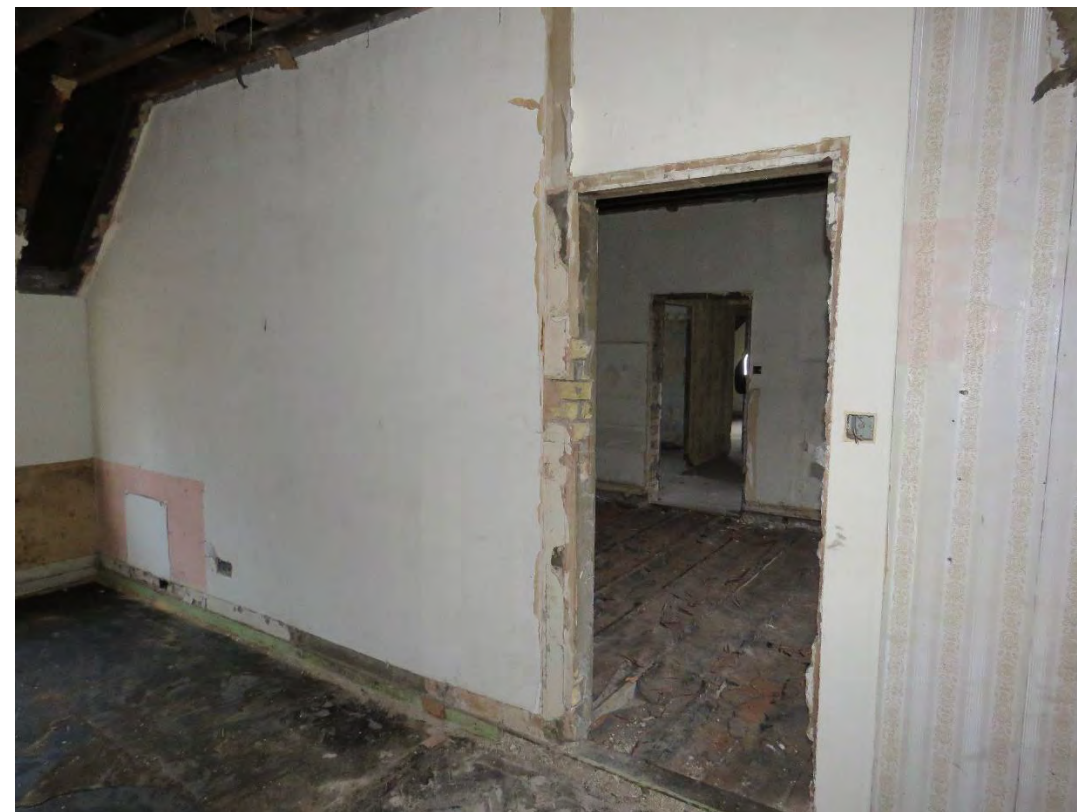
Figure 48: View looking southeast towards the Sitting room. Note the half brick thick modern partition wall dividing the rooms.
