82 Fitzjohn Avenue
Photographic walkthrough

External Photographs

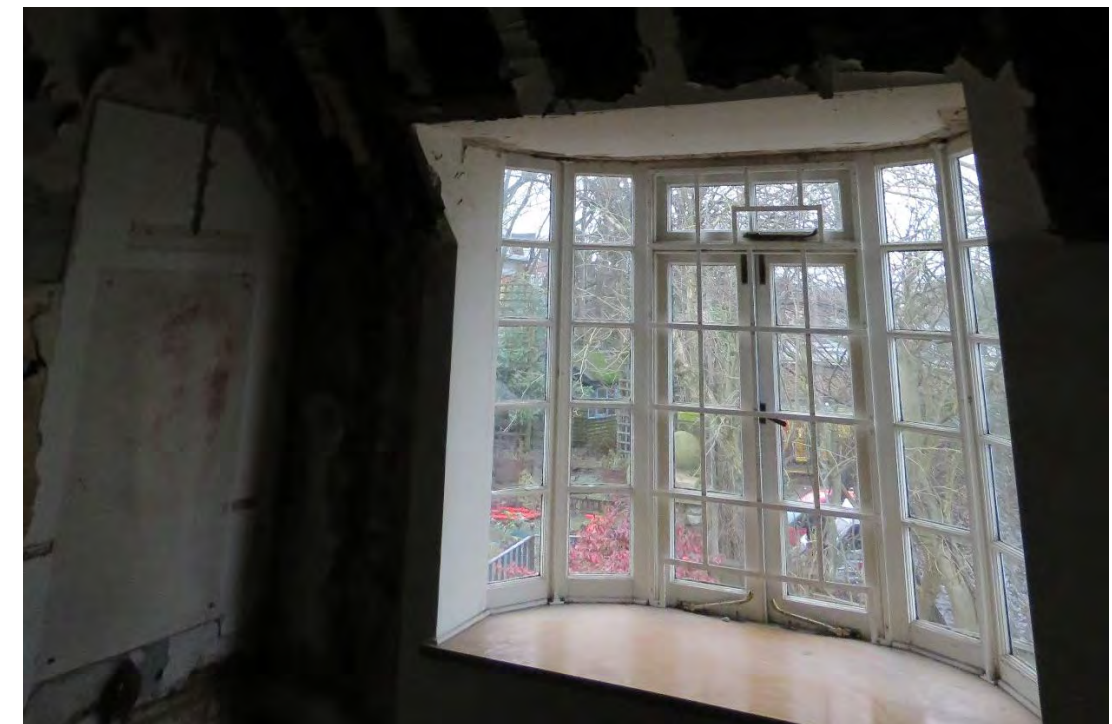
Figure 50: View of the c.1960s bay window. Note the chunky moulded sections, modern casement detailing and poorly proportioned glazing.

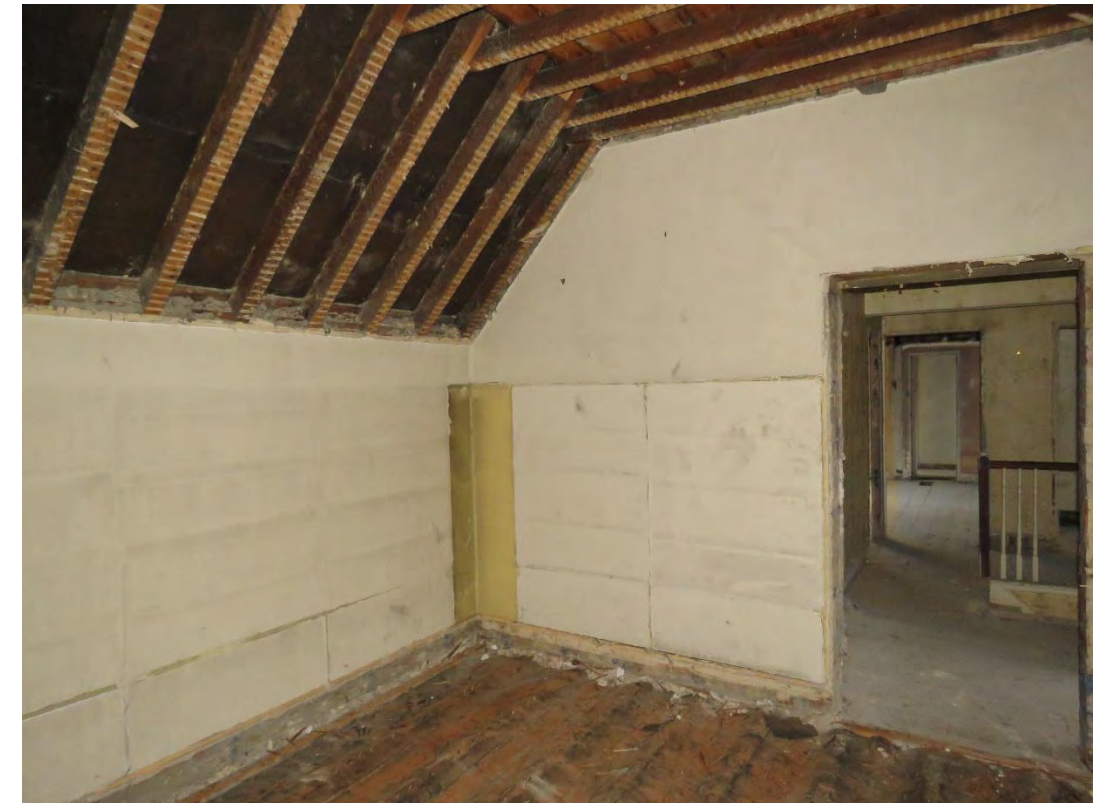
Figure 53: View towards the door and stair landing. This room does not preserve any original wall, ceiling or floor finishes.

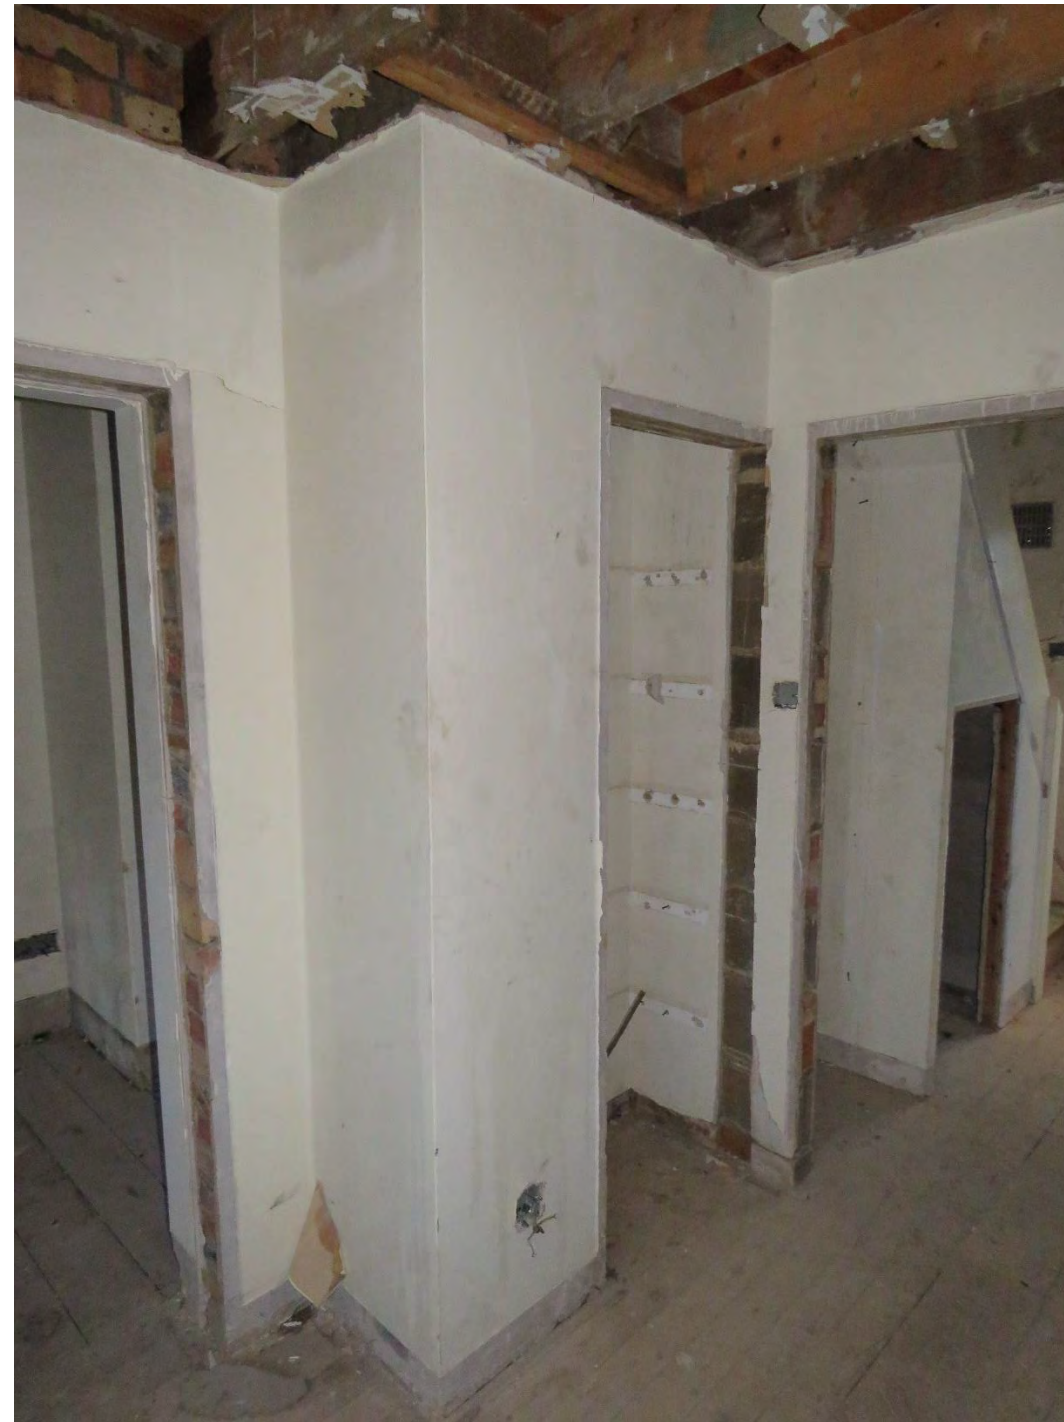
Figure 54: Modern studwork partitions in the dressing room area. The staircase leading to the second-floor bedroom is seen to the right.

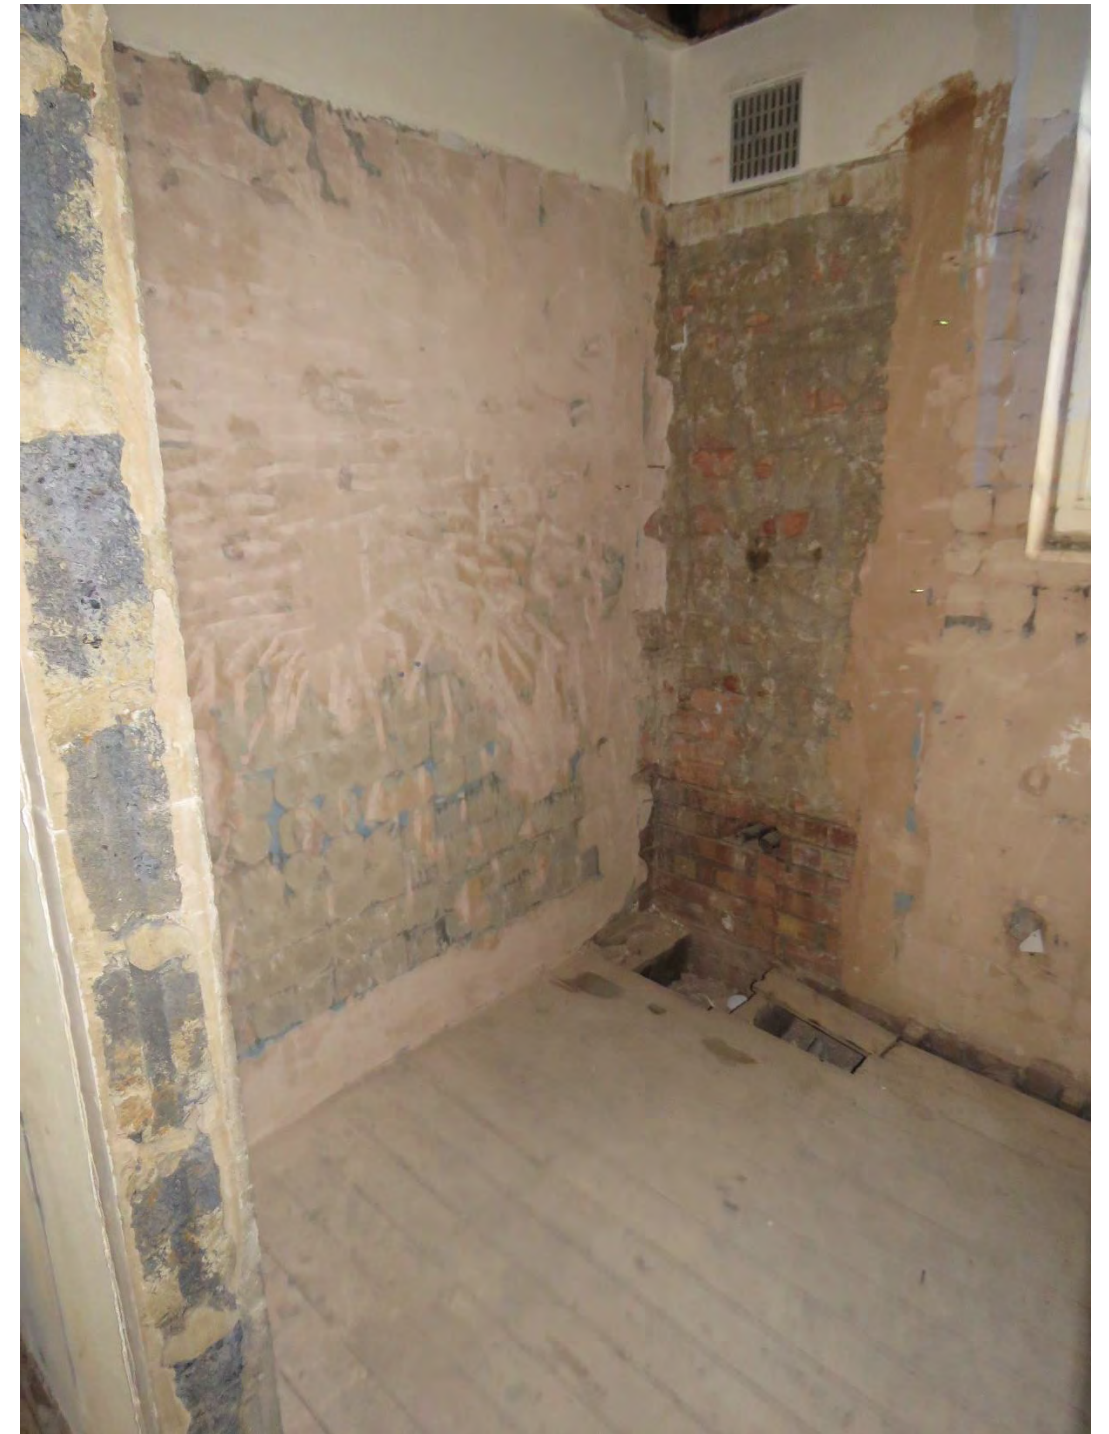
Figure 55: View of the WC/ shower area, part of the dressing room (south side). Note the concrete block partition walls and non-original wall and floor finishes.

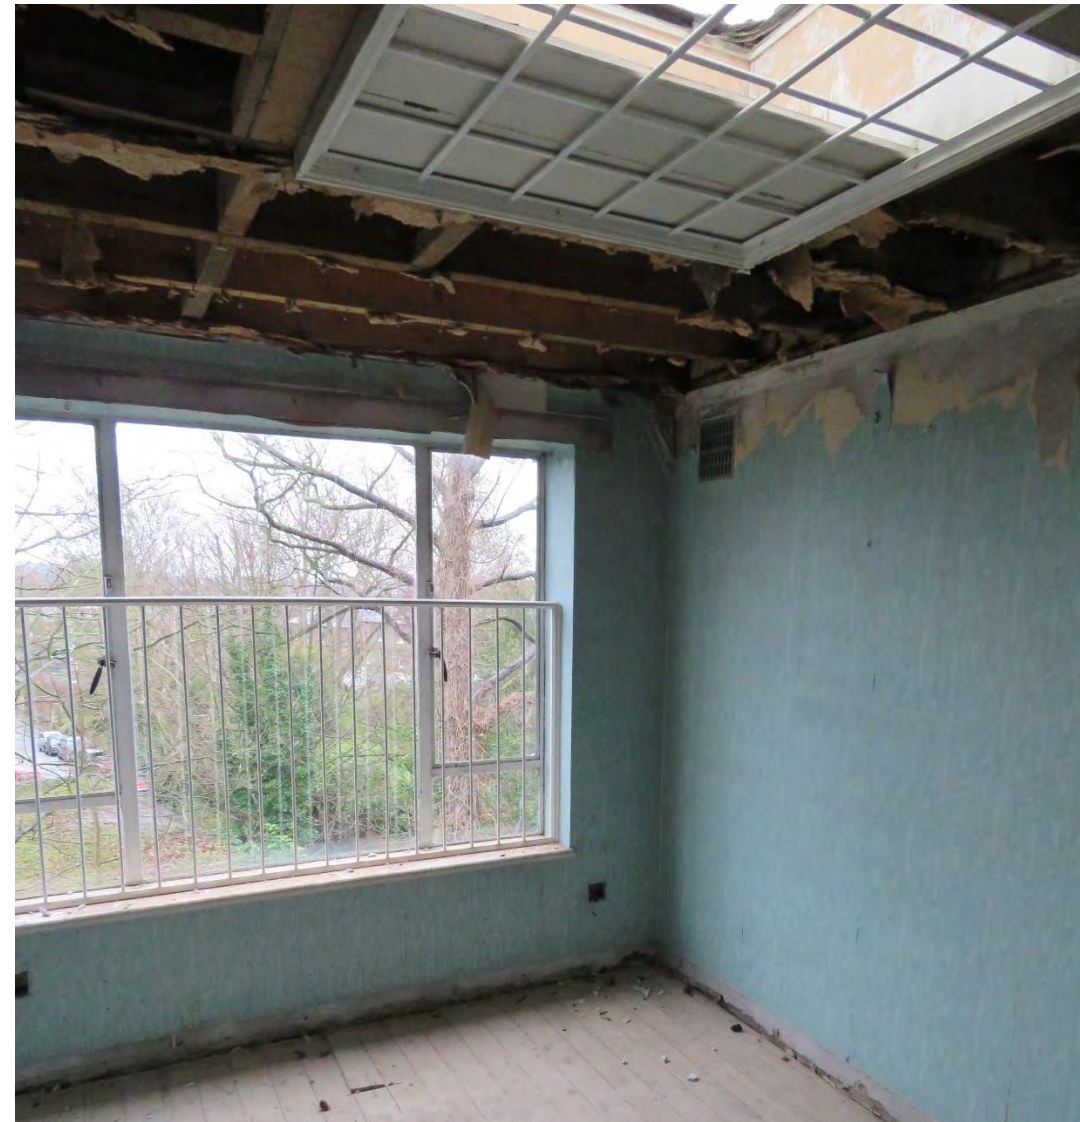
Figure 56: View of the second-floor bedroom looking east. This part of the house was erected in c.1960s and the fabric is of low architectural interest.

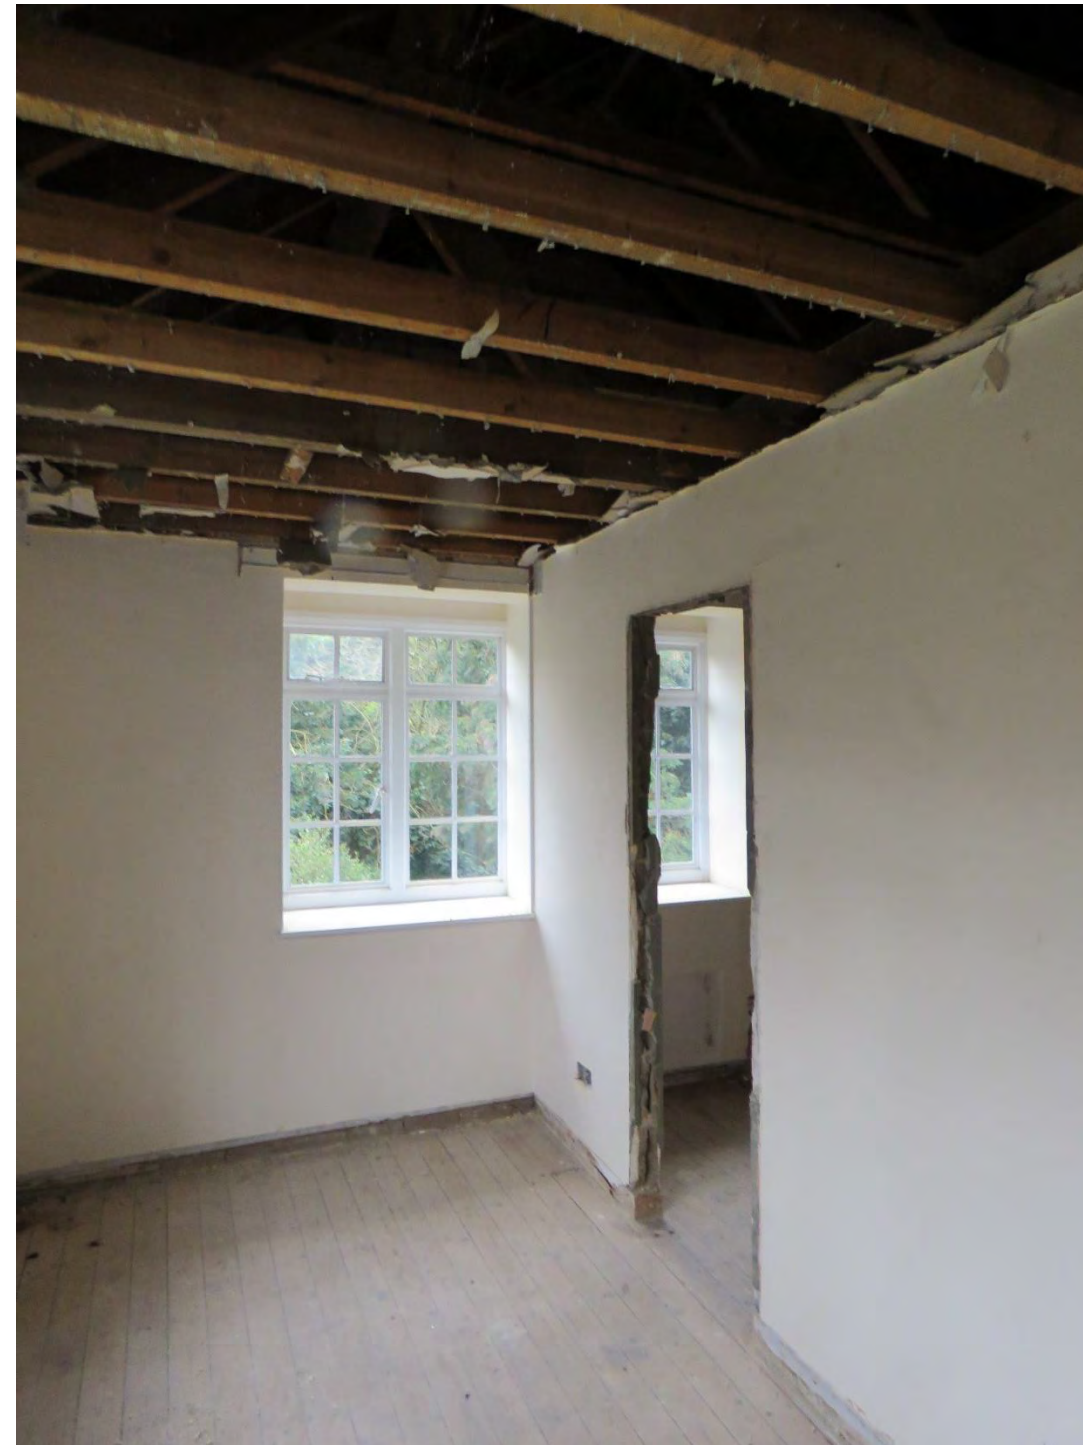
Figure 59: View of one of the rooms in the 1955-65 extension. Note the timber casement windows, modern studwork walls and cheap pine floorboards
