## SITE INVESTIGATION FACTUAL REPORT

Report No: [REDACTED]  
Client: Crawford Claims Management  
Site: Flat 1 30 Lymington Road  
Client Ref: [REDACTED]  
Date of Visit: 14/05/2020

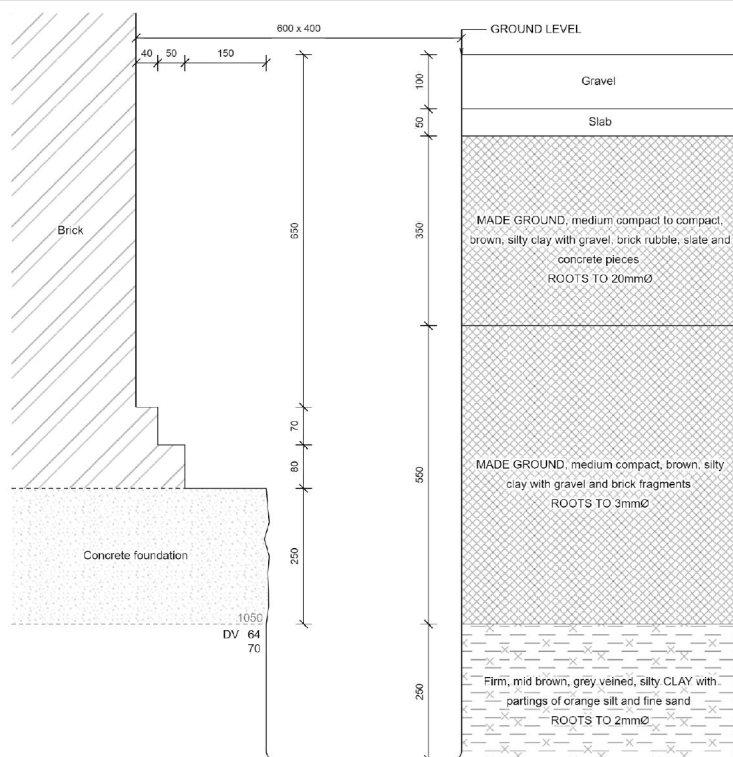
TRIAL PIT REF: TP1

For Strata below 1300mm see Bore Hole log

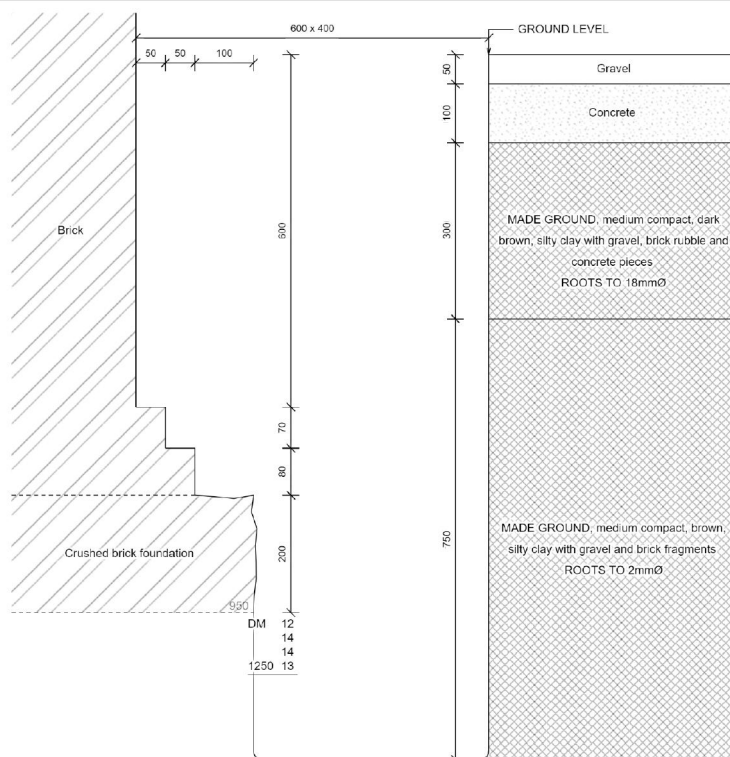
TRIAL PIT REF: TP2

For Strata below 1200mm see Bore Hole log

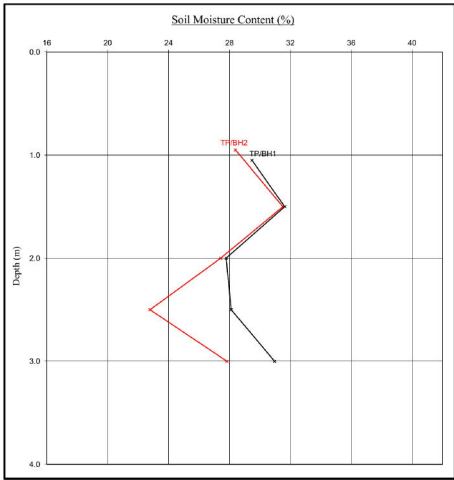
Moisture Content Profiles

Notes:  
1. If plotted,  $\sigma_{v1}$  and  $PL-2$  (after Driscoll, 1983) should only be applied to London Clay (and similarly overconsolidated clay) at shallow depths.  
2. Unless specifically noted the profiles have not been related to a site datum.

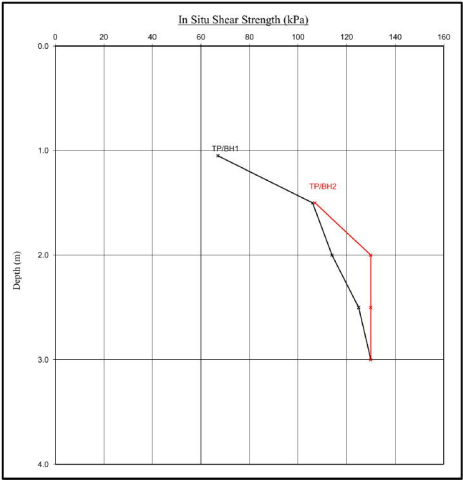
Shear Strength Profiles

Note:  
1. Unless otherwise stated, values of Shear Strength were determined in situ by CET using a Picon Hand Vane the calibration of which is limited to a maximum reading of 140 kPa.  
2. Unless specifically noted the profiles have not been related to a site datum.
