**TECHNICAL REPORT ON A SUBSIDENCE CLAIM**

Flat 1  
30 Lymington Road  
London  
NW6 1HY

**SUBSIDENCE CLAIM**

11<sup>th</sup> December 2019

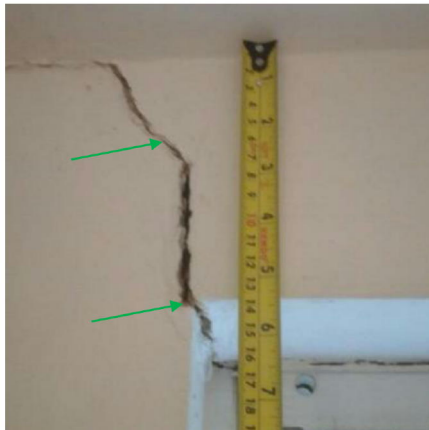
Kitchen

Vertical crack to the top left corner of the external door, which climbs to the ceiling. Maximum crack width 4mm.

Cracking on the ceiling, between the cooker and wall units. Maximum crack width 3mm.

Separation of the worktops, where they meet on the units and the wall.

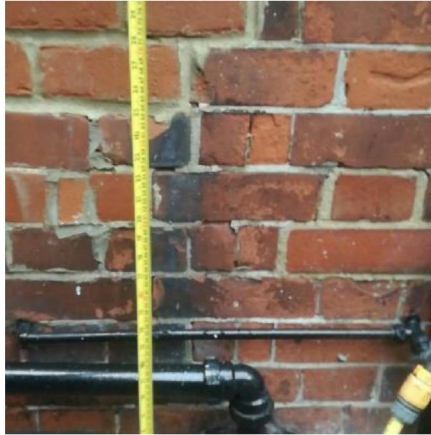
Damage outside kitchen, note the previous repairs

Vertical cracking through the bricks and mortar outside the kitchen area. Cracking next to the top of the kitchen door. Maximum crack width 3mm.

Vertical cracking noted to the underside of the kitchen window. Wall below the window appear to have been re-built.

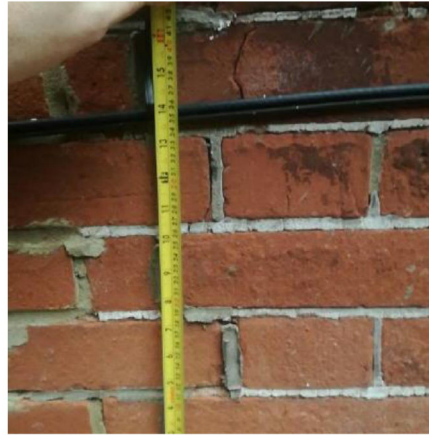
Damage outside kitchen, note the previous repairs
