ADDENDUM TECHNICAL REPORT

151 Gloucester Avenue
London
NW1 8LA

SUBSIDENCE CLAIM

DATE 29 March 2021

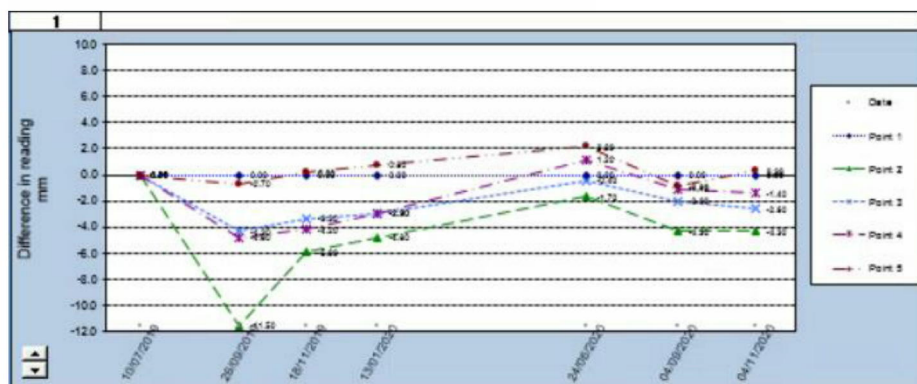
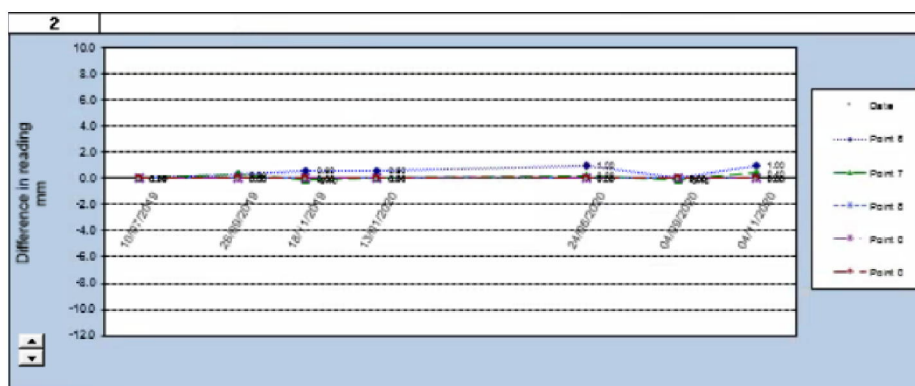
Level monitoring has been completed over the period from July 2019 to November 2020. Over this period, on point 5 to the rear, upward movement has been recorded over the winter months of 2019/2020 followed by downward movement over the summer months of 2020. This seasonal movement confirms a clay shrinkage mechanism. No other type of movement produces these results.

- Level monitoring on point 5 at the rear of the property indicates seasonal cyclical movement with downward movement in the summer months (as the clay shrinks) and upward movement in the winter months (as the clay swells).
