TECHNICAL REPORT ON A SUBSIDENCE CLAIM

[REDACTED]
[REDACTED]
**151 Gloucester Avenue
London
NW1 8LA**

[REDACTED]
SUBSIDENCE CLAIM

DATE 13th November 2018

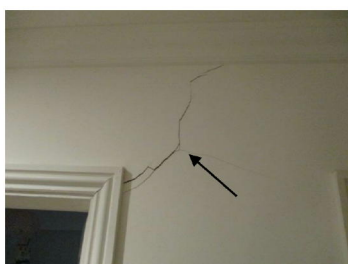
Cracking in basement hallway

Basement Hall - 5mm diagonal crack above rear right hand bedroom door, 3mm diagonal crack above front bedroom door, cracking to ceiling.

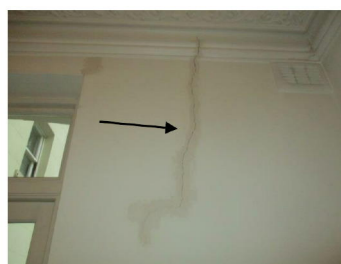
Cracking in ground floor dining room

Dining Room - 3mm vertical tapering crack to right hand side of French doors, cracking to coving.

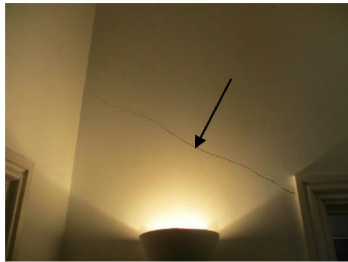
Upper Maisonette - Hall, Stairs and Landing - Cracking to ceiling in entrance section, 2mm diagonal crack above door to lounge, 1mm diagonal crack to right hand party wall, wall / ceiling junction cracking on half landings to rear wall, 3mm vertical crack above front bedroom door, historic distortions noted to stairs.

Cracking in upper flat hallway

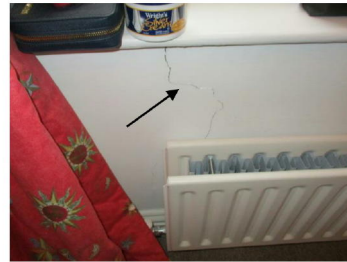
Rear Study - 2mm diagonal crack below window, 1mm diagonal crack above left hand side of hatch, cracking to ceiling, hairline diagonal crack above right hand side of window, coving / wall junction cracking along front elevation, 3mm vertical crack down door frame.

Cracking in upper flat rear study

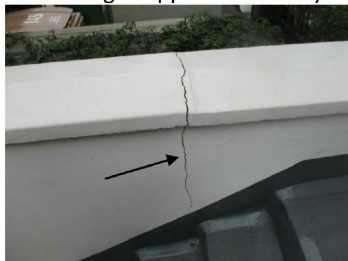
Front Left Hand Boundary Wall - 4mm and 2mm vertical cracks on landing section.

Cracking to front left hand steps boundary wall

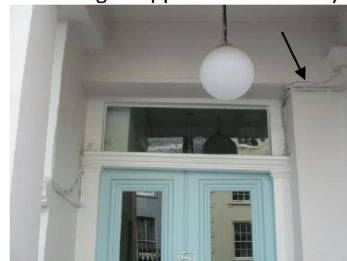
Front Elevation - 3mm horizontal crack above right hand side of front door, significant historic distortion noted to front door frame.

At the time of our visit some significant historic distortions were noted to be affecting predominantly the main front door area and the internal staircases particularly at upper level. These distortions appear to be longstanding and the rectification of these would fall outside of the scope of this claim.

View of historic distortion and recent cracking above front door
