## Arboricultural Appraisal Report

### Subsidence Damage Investigation at:

151 Gloucester Avenue  
London  
NW1 8LA

| REPORT DATE: | 11/02/2020 |

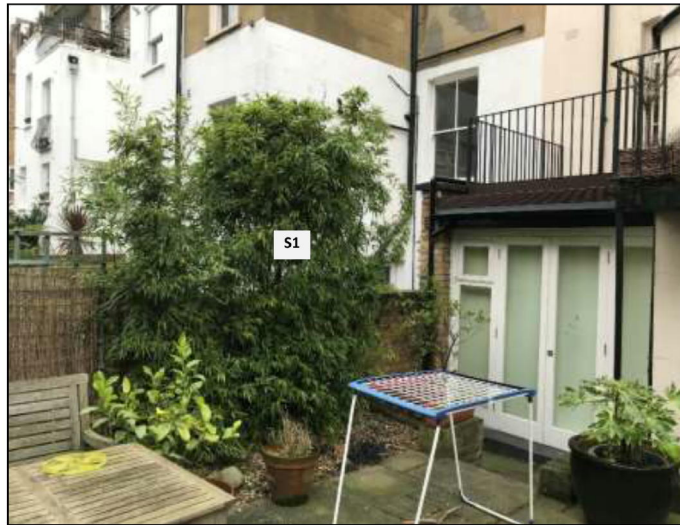
View of S1

Roots were observed to a depth of 1.6m bgl in BH1 and to a depth of 3.1m in BH2 and recovered samples have been positively identified (using anatomical analysis) as *Platanus* spp. (BH1 & BH2) and *Monocotyledon* spp. (BH2), the origin of which will be the Plane trees (T1 & T4) and the Bamboo (S1) confirming their influence on the soils below the foundations.

Based on the technical reports currently available, engineering opinion and our own site assessment we conclude the damage is consistent with shrinkage of the clay subsoil related to moisture abstraction by vegetation. Having considered the information currently available, it is our opinion that the Plane trees (T1 & T4) are the principal cause of or are materially contributing to the current subsidence damage with a secondary influence from the bamboo (S1).

| Tree No. | Species | Ht (m) | Dia (mm) | Crown Spread (m) | Dist. to building (m) | Age Classification | Ownership |
|---|---|---|---|---|---|---|---|
| S1 | Bamboo | 2.3 | 15 Ms | 0.7 * | 2.1 | Younger than Property | Policy Holder |
| Management history | | No recent management noted. | | | | | |

If an arboricultural solution is to be implemented to mitigate the influence of the implicated trees/vegetation we recommend that the Plane trees (T1 & T4) and the Bamboo (S1) are removed. Other vegetation recorded presents a potential future risk to building stability and management is therefore recommended.

| Tree No. | Species | Ht (m) | Dia (mm) | Crown Spread (m) | Dist. to building (m) | Age Classification | Ownership |
|---|---|---|---|---|---|---|---|
| Recommendation | | Remove (fell) to near ground level and treat stump to inhibit regrowth. | | | | | |

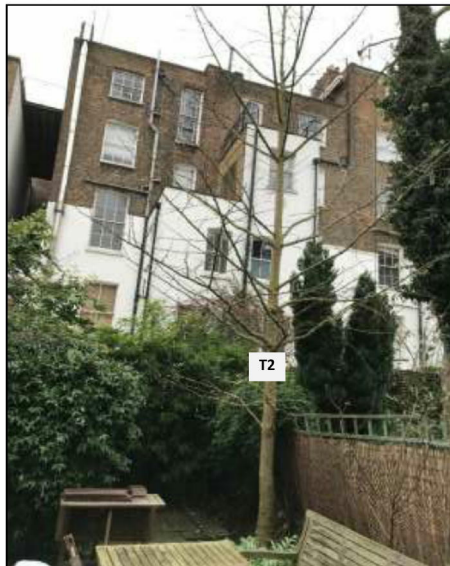
View of T2

| Tree No. | Species | Ht (m) | Dia (mm) | Crown Spread (m) | Dist. to building (m) | Age Classification | Ownership |
|---|---|---|---|---|---|---|---|
| T2 | Ginkgo | 9 | 160 | 5 | 7.5 | Younger than Property | Policy Holder |
| Management history | | No recent management noted. | | | | | |

| Tree No. | Species | Ht (m) | Dia (mm) | Crown Spread (m) | Dist. to building (m) | Age Classification | Ownership |
|---|---|---|---|---|---|---|---|
| Recommendation | | Maintain broadly at no more than current dimensions by periodic pruning. | | | | | |

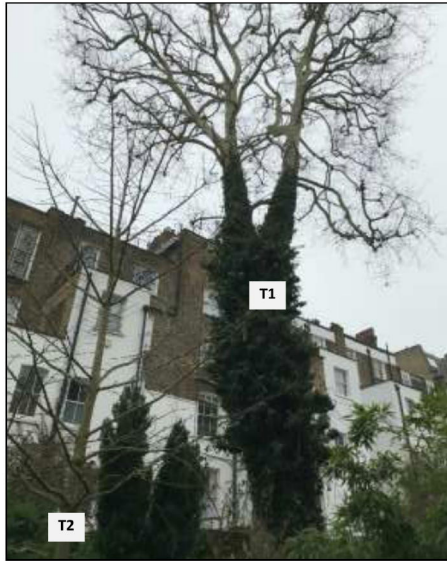
View of T1

| Tree No. | Species | Ht (m) | Dia (mm) | Crown Spread (m) | Dist. to building (m) | Age Classification | Ownership |
|---|---|---|---|---|---|---|---|
| T1 | Plane (London) | 25.3 | 1500 * | 16.5 * | 10.8 | Similar Age to Property | Third Party<br>153 Gloucester Road<br>NW1 8LA |
| Management history | | Subject to past management/pruning. | | | | | |

| Tree No. | Species | Ht (m) | Dia (mm) | Crown Spread (m) | Dist. to building (m) | Age Classification | Ownership |
|---|---|---|---|---|---|---|---|
| Recommendation | | Remove (fell) to near ground level and treat stump to inhibit regrowth. | | | | | |

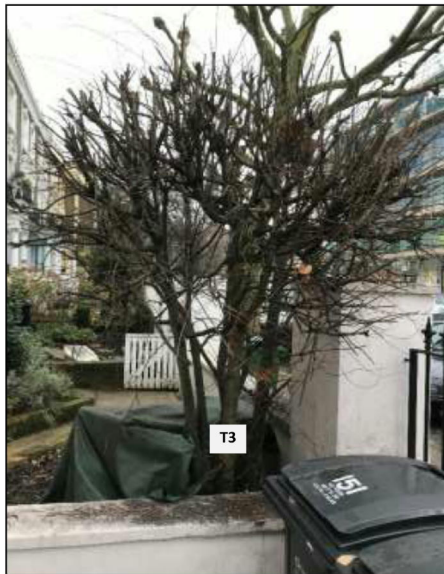
View of T3

| Tree No. | Species | Ht (m) | Dia (mm) | Crown Spread (m) | Dist. to building (m) | Age Classification | Ownership |
|---|---|---|---|---|---|---|---|
| T3 | Tamarisk | 2.9 | 80 Ms | 3 | 5.3 | Younger than Property | Third Party<br>153 Gloucester Road<br>NW1 8LA |
| Management history | | Very tentative identification. | | | | | |

| Tree No. | Species | Ht (m) | Dia (mm) | Crown Spread (m) | Dist. to building (m) | Age Classification | Ownership |
|---|---|---|---|---|---|---|---|
| Recommendation | | Maintain broadly at no more than current dimensions by periodic pruning. | | | | | |

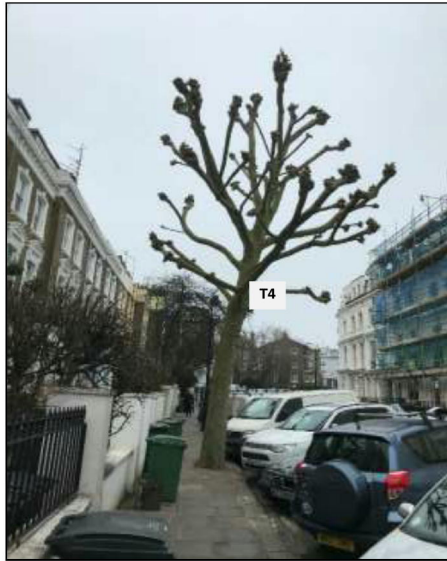
View of T4

| Tree No. | Species | Ht (m) | Dia (mm) | Crown Spread (m) | Dist. to building (m) | Age Classification | Ownership |
|---|---|---|---|---|---|---|---|
| T4 | Plane (London) | 12.4 | 560 | 8 | 11.1 | Younger than Property | Local Authority |
| Management history | | Recently reduced/pruned. | | | | | |

| Tree No. | Species | Ht (m) | Dia (mm) | Crown Spread (m) | Dist. to building (m) | Age Classification | Ownership |
|---|---|---|---|---|---|---|---|
| Recommendation | | Remove (fell) to near ground level and treat stump to inhibit regrowth. | | | | | |

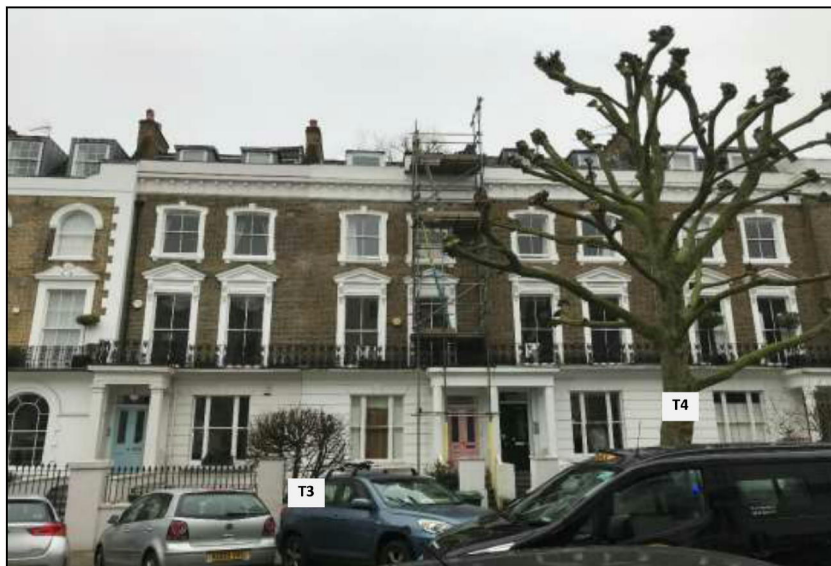
View of Front elevation

Damage is noted throughout the property with internal cracks on several levels and external cracking to the front and rear elevations.

At the time of the engineer's inspection (01/11/2018) the structural significance of the damage was found to fall within Category 3 (moderate) of Table 1 of BRE Digest 251. For a more detailed synopsis of the damage please refer to the surveyor's technical report.
