# PATRICK STILEMAN LTD

### WRITTEN ARBORICULTURAL ADVICE

Site	9 Steele's Road, London, NW3 4SE
Date	26 <sup>th</sup> March 2021
Date of site visit	18 <sup>th</sup> March 2021
Client	James Stephens
Document ref	TI12022101
Subject	Management of trees in rear garden

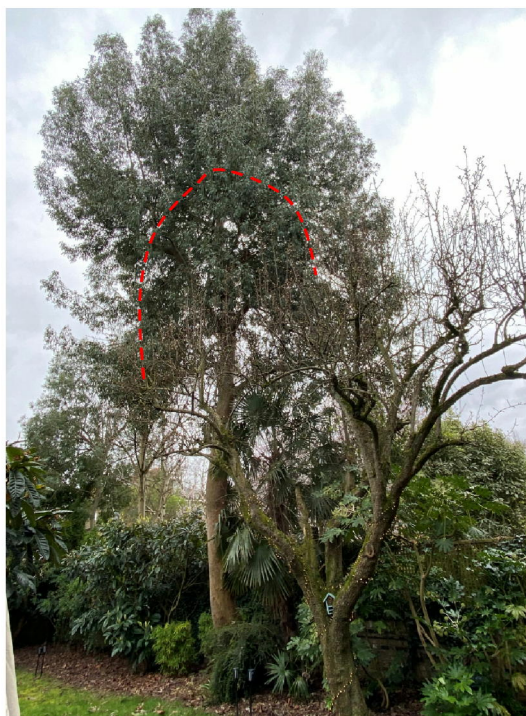
12. The tree has a single, relatively straight stem which I assess to be solid with no decay or observable structural defects at its base.
13. The tree has a full crown which is re-growing vigorously in response to heavy past cutting (topping), undertaken around 6-8 years' ago I assess based on the size of the re-growth. The past work to the tree would have removed the majority of the crown to a scaffold framework at a height of approximately 11 metres (see Photographs below).

14. The new crown which has developed since the past cutting is formed of multiple slender stems from each former topping point which has resulted in the tree now having a dense crown with numerous closely-spaced leaves through which little light can pass.

***Photograph 1.*** Former size of crown following past topping indicated by broken red line

17. It is apparent that the tree is growing rapidly (see Photographs 1 and 2), and has high growth potential. Dominance of the tree to the property will increase as the tree grows if action is not taken.

21. For the reasons set out above I consider that there is clear justification for the tree's removal and I support this as a management option.

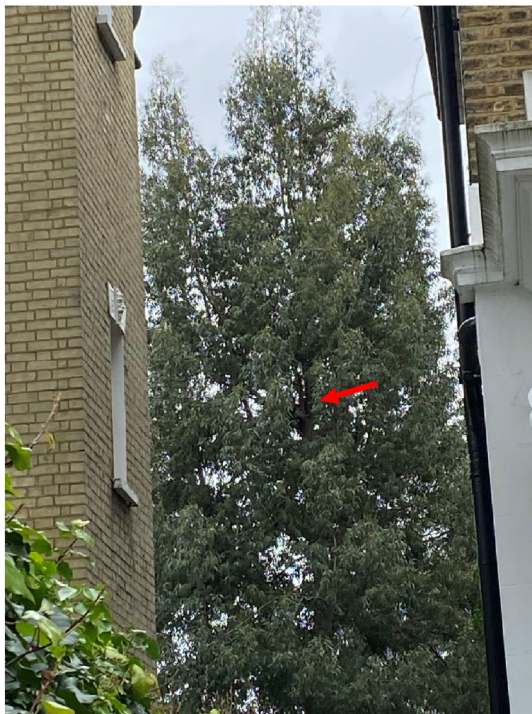
**Photograph 2.** *Zoomed view of crown through gap between buildings. Former topping point on principal stem indicated by red arrow*

15. I do not consider that structural failure of Tree 1 is currently foreseeable – the base appears to be sound, and the vigorous crown indicates that the roots, and vascular system generally, are fully functional. The tree's crown currently appears to be stable; however as the re-growth continues to develop in size and weight there is future potential for branch failure at the point where they are likely to be poorly attached to the past cutting points in the tree.

16. The tree's crown is heavily shading and dominant to the property with the tree positioned in close proximity to, and due south of, the patio. The tree is evergreen and as a consequence heavy shading from the tree is year-round.

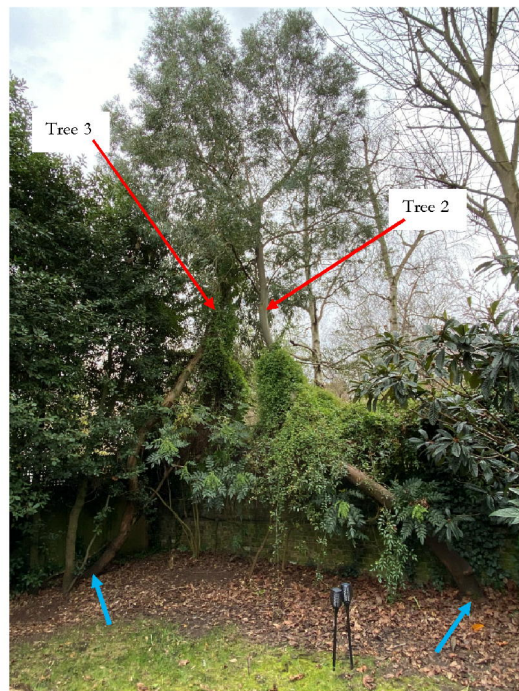
22. Trees 2 and 3 are both very poor quality, suppressed Eucalyptus trees with heights of approximately 10 metres. They have slender, heavily-leaning stems with diameters of approximately 200mm, and crowns with pronounced asymmetry to the south and north respectively, with the crown of each tree growing into the other.

23. The trees have poor future prospects with no potential to develop into amenity features of value.
24. Being located in the southern corner of the small garden, Trees 2 and 3 cause moderate shading to the amenity space. The trees have high future growth potential and the shade that they cast will increase with time if the trees are left.

**Photograph 3.** Trees 2 and 3. The base of each tree is indicated with a blue arrow.

25. As with Tree 1, there are no reasonable pruning options available for Trees 2 and 3.
26. There are no public views of Trees 2 and 3.
27. For the reasons set out I consider that removal of Trees 2 and 3 is an entirely sensible management option.

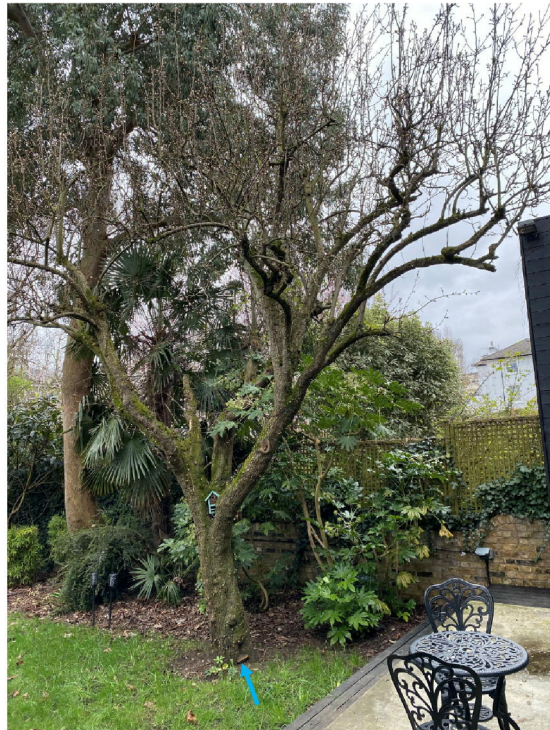
28. Tree 4 is a pear tree growing close to, and overhanging the patio. It is a mature tree with a height of 5 metres and stem diameter of 340mm. Tree 4 has re-grown from heavy past crown reduction (approximately 5-6 years' ago I assess based on the size of re-growth) and has low crown vitality.

29. At the base of the tree on the north side there is a *Ganoderma australe* fungal fruiting body. My assessment of the stem using a sounding mallet is that decay associated with the fungus is not significant, and I do not consider that failure of the tree is currently foreseeable particularly given its small crown volume.

**Photograph 4.** Tree 4. *Ganoderma* fruiting body indicated with a blue arrow.

30. I do not consider that there is any requirement to undertake work to the pear tree at this stage; however it is a small tree of low significance which cannot be seen from the public domain, and if there is a desire to remove it in order to create a more open patio this would be entirely defensible.
