TECHNICAL REPORT ON AN ALLEGED SUBSIDENCE CLAIM

Origin Housing  
Flat 1  
Trevithick House  
York Rise  
London  
NW5 1DR

DATE 1<sup>st</sup> February 2021

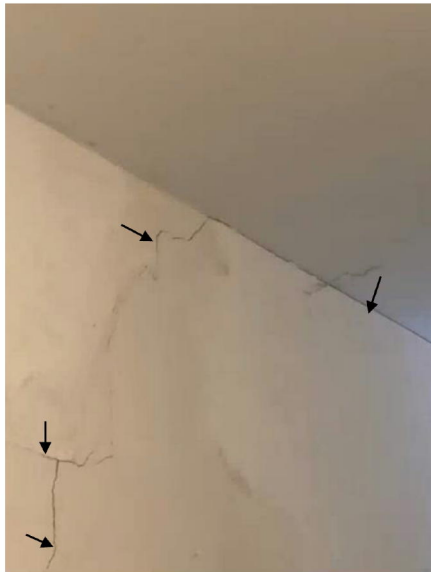
Cracking to middle bedroom

**Middle front (small) bedroom**

- There are signs of 2mm cracking along the central dividing wall to the lounge and cracking along the other walls.
- There is cracking along the ceiling with cracking widths up to 2mm.

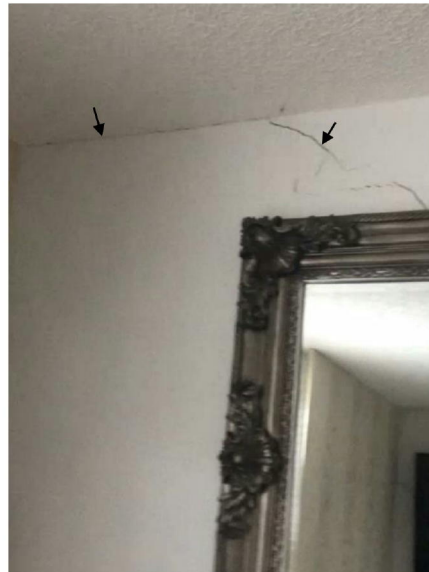
Cracking to lounge

**Lounge**

- There are signs of 1mm - 2mm diagonal cracking within the front wall and within the central wall which divides the lounge from the middle small bedroom.
- There is cracking along a majority of the ceiling and wall junctions with a width up to 1mm.

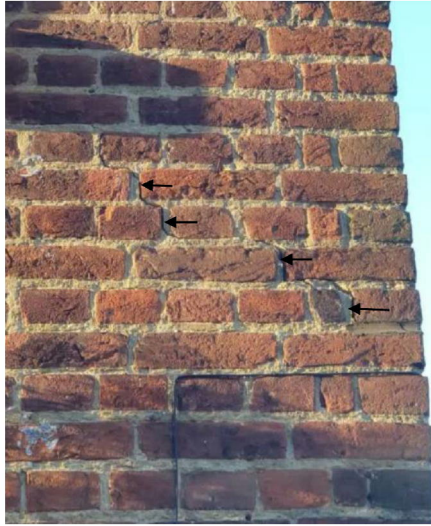
Stepped cracking to front elevation

**Front Elevation - Right corner**

- 1mm stepped diagonal was noted commencing 17 courses above the brick on edge course.

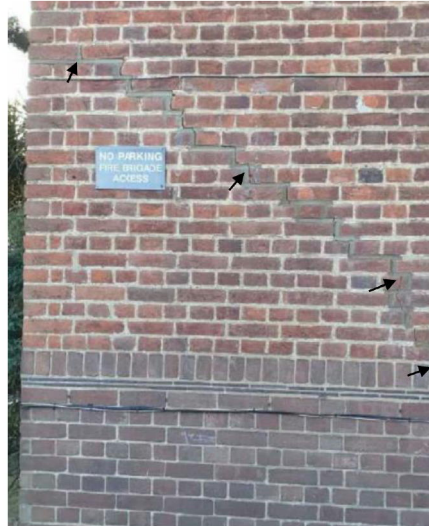
Stepped cracking to right hand side elevation

**Right Elevation - Front corner**

- 1-2mm stepped diagonal was noted commencing 17 courses above the brick on edge course and radiating down to the brick on edge course. The crack was previously repaired in circa 2018
- 1mm diagonal crack was noted below DPC level adjacent to the ground floor balcony

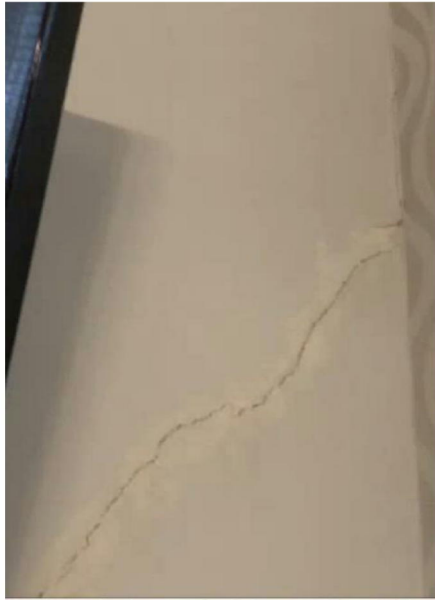
Cracking to middle bedroom

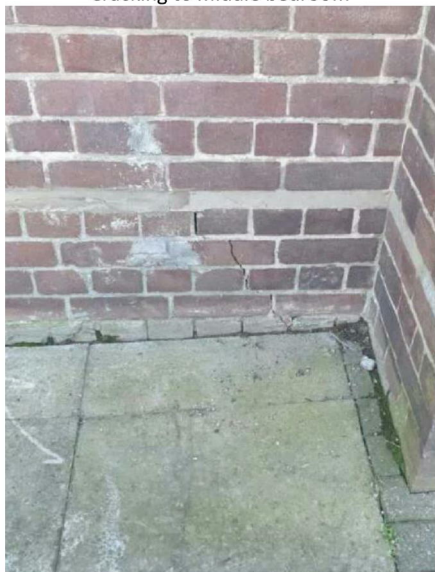
Cracking to right hand side
