SITE INVESTIGATION FACTUAL REPORT

20A Merton Rise, London, NW3 3EN

<h1>SITE AND DRAINAGE LAYOUT</h1>	
Site Crew:	Sam McNiff / Harry Kelly	Date:	10th December 2020
Address:	20A Merton Rise, London, NW3 3EN		
Geocore Ref:		Client Ref:

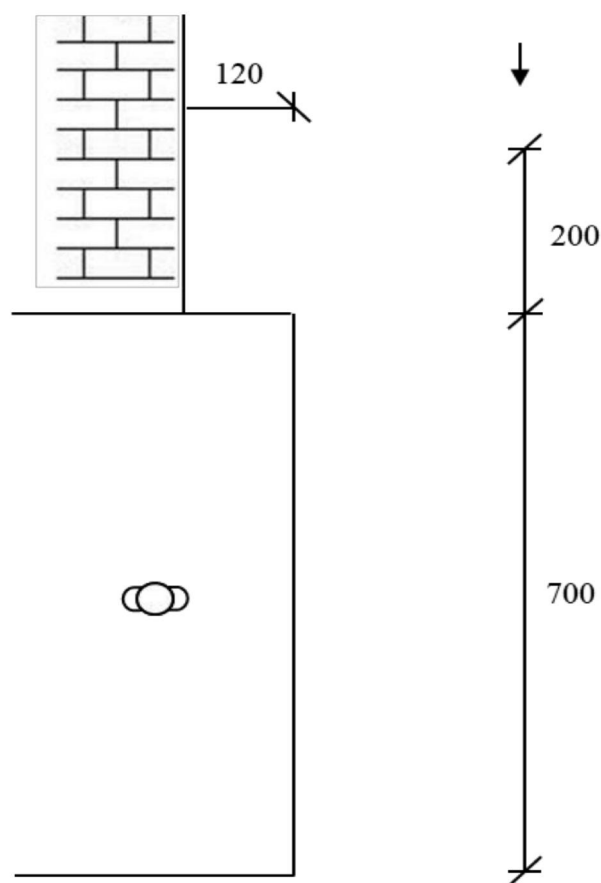
For strata information, please refer to borehole log TPBH1.

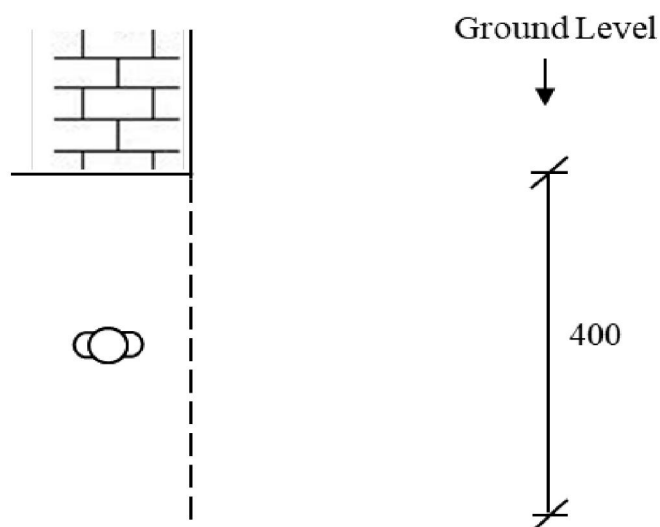
For strata information, please refer to borehole log TPBH2.

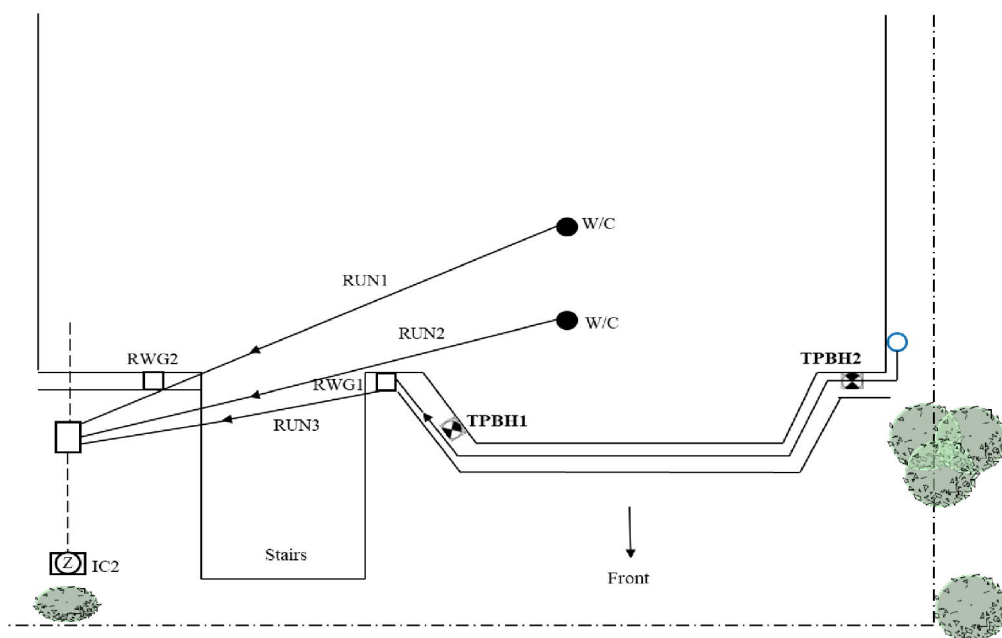
The only drainage within 3 metres of the area of damage is RWG 1. There is also an RWP with a 68 mm plastic pipe which runs across the front of the building above ground and also discharges into RWG 1. The drain run has silt deposits within the pipe but still working. The pipe is 100mm PVC.

Runs 1 and 2 are both PVC.

The drain run upstream of I/C 1 appears to have been relined.

The interceptor trap within I/C 2 is blocked.

Item 1: Drainage system would benefit from a high pressure water clean.
