Arboricultural Appraisal Report

Subsidence Damage Investigation at:

20A Merton Rise
London
NW3 3EN

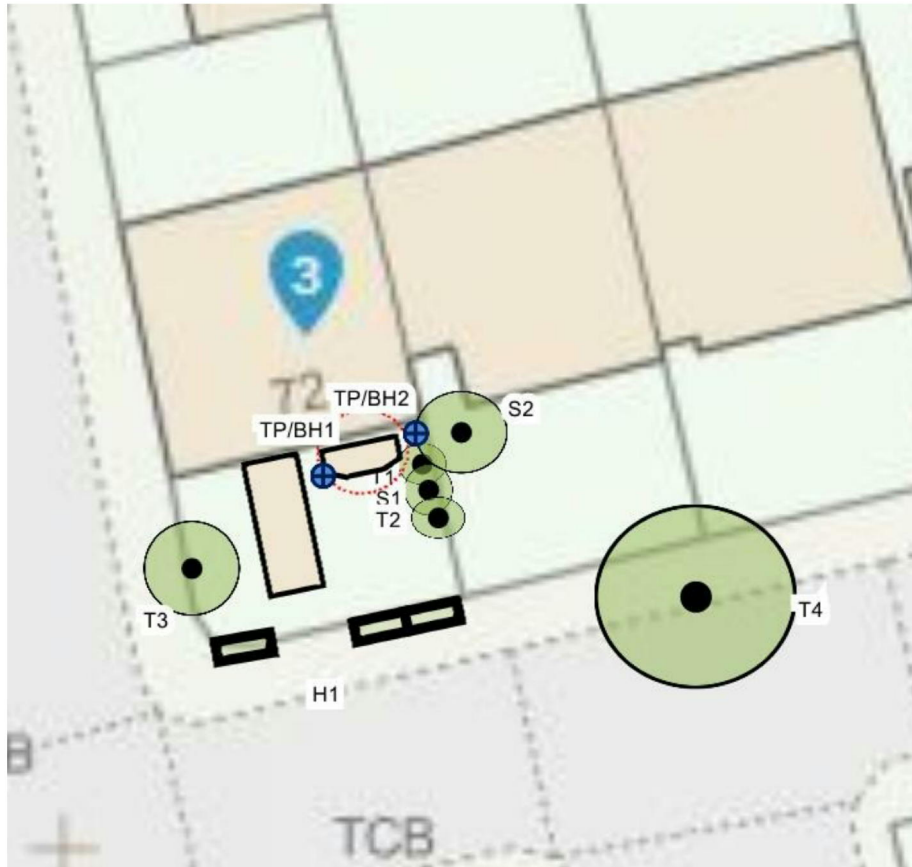
Site Plan

Approximate areas of damage

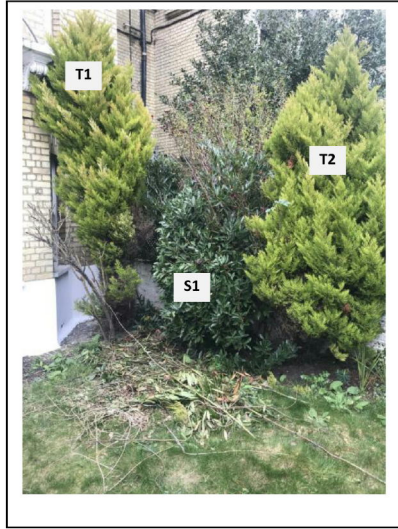
View of T1, T2 & S1

Based on the technical reports currently available, engineering opinion and our own site assessment we conclude the damage is consistent with shrinkage of the clay subsoil related to moisture abstraction by vegetation. Having considered the information currently available, it is our opinion that the Cypress (T1), laurel (S1) and the Bay Laurel (S2) are the principal cause of or are materially contributing to the current subsidence damage.

If an arboricultural solution is to be implemented to mitigate the influence of the implicated trees/vegetation we recommend that the Cypress (T1), S1 Laurel and Bay Laurel (S2) are removed. Other vegetation recorded presents a potential future risk to building stability and management is therefore recommended.
