Arboricultural Appraisal Report

Subsidence Damage Investigation at:

Flat 2 1F Oval Road
London
NW1 7EA

CLIENT:	Crawford & Company
CLIENT REF:	[REDACTED]
MWA REF:	[REDACTED]
MWA CONSULTANT:	Andy Clark
REPORT DATE:	19/05/2020

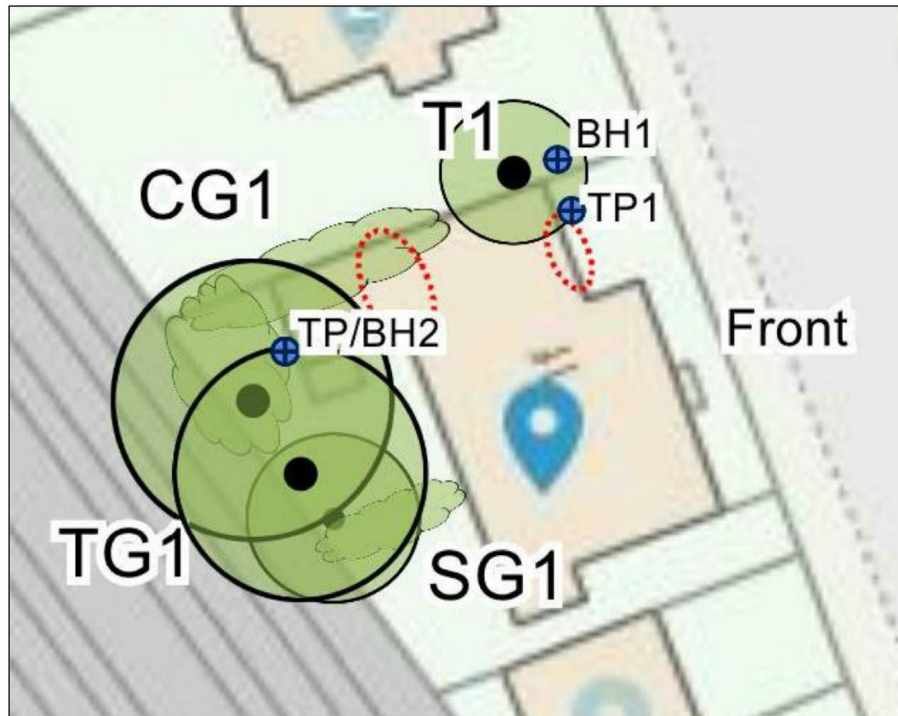
Site Plan

Approximate areas of damage

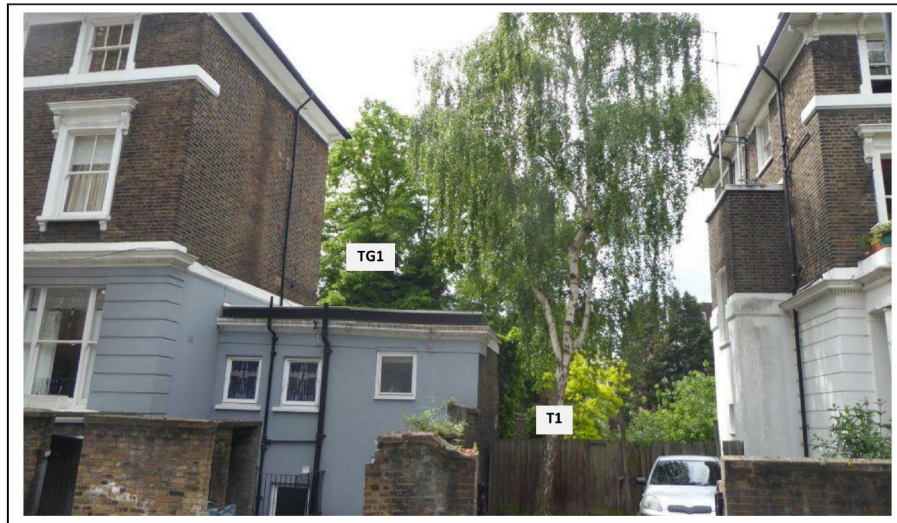
Based on the technical reports currently available, engineering opinion and our own site assessment we conclude the damage is consistent with shrinkage of the clay subsoil related to moisture abstraction by vegetation. Having considered the information currently available, it is our opinion that the Limes [x2] of TG1 group are the principal cause of the current subsidence damage, combined with significant contribution from T1 Birch, particularly at the property frontage, and CG1 Ivy group.

View of T1 Birch with Limes of TG1 group visible to rear of building

If an arboricultural solution is to be implemented to mitigate the influence of the implicated trees/vegetation we recommend that T1 Birch, the Lime trees in TG1 and the Ivy of CG1 group are removed. Other vegetation recorded presents a potential future risk to building stability and management is therefore recommended.

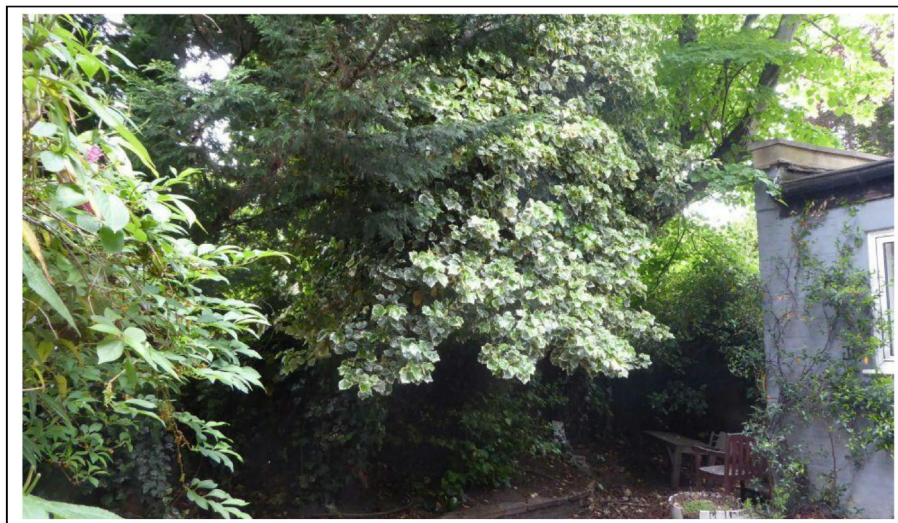
Roots were observed to a depth of 2.0m bgl in BH1 and to 1.6m bgl in TP/BH2, and recovered samples have been positively identified (using anatomical analysis) as *Betula* spp., *Tilia* spp. and *Hedera* or the related *Fatsia* spp.; the origins of which will be T1 Birch, the Lime trees of TG1 Lime and Cypress group and the Ivy of CG1 group, confirming their influence on the soils below the foundations.

View of TG1 Limes with significant Ivy growth (CG1) throughout and under-storey

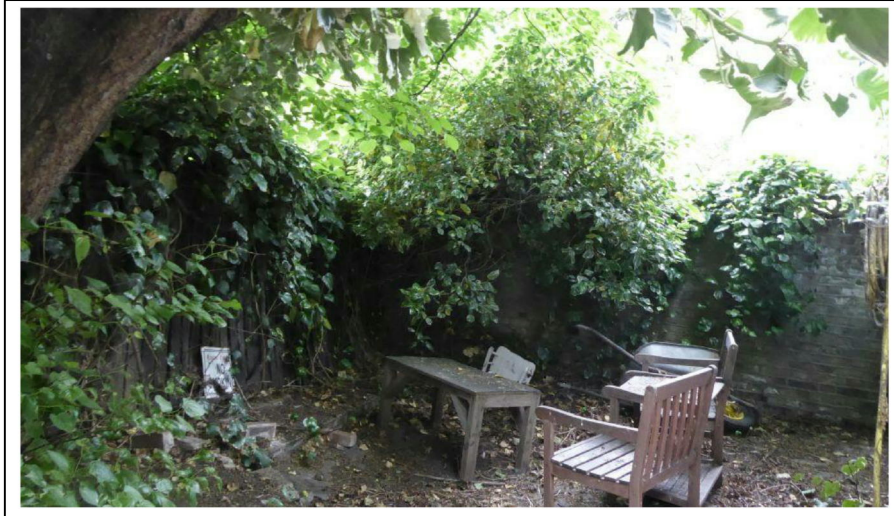
View of CG1 Ivy growth continuation

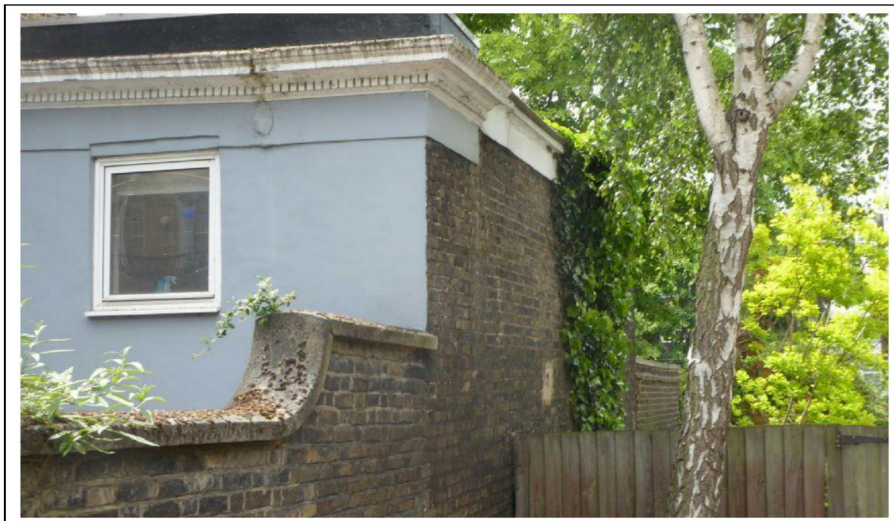
Continuation of CG1 Ivy growth against right-hand flank and over roof – remove all
