## Site Investigation Report

Client	Crawford & Co - Allianz (Subsidence)
Client ref	
Visit date	20/02/2020
Report date	13/03/2020

### Job Summary

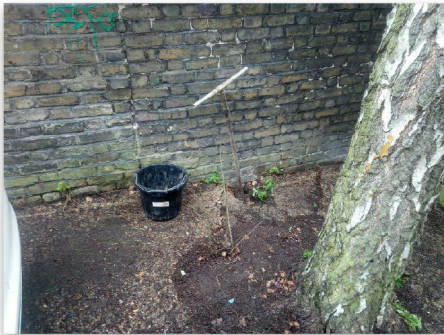
Trial Hole 1	
Fig 1.1: Trial Hole 1 Location	Fig 1.2: Trial Hole 1 Footing

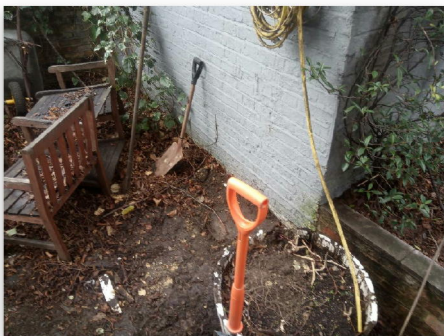
Trial Hole 2	
Fig 2.1: Trial Hole 2 Location	Fig 2.2: Trial Hole 2 Footing

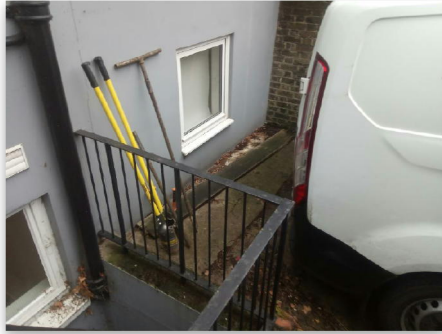
Fig 7.1: Trial Hole 1 Original Location

Overview	
Brief	Auger were commissioned by Crawford & Co - Allianz (Subsidence) to undertake a site investigation within the area of concern at the property.
Trial Hole Findings	Trial Hole 1 could not be completed due to the raised ground level on the customer's property. Additionally, the property had a basement flat that prevented our engineer reaching the desired depth d the trial hole. Due to this we wouldn't be able to encounter the foundations and footing of the property. We therefore, a borehole was dug out in the neighbouring property to collect the necessary soil samples down to 3mtrs.
