TECHNICAL REPORT ON A SUBSIDENCE CLAIM

Kenham Property Company Limited
Flat 2
1F Oval Road
NW1 7EA

[REDACTED]
SUBSIDENCE CLAIM

31st December 2019

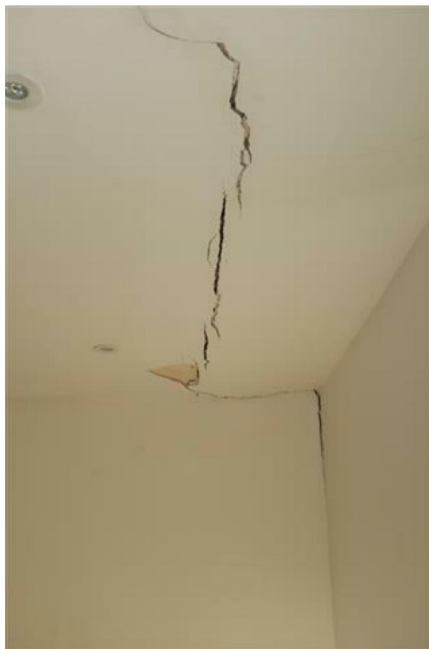
Cracking in ceiling at junction of rear outrigger with main

The most significant damage occurs in Bedroom 1 in the rear single storey outrigger. There is cracking across the ceiling approximately 15mm in width with pieces of plaster falling away. This cracking tracks down the side wall diminishing towards floor level. There is no damage to the adjacent en-suite bathroom to Bedroom 1 but this is in the two storey section.

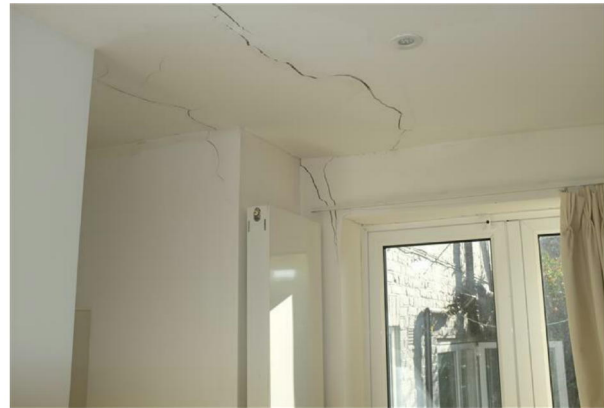
Separation cracking in rear outrigger at junction with two storey section

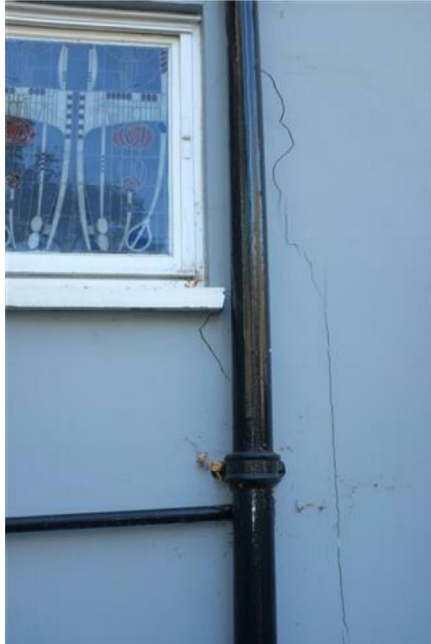
External cracking front right hand side of two storey section

Externally on the front of the two storey section there is predominantly vertical cracking up to 3mm width approximately to the right of the window extending full height. There was no access to the rear part of the right flank wall of the two storey section but from the neighbour's front parking area stepped diagonal and vertical cracking up to 3mm in width opposite the birch tree. We noted also some previous repairs in this area. To the rear of the property where the single storey outrigger abuts the two storey section there is vertical and stepped diagonal cracking on the right hand side of the French doors. It is likely that the flat roof flashing to the two storey section has pulled.

The mechanism of movement indicated by the damage is a slight rotation of the right hand area of the two storey section towards the tree located in the right hand neighbour's front parking area, with dislocation occurring to the right of the window as depicted. A more significant rotation of the rear single storey outrigger has occurred towards the trees located in the rear garden.

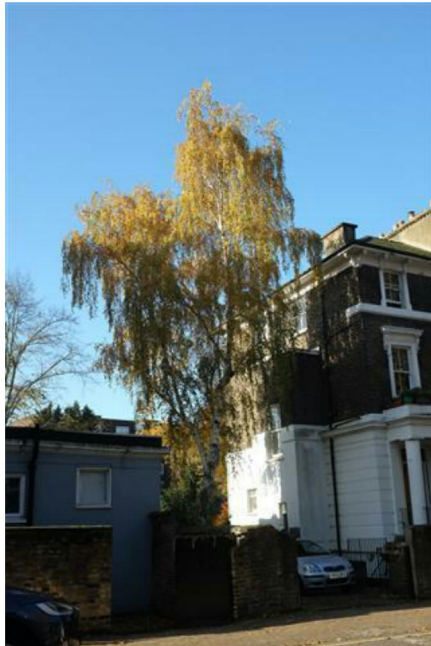
Birch tree in right hand neighbour's front drive

With regards to the third party birch tree our recommendation is that this also be removed to mitigate the damage and avoid further occurrences. Our Mitigation Unit will liaise with your neighbour in this respect.

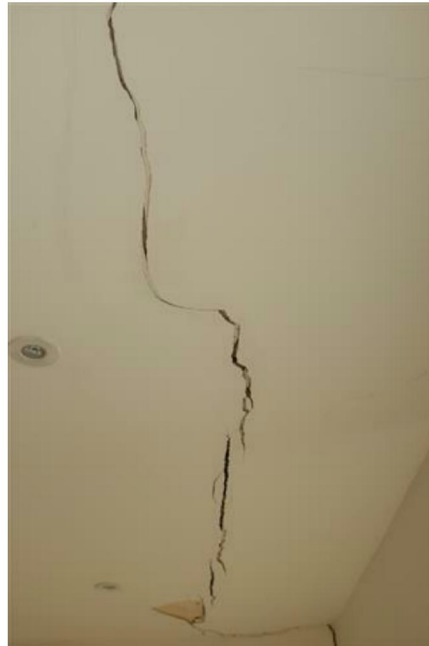
separation cracking in ceiling in rear outrigger

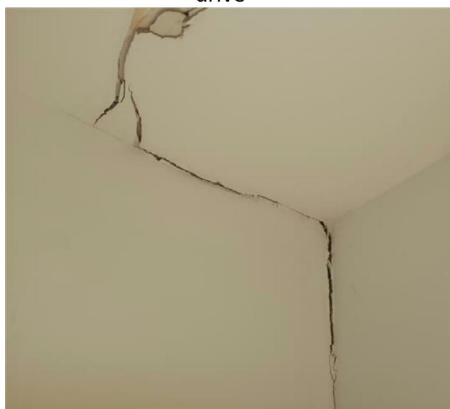
Separation cracking in rera outrigger at junction with main

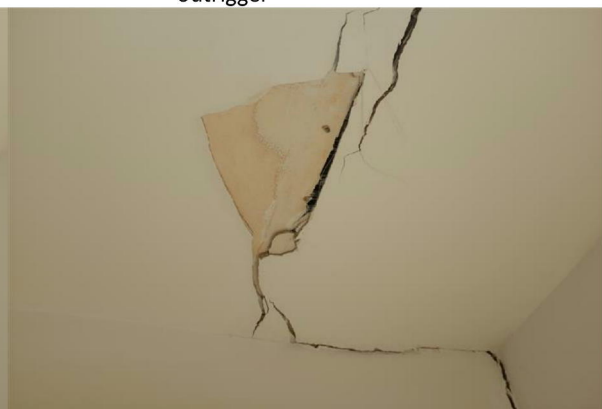
Ceiling cracking in rear outrigger

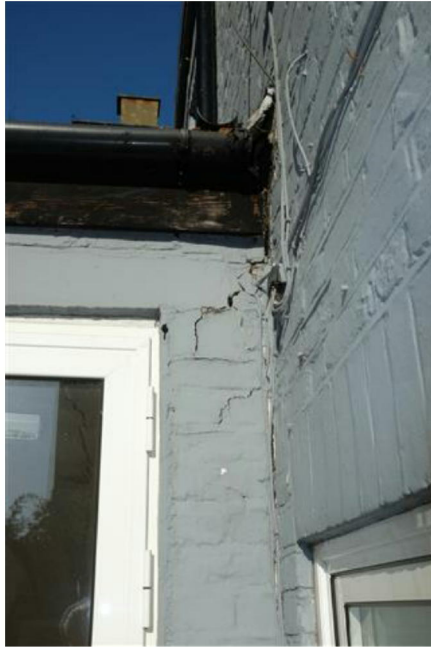
Separation cracking rear outrigger with
two storey section
