## Tree Condition Survey

A Tree Condition Assessment Report utilising Impulse tomography and Resistograph drilling

Christ Church  
Christchurch Hill  
Hampstead  
London NW3 1AB

Date completed:	02.04.18

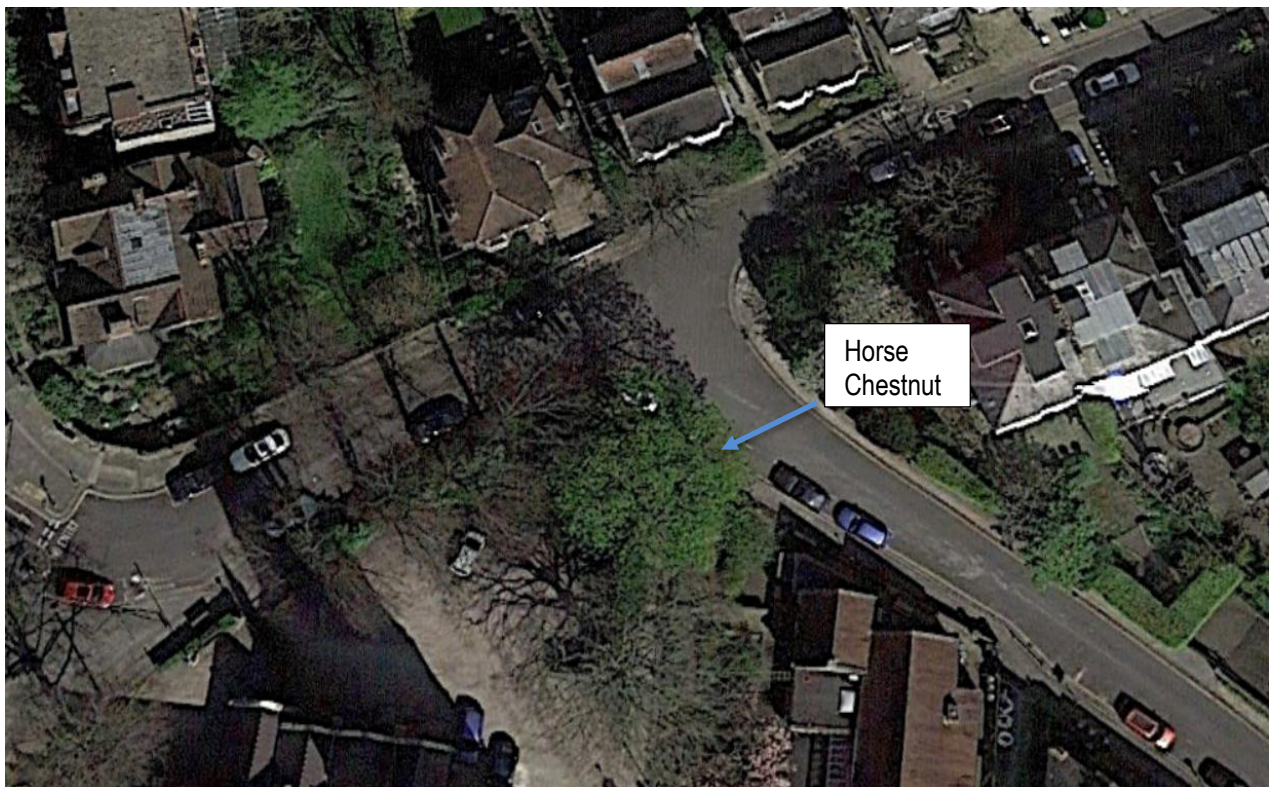
Photo 1: Overview of position of tree within the environment

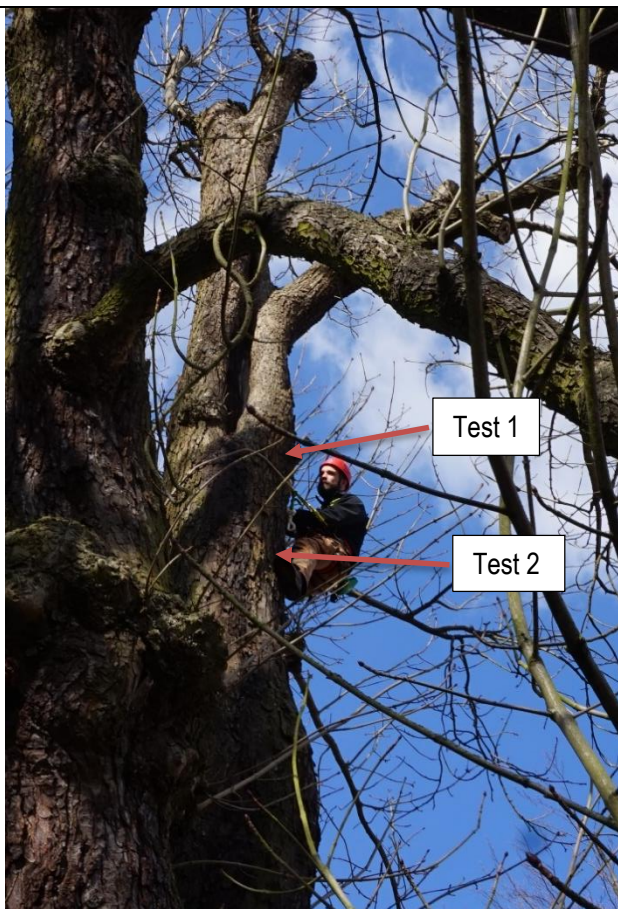
Photo 3: Limb to north. Tests carried out at approx. 7.5 and 6.5m.

The limb to the north exhibited structural defects and decay due to historic storm damage. The drill reading at 7.5m showed 200mm of intact wood below the decay, which recovered significantly 1m further down the stem. The limb to the east revealed in significant pockets of decay, although the whole limb exhibited a high degree of unusual movement with the climber in position. There were no visible signs of decay or structural condition at the base of the union of this stem at approx. 4m.

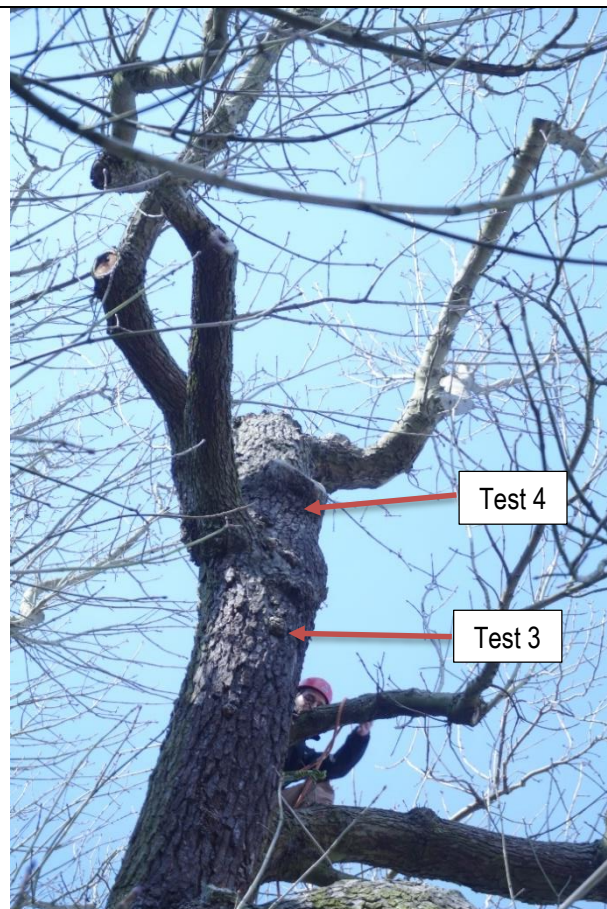
Photo 4: Limb to east. Tests carried out at approx. 8 and 7m.

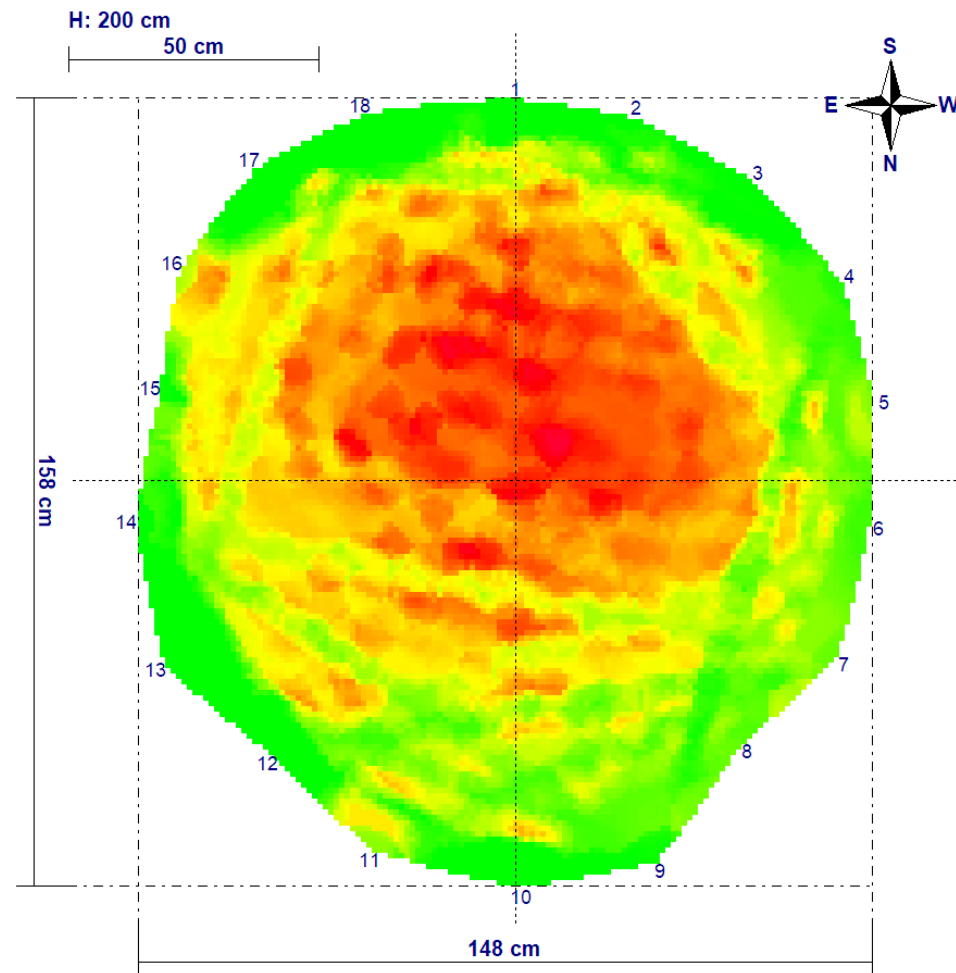
## 4.2 Impulse tomography test on base of main stem at 150cm above ground level to south

There is decay and strength loss at both areas of the readings on the main stem. (Note: no readings were made to the very base of the tree, to the north, as it was not possible to apply the sensors to achieve a reading across a horizontal plane). The decay and consequent strength loss within the main stem is significant. (The tomogram reading to the base of the tree is substantiated by the drill readings).

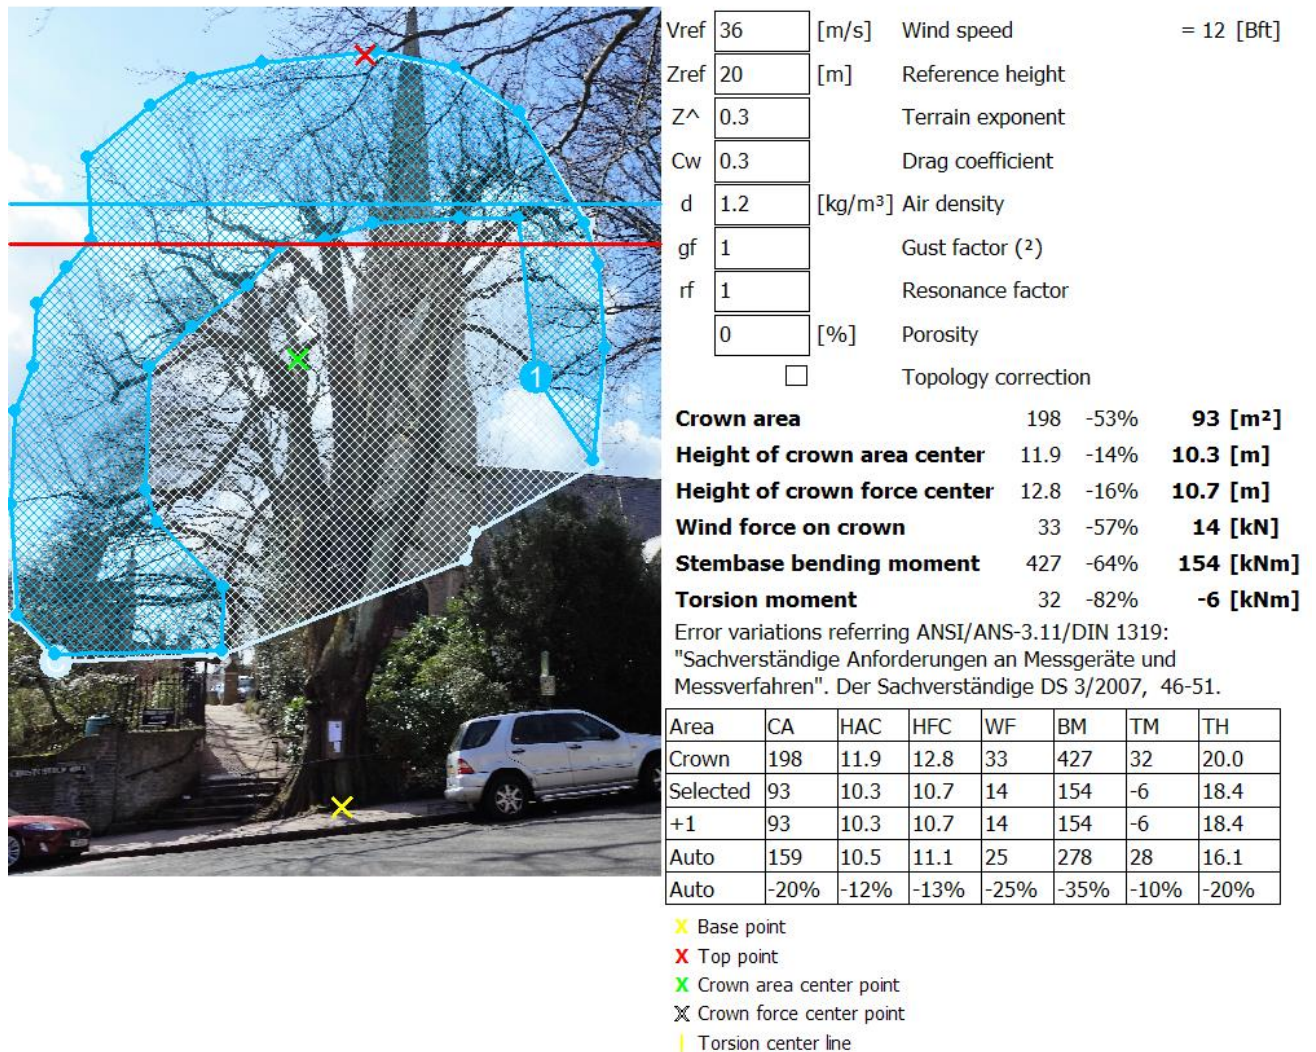
## 8. Wind Loading

The horizontal light blue line represents the height reduction required to reduce wind loading by 35%. This is viewed with respect to the mechanical strength loss measured as 32%.

The horizontal red line represents the extent of a 5m crown reduction. This is considered as means of remediating the end loading of weight and top down decay within the main vertical stems.

The white shaded area of the crown shows the remaining crown following reduction works. This reduces the stem base bending moment by 64%. This adequately compensates for the mechanical strength loss measured at the area of the lowest tomogram.

Recommended works in relation to Structural condition	Time scale
Reduce tree by approx. 5m in height and approx. 2m in spread. This will involve cutting back into larger limbs and leaving relatively large wounds, removing decay at previous large reduction points. Installation of non- invasive cable bracing suitable to brace possible failure of vertical stems. (Installation only to reduce impact should failure occur).	Within the next 3 months.
Recommended works in relation to Biological Functioning	Time scale
Monitor for Horse Chestnut Leaf Miner	Within the next 3- 4 months
Install Pheromone traps if presence is found to be currently significant	Within the next 3- 4 months
Introduce Phosphite drench through injection to soils and beneath paving slabs if possible (to improve cell structure in relation to further fungal progression).	Within the next 3- 4 months
Recommended works in relation to Monitoring & Further Inspection	Time scale

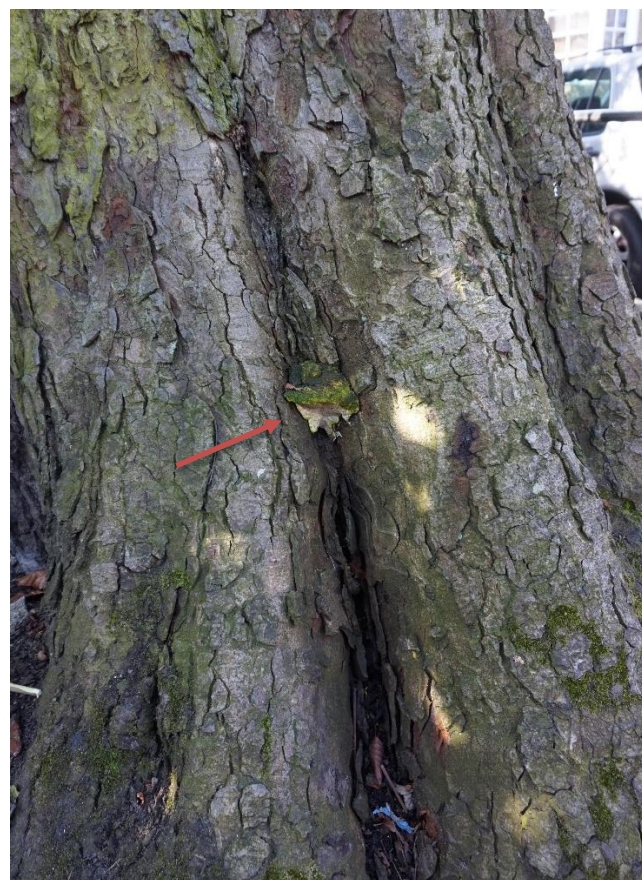
The fruiting body was identified through morphology as *Rigidoporus ulmarius*. Lonsdale describes the decay caused as 'a friable brown rot with cubical cracking... usually confined to the central region of the buttress zone of the tree'.

Photo 9: Fungal fruiting body to east of main stem

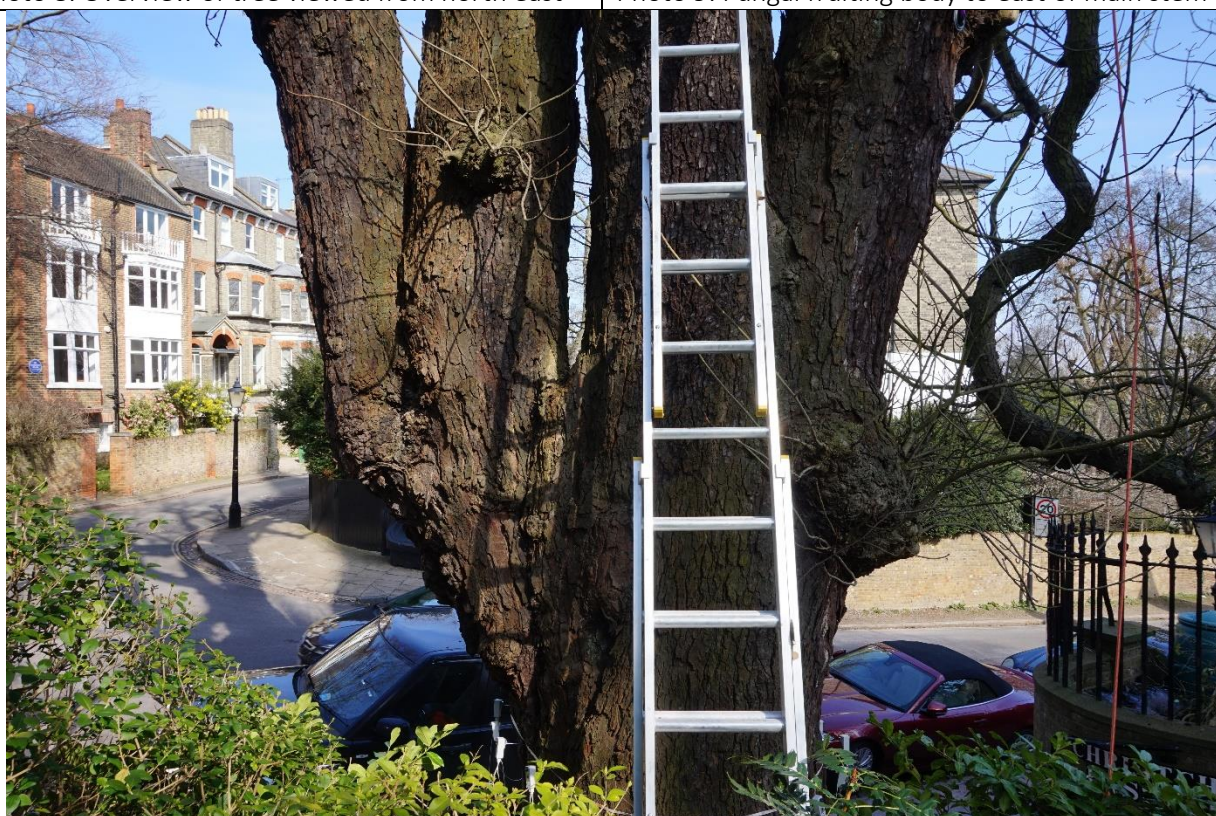
Photo 10: Main union of stems at approx. 2.5m

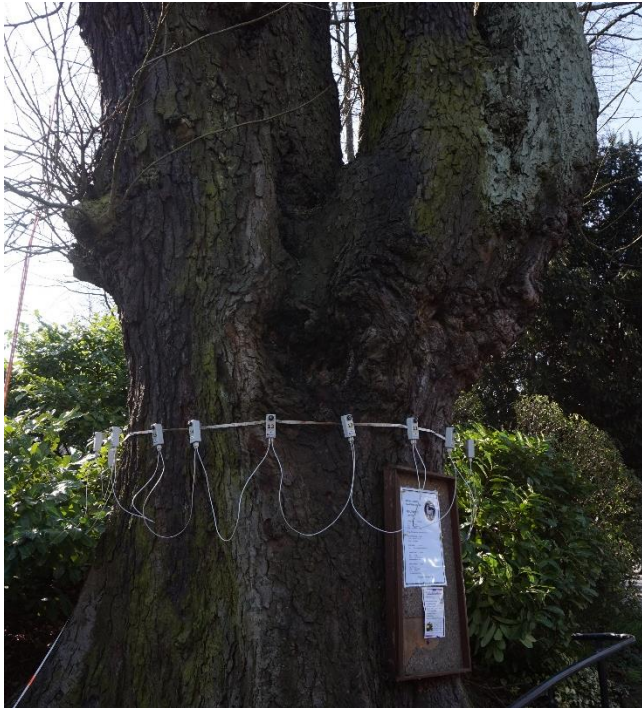
Photo 11: Main target canker below main union at approx. 2.5m on stem to east

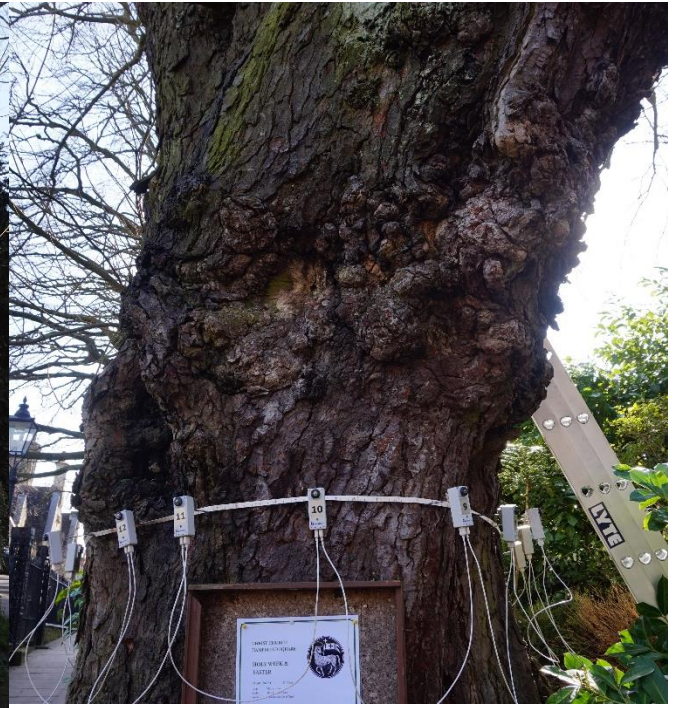
Photo 12: Further smaller target canker on main stem to north west at approx. 2.5m
