Arboricultural Consultancy for Esure

Insured		Address	34 Laurier Road, London, NW5 1SJ		
Client	Subsidence Management Services	Contact	Delroy Brown	Claim No.	
ES Ref		Consultant	Kirk Thompson	Contact No.	
Report Date	03/12/2020

Scope of Report: To survey the property and determine significant vegetation contributing to subsidence damage, make recommendation for remedial action and assess initial mitigation and recovery prospects. The survey does not make an assessment for decay or hazard evaluation.

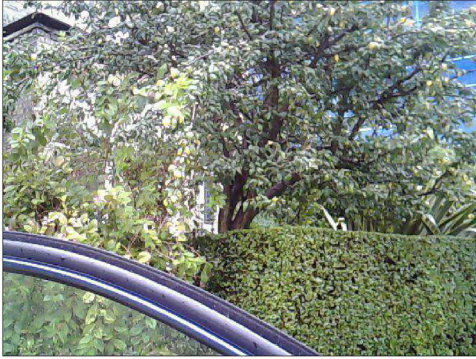
T5 - Plum

Our survey of the site identified H1 (Cypress) and T5 (Plum), given their position relative to the damage it is in our opinion that the roots identified within TP/BH1 will emanate from this vegetation.

Based on our site investigations, and taking account of vegetation location, relative to the focal area of movement/damage, it is our opinion that H1 and T5 are considered the dominant features, and accordingly we have identified them as the principal cause of the subsidence damage.

Tree No.	Species	Age Cat	Approx. Height (m)	Distance to Building (m) *	Ownership	Action	Requirement
H1	Cypress	1	2.9	1.8	A - Third Party	Remove	Remove close to ground level.
T5	Plum	1	6.8	5.9	A - Third Party	Remove	Note: Distance recorded to area of movement, where tree stands 3.5m from front elevation. Remove close to ground level and treat stump to inhibit regrowth.

Consequently, removal of H1 and T5 will offer the most certain and reliable Arboricultural solution likely to restore long-term stability.

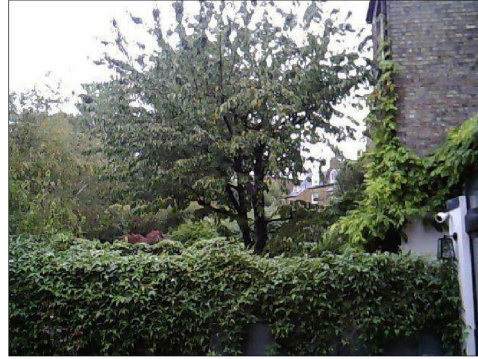
T1 - Cherry

Tree No.	Species	Age Cat	Approx. Height (m)	Distance to Building (m) *	Ownership	Action	Requirement
C1	Jasmine	1	2.4	2.4	C - Insured	No action	No works.
S1	Weigela	1	2.5	3.5	C - Insured	Action to avoid future risk	Do not allow to exceed current dimensions by way of regular pruning.
T1	Cherry	1	9	7.5	A - Third Party	Action to avoid future risk	Do not allow to exceed current dimensions by way of regular pruning.
T2	Maple	1	10.5	3	A - Third Party	Action to avoid future risk	Crown reduce overall canopy by 30% (minimum) to achieve a crown volume reduction in line with BRE IP7/06. Maintain at reduced dimensions by re-pruning back to points of previous reduction on a strict 2-3 year cycle.
T3	Snowy Mespilus	1	2.8	2.5	A - Third Party	No action	Do not allow to exceed current dimensions by way of regular pruning.
T4	Birch	1	6	4.5	A - Third Party	Action to avoid future risk	Do not allow to exceed current dimensions by way of regular pruning.

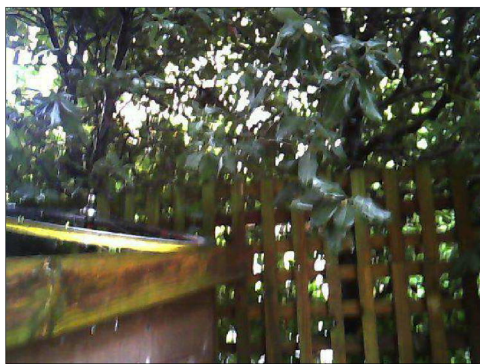
TG2 - Photinia

TG1	Mixed Species Group: Includes Pear, Bay Laurel & Pittosporum.	1	9.2	11.5	A - Third Party	No action	No Works.
TG2	Photinia	1	4.5	2.8	A - Third Party	Action to avoid future risk	Do not allow to exceed current dimensions by way of regular pruning.
Age Cat: 1 = Younger than property; 2 = Similar age to the property; 3 = Significantly older than property
