**FURTHER INVESTIGATION REPORT:**

5 Oval Road  
London  
NW1 7EA

**Ref:** LRE/5OLR/PCS/01

**Date:** 4<sup>th</sup> September 2020

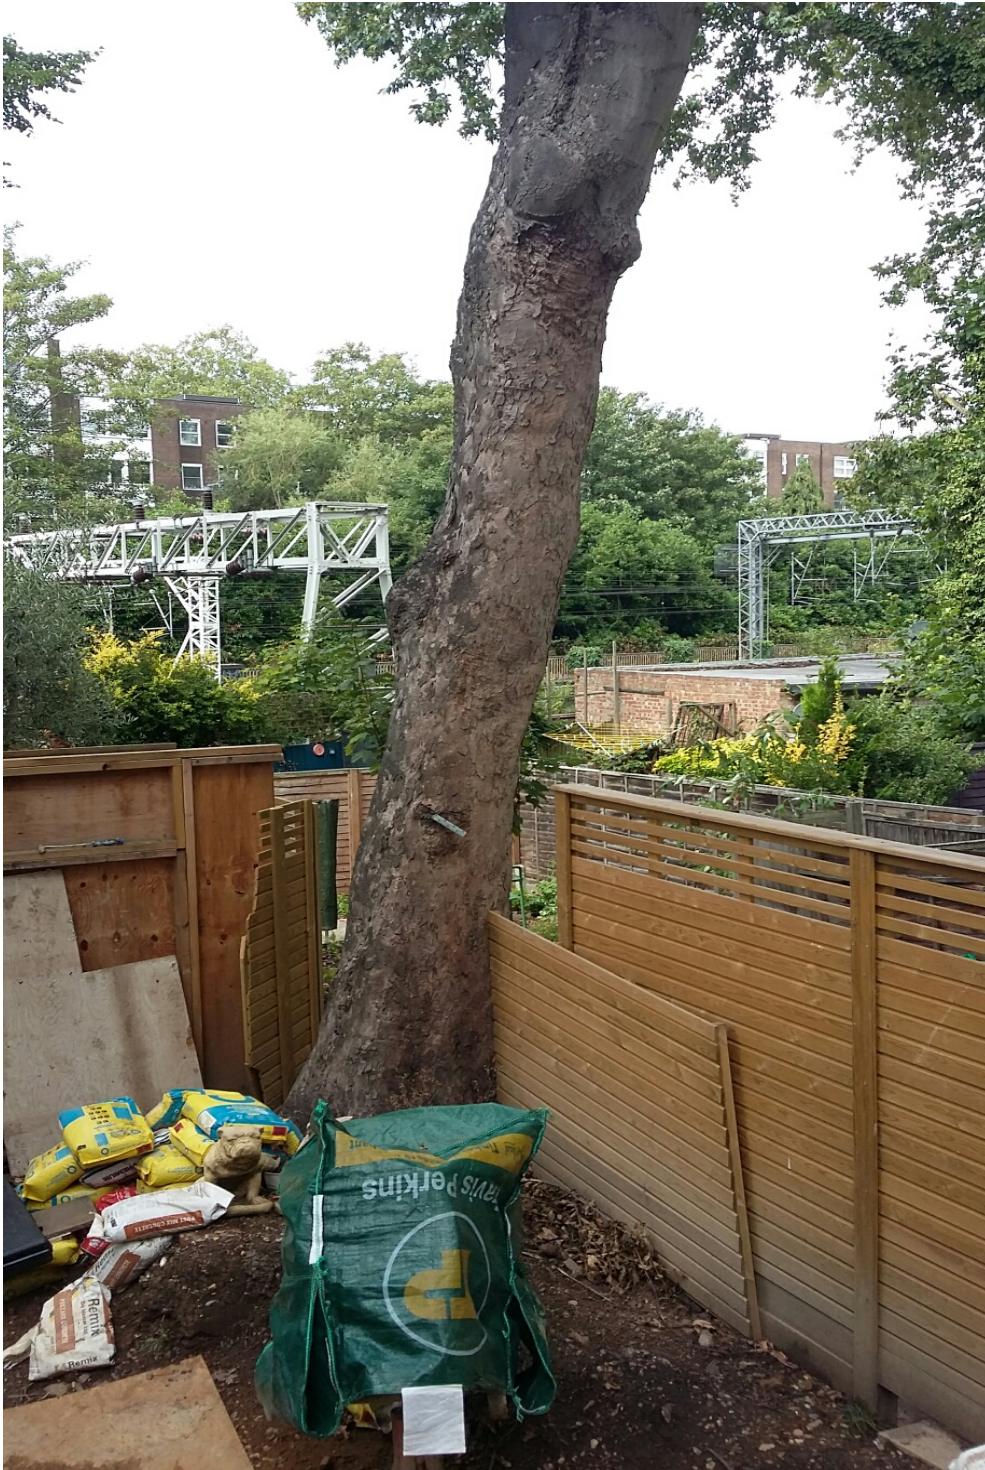
Photograph 1: Location of T6

The tree is situated on the northern boundary of the property, with a panel fence loosely attached to the east and west of the stem. The stem leans to the north over the adjoining council-owned property (No7 Oval Road) and is bifurcated at 6m with a narrow fork. The property is being developed and site usage appears relatively intensive. According to the British Geological Survey, the site overlies London Clay (please see <http://mapapps.bgs.ac.uk/geologyofbritain/home.html>).

Fell tree within 3 months of the date of this report.

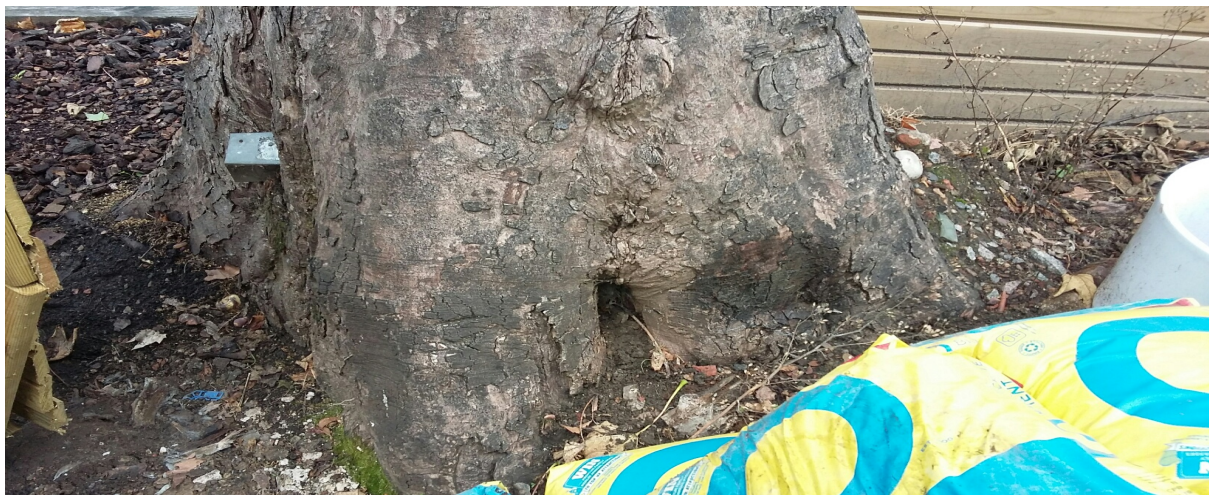
There is a small cavity measuring 10cm by 5cm at ground level to the south of the stem (see Photograph 2). No immediate fungal fruit bodies or pathogens are evident at the seat of decay, nor is inspection of the internal wood readily possible. There are metal brackets included in the stem at 0.4 and 1.5m to the West and 2m to the east. The canopy appears full and well balanced with no obvious dieback, but has been crown raised in the past, leaving a long unmodified 'lever-arm' to the main stem and relatively low crown ratio. There is moderate swelling in the base of the tree around the cavity with the diameter increasing markedly to >1000mm, compared to 700mm at 1.5m height.

Photograph 2: Small cavity at base of tree

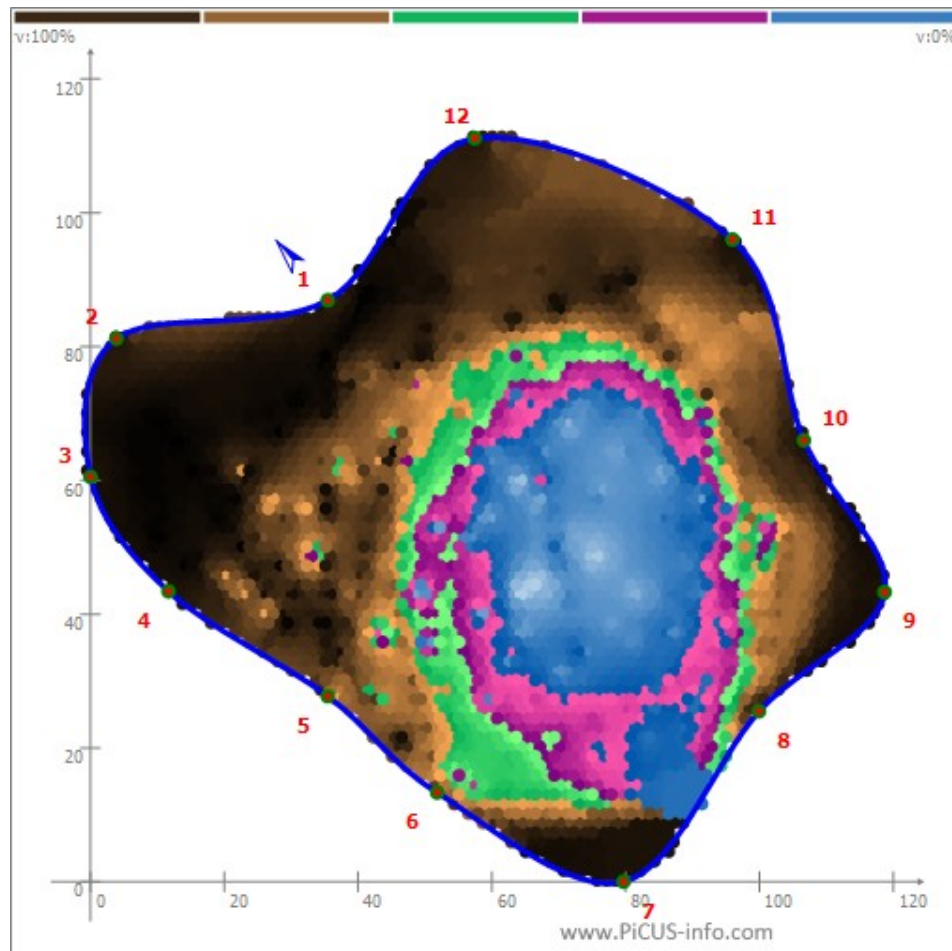
One tomograph was taken, at a level 10cm above ground. The tomograph shows an area of decay to the south of the stem with a cavity shown in blue, advanced decay coloured pink/purple and the incipient or early decay coloured green.

Figure 1: Tomograph of T6 taken at 10cm above ground level

No single pathogen / disease can be confirmed at this time, though annual fungal fruit bodies may reveal themselves presently in Autumn. Equally, bodies of perennial fruiting fungi are not always evident on impacted trees. However, it is most likely the decay is caused by one or more of the common decay fungi colonising hardwood / broadleaved trees (e.g. *Ganoderma* spp). These degrade the internal timber with often less obvious symptoms in the tree's external physiognomy, though sometimes a marked basal swelling and / or general thinning / dying back of the canopy. Basal swelling has been observed here as is common in *Ganoderma* decay.

Whilst the percentage cross-sectional area of decay (55%) to sound wood (45%) indicated on the tomograph does not necessarily occupy a high proportion of the overall cross-section of the stem, its eccentric position means it does occupy a large part of the southern half of that stem with the result that the residual walls at points 6 and 8 are particularly narrow (c. 3cm). A higher percentage of 70% decay to 30% sound wood is generally considered a statistical safety threshold. However, Fraedrich and Smiley (1999) recommend increasing the sound wood requirement for trees with asymmetric decay columns, trees that are leaning, trees with low crown ratios, trees with other defects and trees on high use sites. Given the other observed defects in the tree, ongoing adjacent construction works and difficulty in carrying out a crown reduction due to the past pruning history, its retention is deemed, on balance, imprudent. Given the size and position of the cavity, in conjunction with the leaning stem and other defects / site conditions, I would be reticent to award this tree much more than 10 years Safe Useful Life Expectancy.

Consult with a structural engineer on providing a heave risk assessment with regards to potential ground movement following the removal of a mature tree. NB replacement planting may also be a condition of planning consent to remove the existing tree: the design of foundations and other structures should also take this condition (and future tree growth) into consideration.
