Arboricultural Appraisal Report

Subsidence Damage Investigation at:

Heath Court, 10-12 Frognal
London
NW3 6AH

CLIENT:	Crawford & Company
CLIENT REF:	[REDACTED]
MWA REF:	[REDACTED]
MWA CONSULTANT:	Andy Clark
REPORT DATE:	06/07/2020

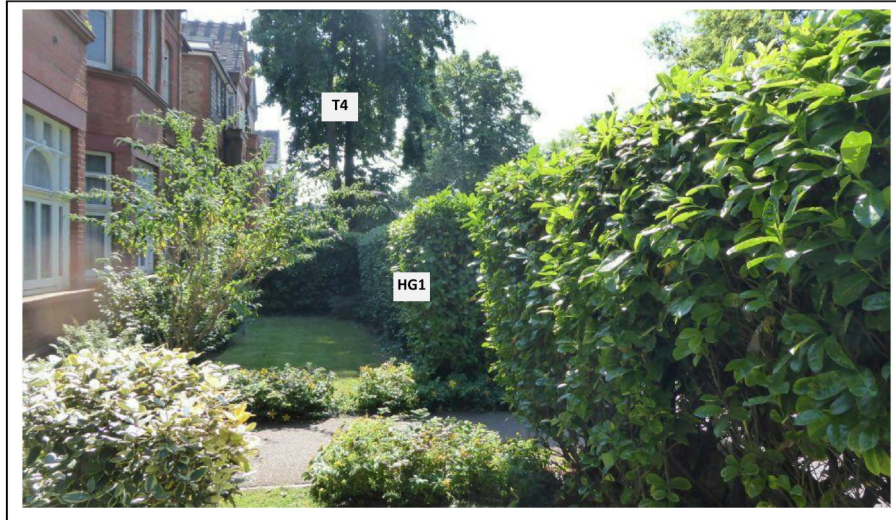
The origin of the Prunus spp. roots retrieved at the property frontage will be from the Laurel, HG1. The source of the Betula spp. roots is unclear, as no significant related vegetation was observed within influencing distance of the building.

Irrespective of the identification of recovered root samples at the frontage, the roots of T4 Lime will have a significant presence below the area of damage at the front left hand corner of the building and will be influencing soil moisture and volumes.

View of T4 Lime and HG1 Laurel hedgerow. Small shrubs are not considered relevant

If an arboricultural solution is to be implemented to mitigate the influence of the implicated trees/vegetation we recommend that the Poplars of TG1 group are removed, combined with the removal of T1 Bay, T4 Lime, nearby stems of HG1 group and TG2 Cypress group. Other vegetation recorded presents a potential future risk to building stability and management is therefore recommended.

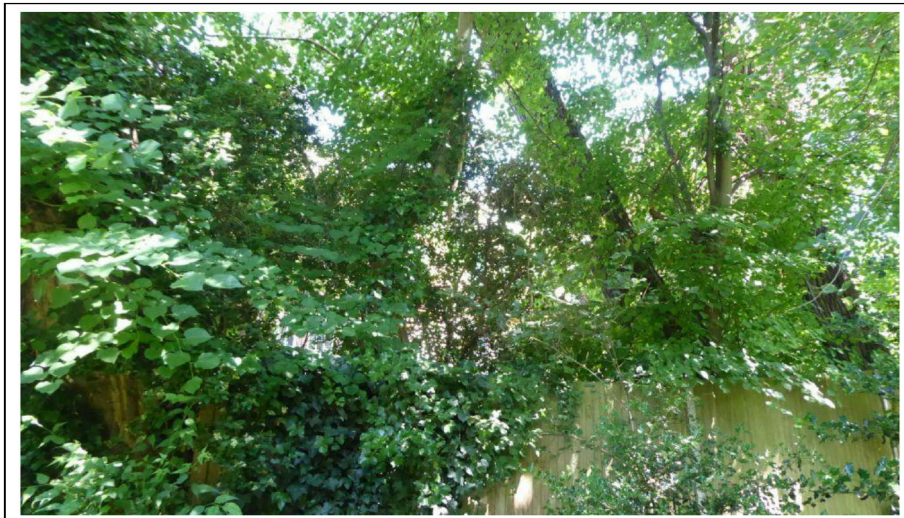
Based on the technical reports currently available, engineering opinion and our own site assessment we conclude the damage is consistent with shrinkage of the clay subsoil related to moisture abstraction by vegetation. Having considered the information currently available, it is our opinion that TG1 Poplar group is the principal cause of movement of the building and the arising current damage. T1 Bay, T4 Lime, HG1 Laurel group and TG2 Cypress group will also likely be exacerbating the movement locally and are a contributory factor.

View of TG1 group beyond boundary fence
