TECHNICAL REPORT ON A SUBSIDENCE CLAIM

**Heath Court Management Ltd
Heath Court
10-12 Frogna
London
NW3 6AH**

SUBSIDENCE CLAIM

4th June 2020

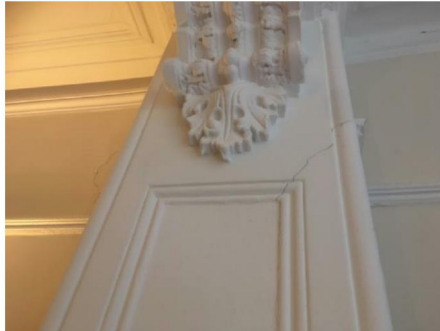
Typical cracking to flats

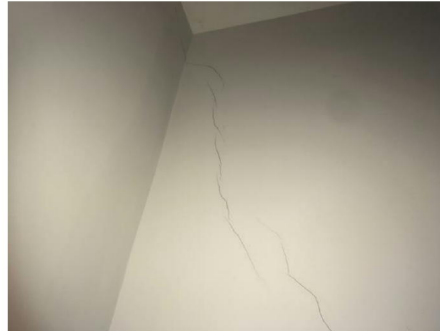
Typical cracking to flats

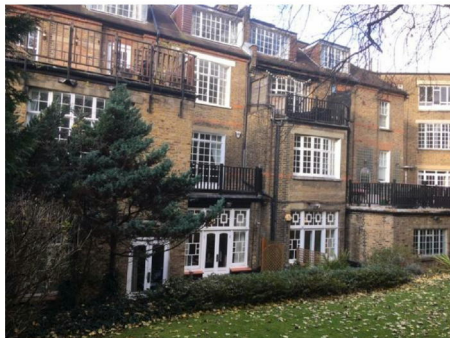
Rear view

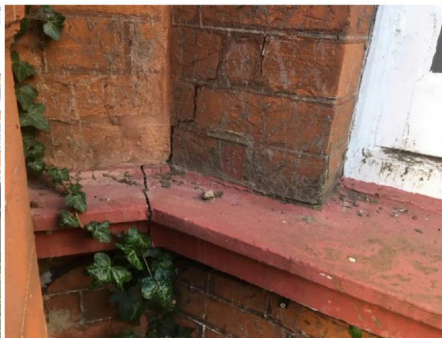
External cracking to bay

To the front bay (right of main entrance) slight stepped cracking was noted to the left hand return wall at lower level.

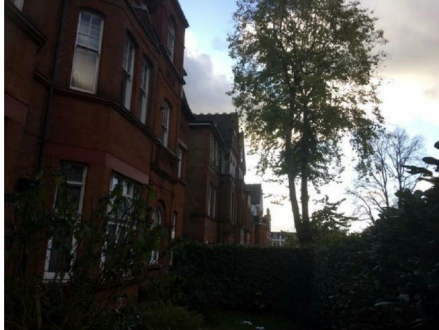
Tree at front

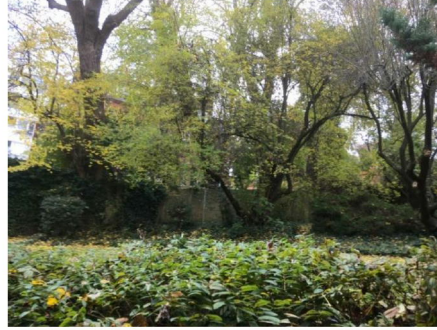
Trees at rear

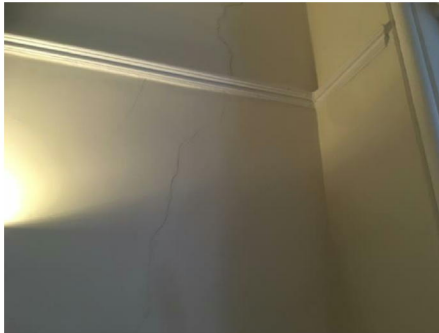
Typical cracking to flats

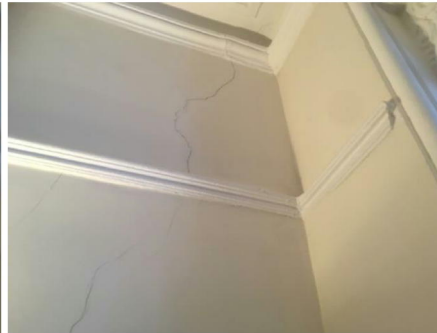
Typical cracking to flats

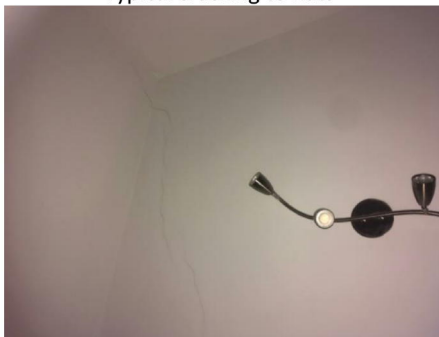
Typical cracking to flats

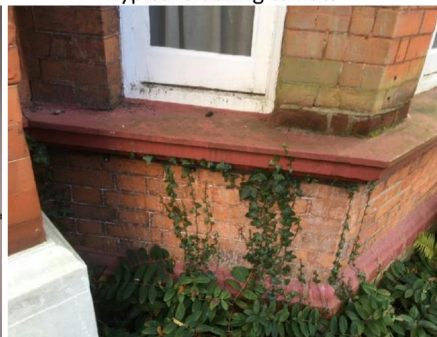
External cracking to bay
