## Arboricultural Appraisal Report

### Subsidence Damage Investigation at:

Heath Court, 10-12 Frognal  
London  
NW3 6AH

CLIENT:	Crawford & Company
CLIENT REF:	 
MWA REF:	
MWA CONSULTANT:	Andy Clark
REPORT DATE:	06/07/2020

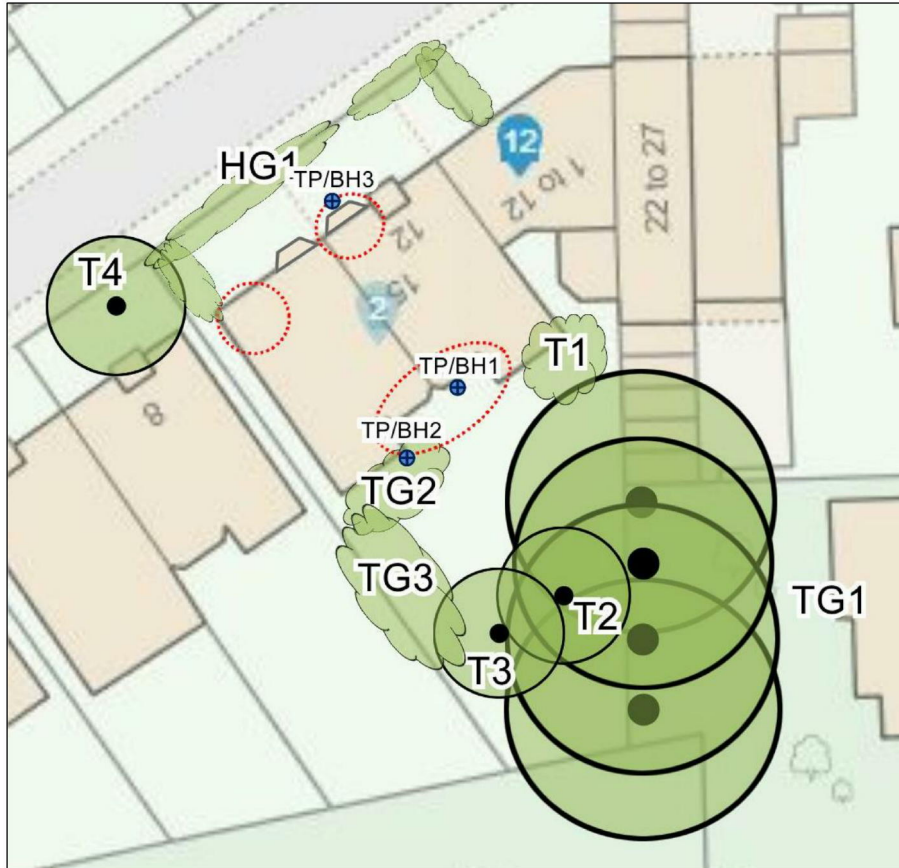
Site Plan

Approximate areas of damage

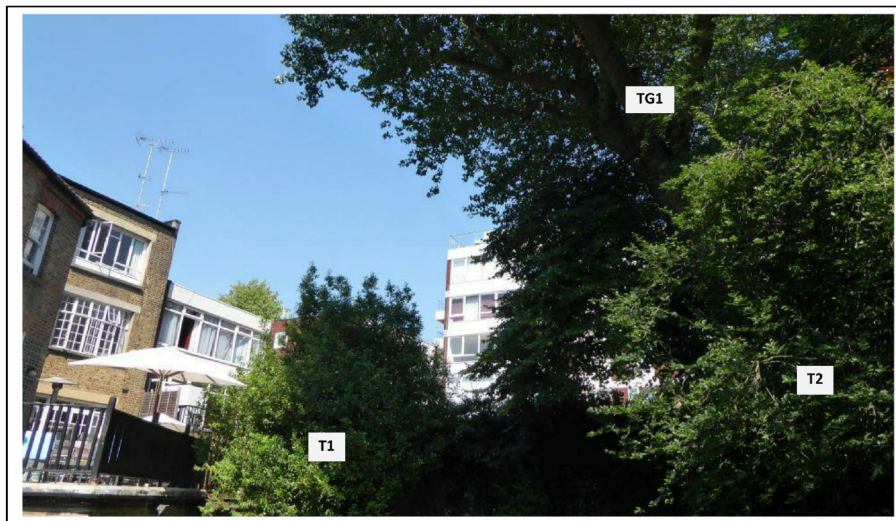
In relation to the damage at the rear, the retrieved root samples tested negative for Starch suggesting them to be dead at the time of retrieval, however there is corresponding vegetation within influencing distance which is likely to account for some of the samples – in particular the Salicaceae spp. roots, which will likely originate from the large dominant Poplars of TG1 group. No Acer spp. or Carpinus spp. vegetation however was observed nearby. Proximal vegetation to the rear may also have a contributory localised influence, particularly T1 Bay and TG2 Cypress group.

View of T1 Bay, T2 Plum and the closest Poplar stem of TG1 group

If an arboricultural solution is to be implemented to mitigate the influence of the implicated trees/vegetation we recommend that the Poplars of TG1 group are removed, combined with the removal of T1 Bay, T4 Lime, nearby stems of HG1 group and TG2 Cypress group. Other vegetation recorded presents a potential future risk to building stability and management is therefore recommended.

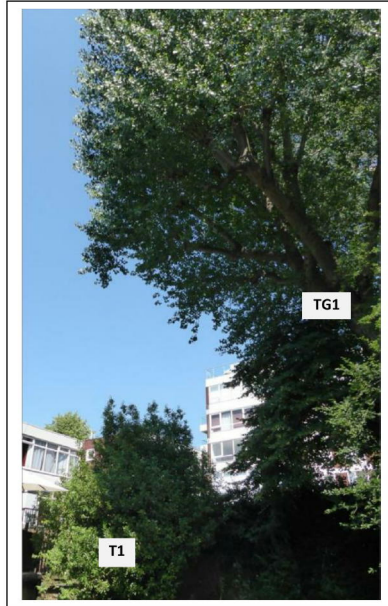
View of T1 Bay and closest Poplar stem  
of TG1 group

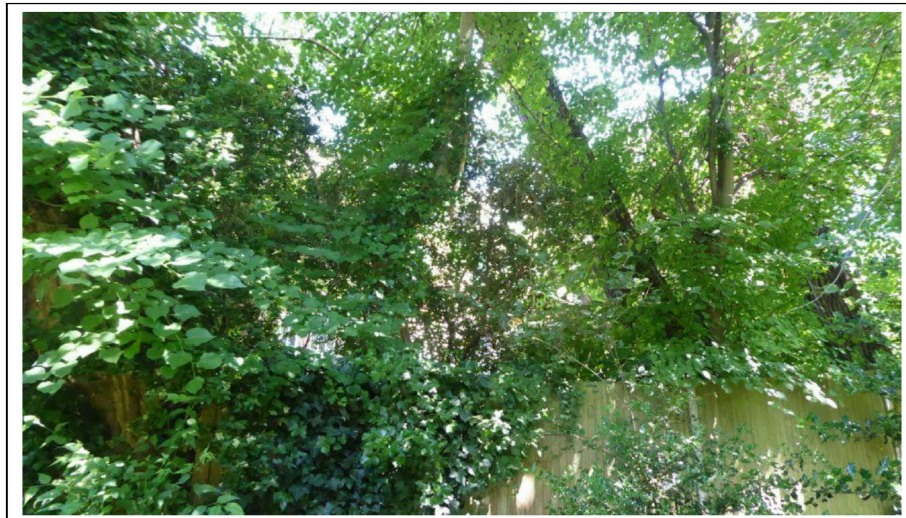
Based on the technical reports currently available, engineering opinion and our own site assessment we conclude the damage is consistent with shrinkage of the clay subsoil related to moisture abstraction by vegetation. Having considered the information currently available, it is our opinion that TG1 Poplar group is the principal cause of movement of the building and the arising current damage. T1 Bay, T4 Lime, HG1 Laurel group and TG2 Cypress group will also likely be exacerbating the movement locally and are a contributory factor.

View of TG1 group beyond boundary fence
