**TECHNICAL REPORT ON A SUBSIDENCE CLAIM**

**Heath Court Management Ltd  
Heath Court  
10-12 Frognal  
London  
NW3 6AH**

**SUBSIDENCE CLAIM**

4<sup>th</sup> June 2020

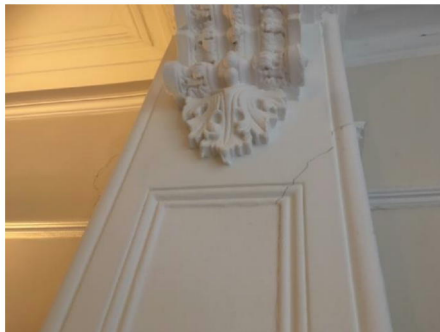
Typical cracking to flats

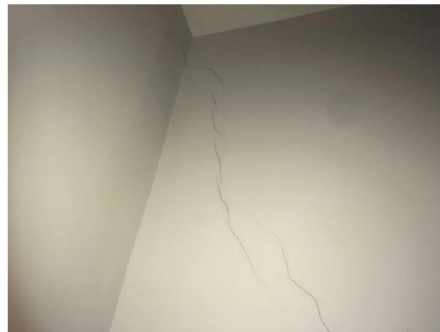
Typical cracking to flats

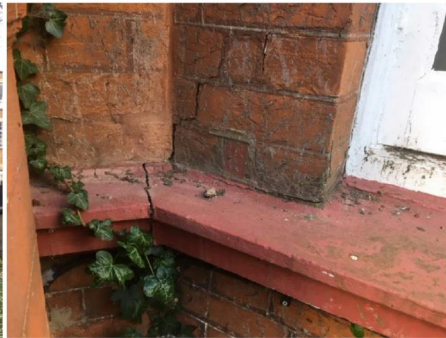
External cracking to bay

To the front bay (right of main entrance) slight stepped cracking was noted to the left hand return wall at lower level.

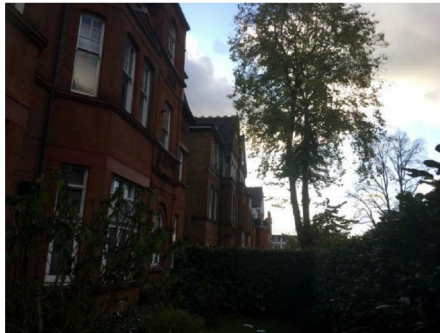
Tree at front

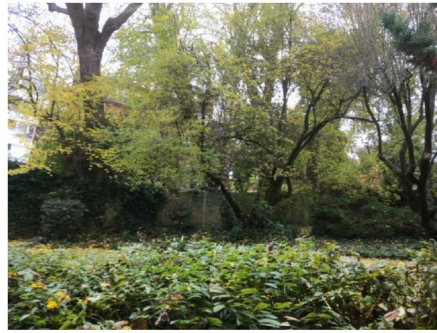
Trees at rear

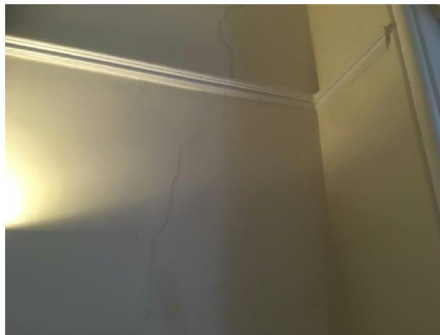
Typical cracking to flats

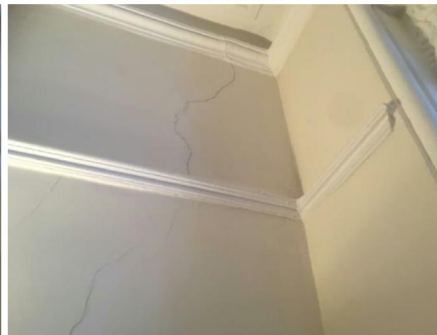
Typical cracking to flats

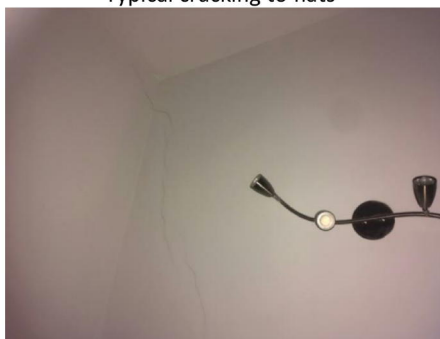
Typical cracking to flats

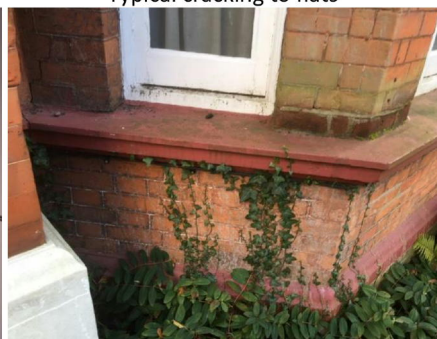
External cracking to bay
