22 - 25 ELY PLACE / ST ANDREWS HOUSE

Existing Boundary Wall
Essential Structural Repairs

Design & Access statement

SAH-AUK-ZZ-ZZ-RP-A-07003 P01 (2021.03.31)

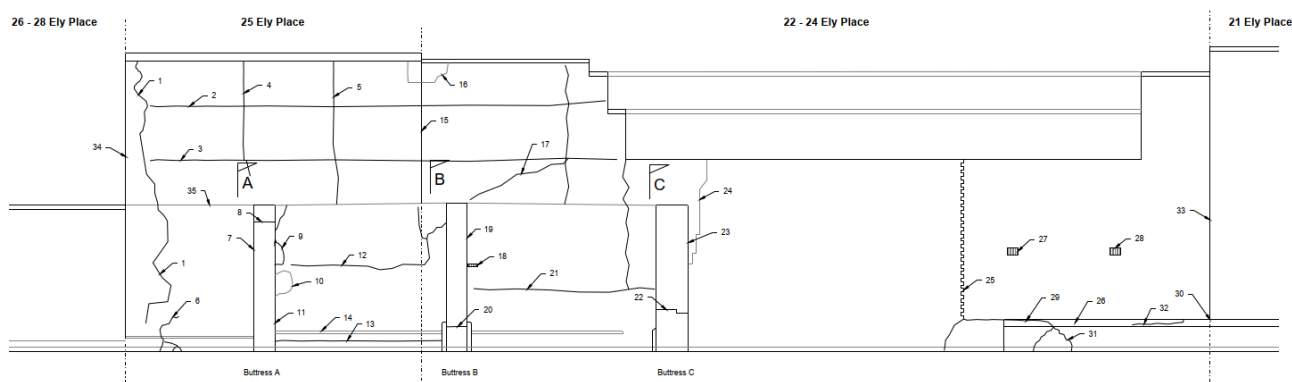
Fig.1, Boundary Wall, East Facing : Several Cracks are evident and the existing primary features need to be stabilised.

In order to stabilise and preserve the wall, it is proposed to undertake structural repairs to do so, and which will require a mix of invasive and cosmetic works. Based on the visible evidence and assumption that the settlements of the buttress's bases have now ceased, the repair work to the buttresses could commence. This will involve cleaning and removing moss and loose mortar, bricking up and packing up the main cracks as well as filling up the vertical gaps between the buttresses and existing rear wall. Remedial work are likely to include installation of remedial ties to connect the buttresses into the rear wall. This could be done using proprietary Helifix stitching system or SockFix anchors and is described in 1.4 below in a little more detail.

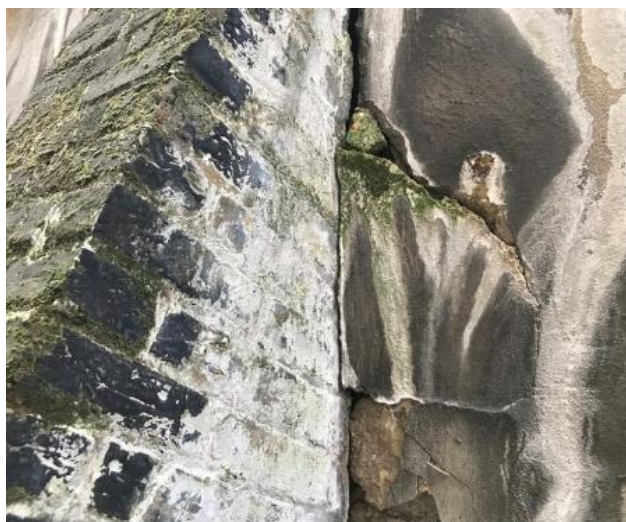
Fig.2, Buttress A : Cracking at the junction with the wall

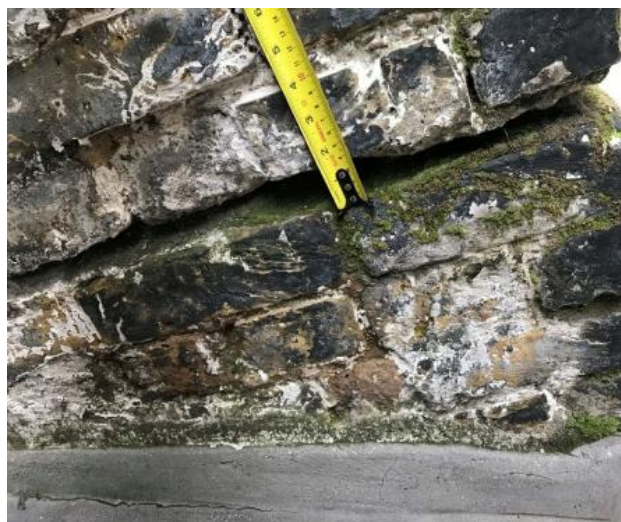
Fig.3, Buttress B : Left Side View, large base crack

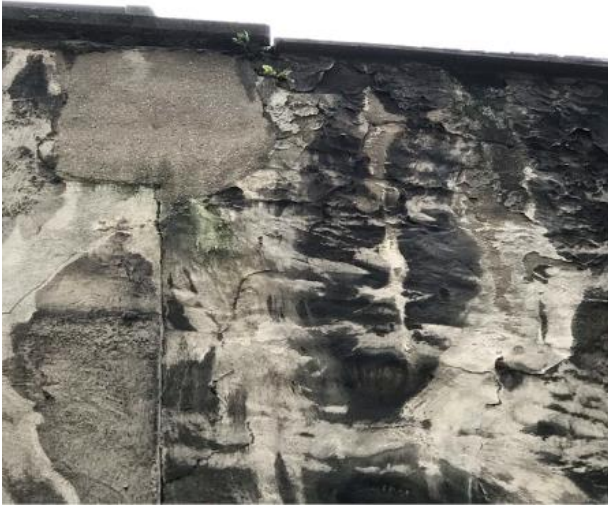
*Fig.4, **Top of Wall** : View onto No 25 & No 24 Ely Place Rear Wall top section illustrating previous remedial localised works*

Some key invasive measures have been noted to date. Due to numerous cracking, warping, discolouration, and generally very poor condition of the existing render to No 24 and No 25 Ely Place we propose removing the render entirely in order to assess the cracking to the existing brickwork. A HeliBar system stitching system is then proposed for to any found cracks as well as new render laid on repaired and primed brickwork surface with use of mechanically fixed expanded metal lathing (E.M.L.).

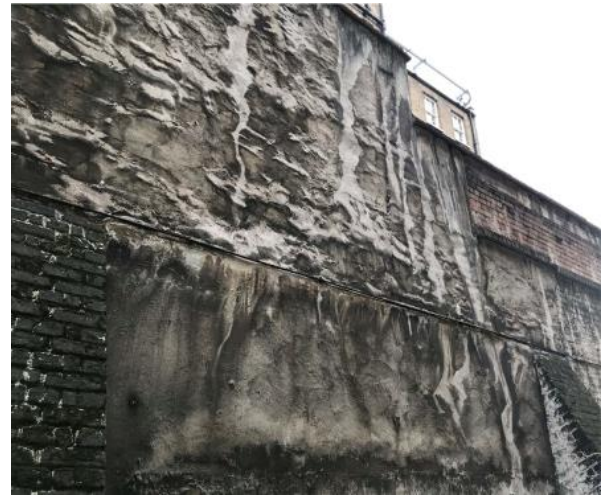
*Fig.5, **Boundary Wall, East Facing** : View onto No 22-24 Ely Place Rear Wall top section including Buttresses B & C*

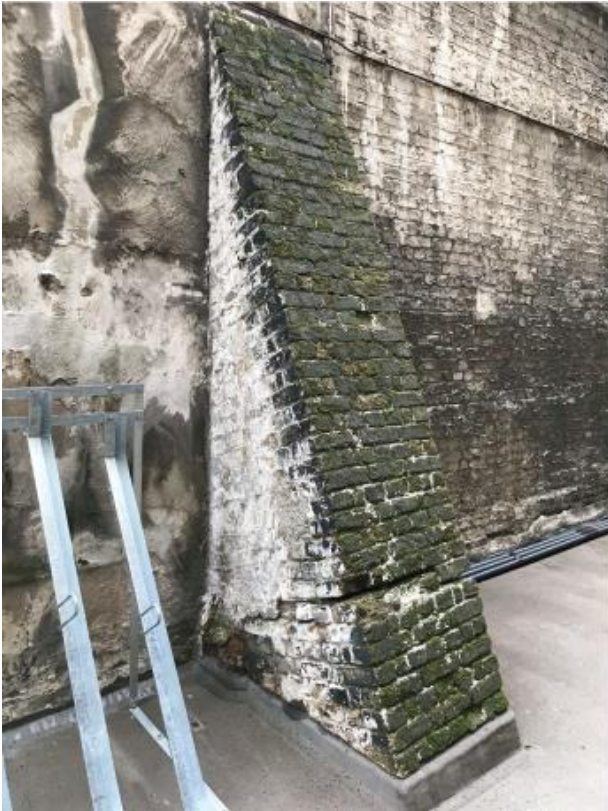
*Fig.6, **Buttress C** : Severe Cracking and separation*

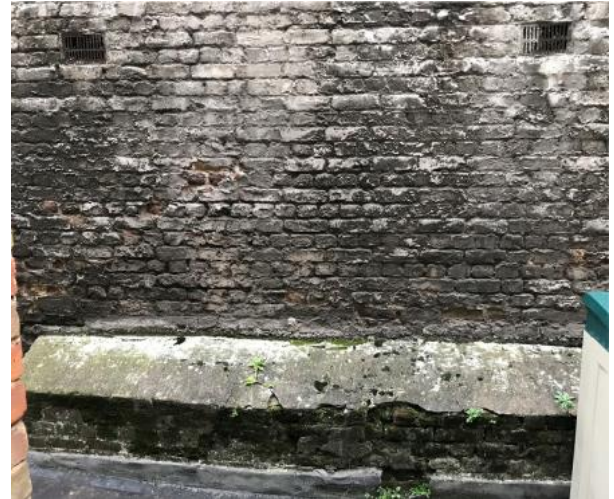
*Fig.7, **22 Ely Place** : View of damage and wear at the bottom of the wall*

We also propose that the existing plinth near No 22 and 21 Ely Place should also have the top render replaced after the cracks are stitched or rebuild to reinstate the weatherproofing.
