project **No. 10 Bedford Square, London,**  
Existing Roof Condition Photos

Paul Bowman  
29<sup>th</sup> April 2021  
1806\_3.0

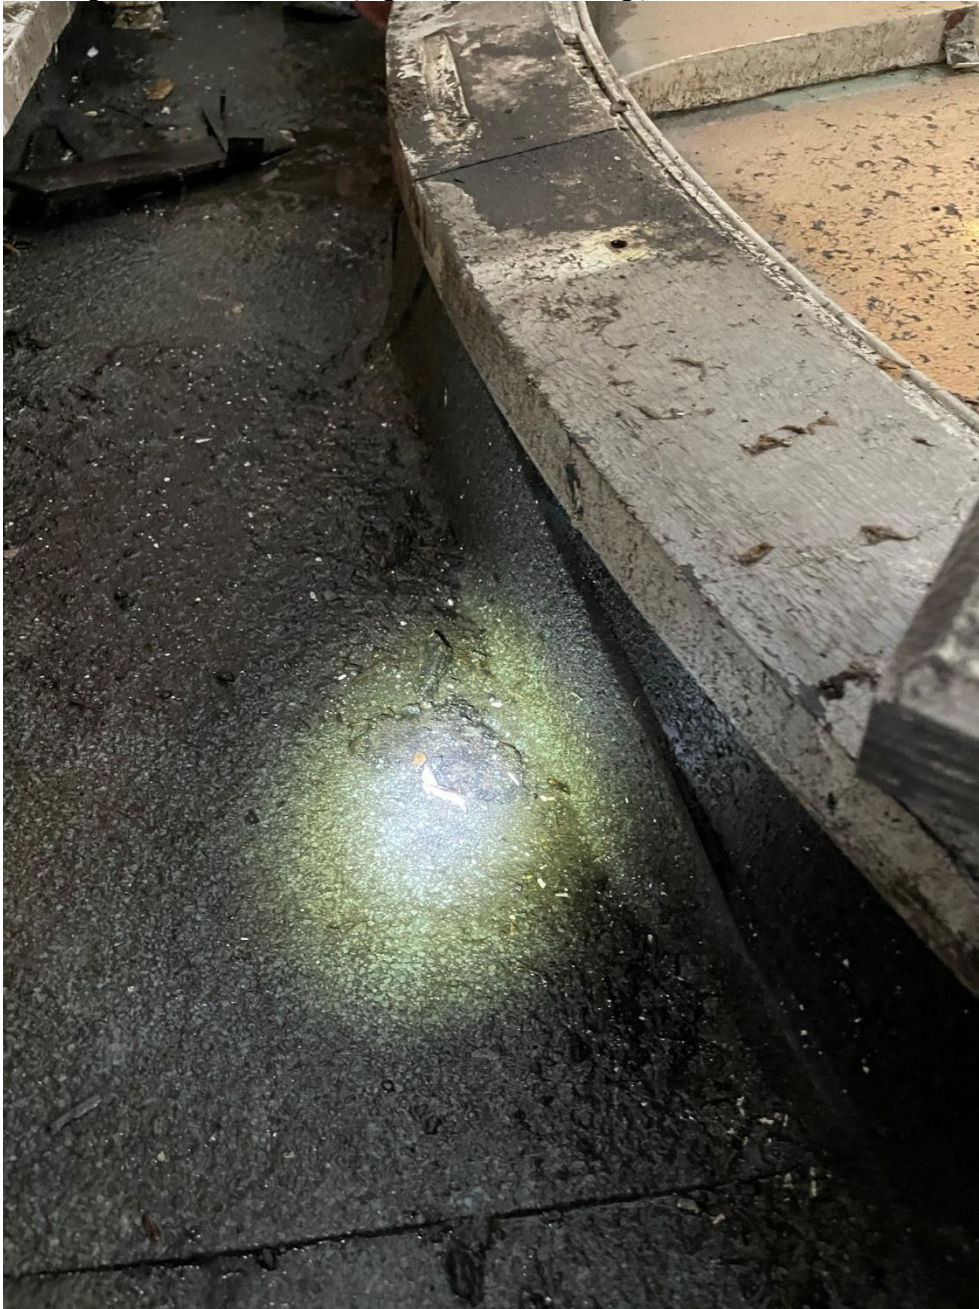
- 1.2 Existing roof finish around skylight upstand showing poor condition of felt:

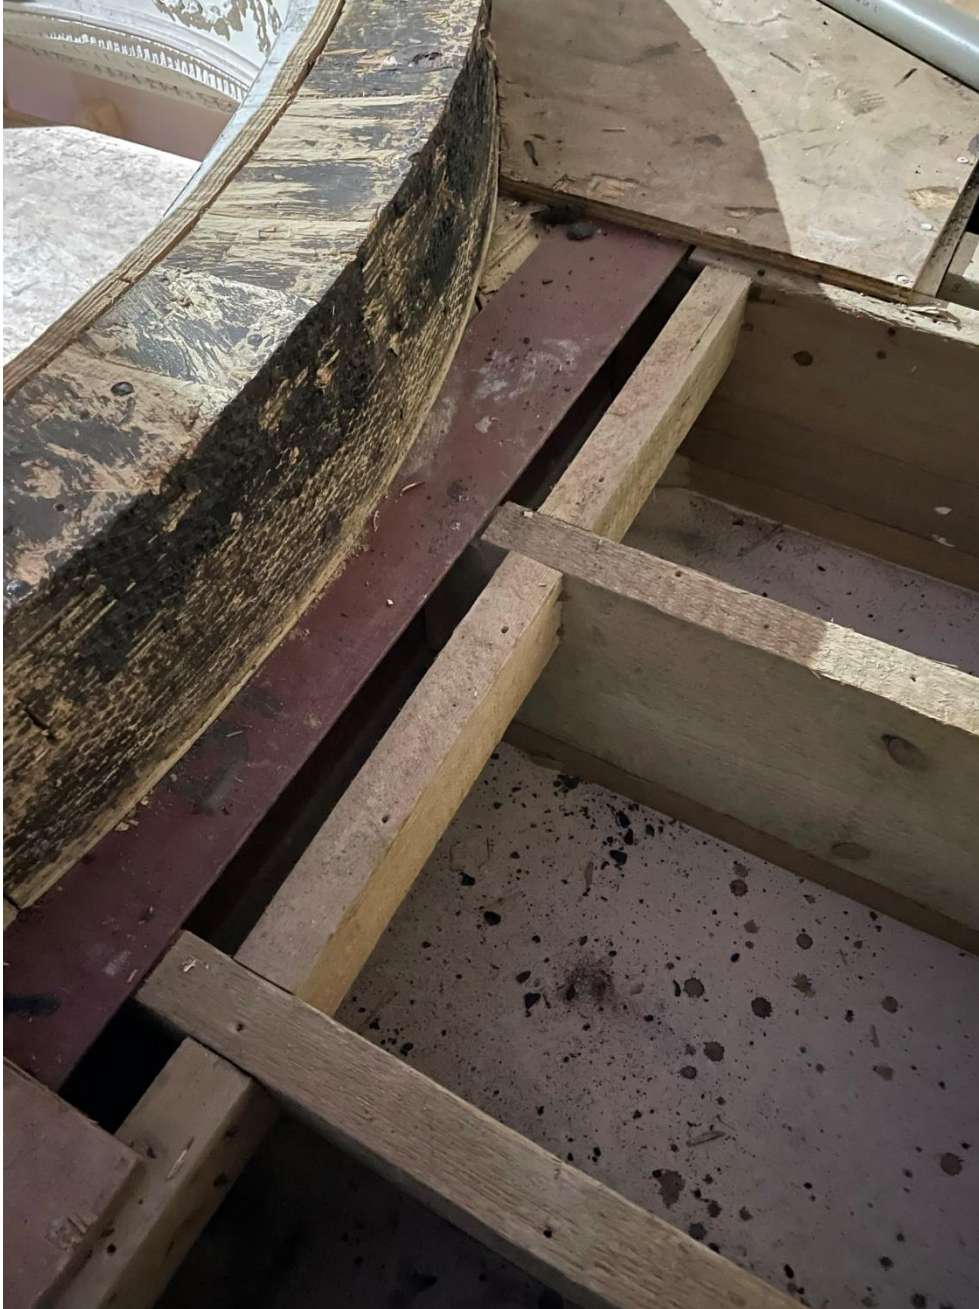
- 1.3 Existing modern roof construction showing existing skylight ply upstand, trimmer steelwork, timber joists, furrings, ply deck and plasterboard ceiling finish to Grand Stair.

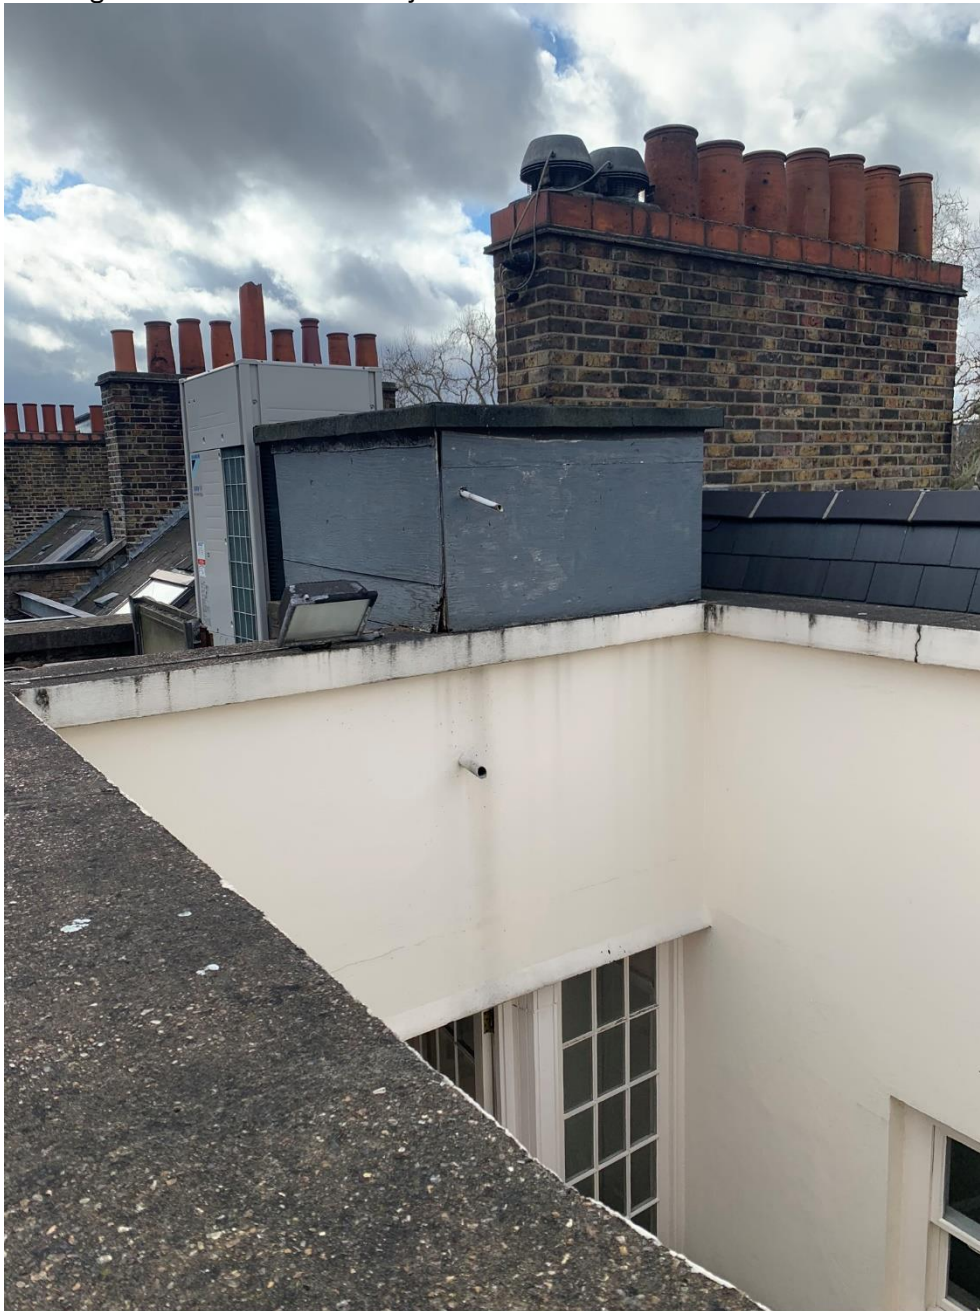
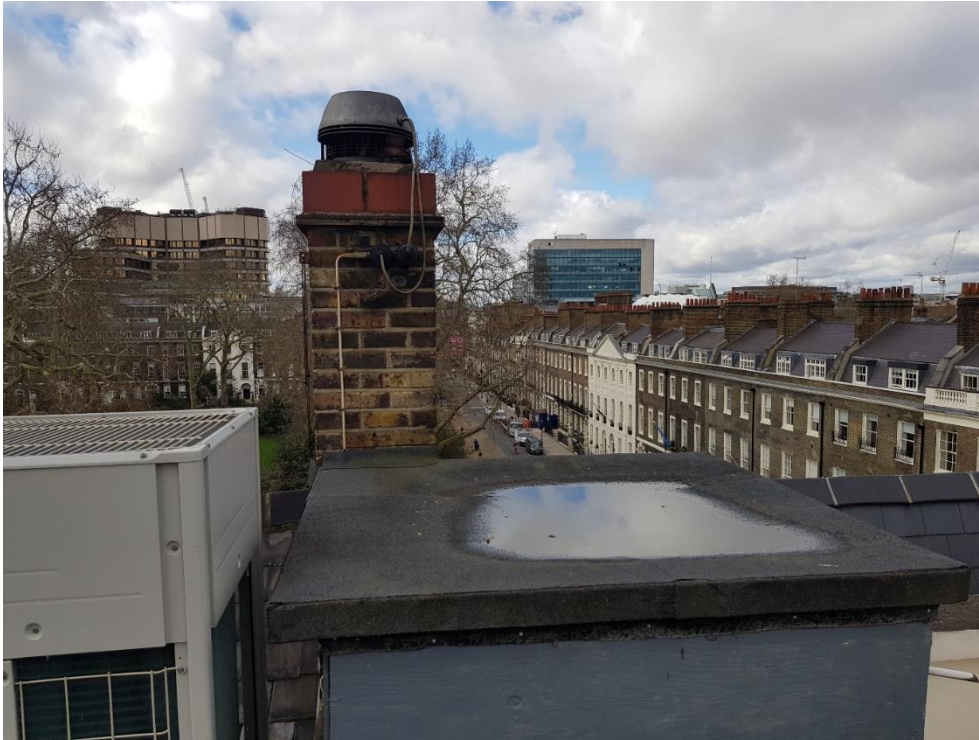
3.0 Existing Water tank enclosure adjacent to the roof access hatch.

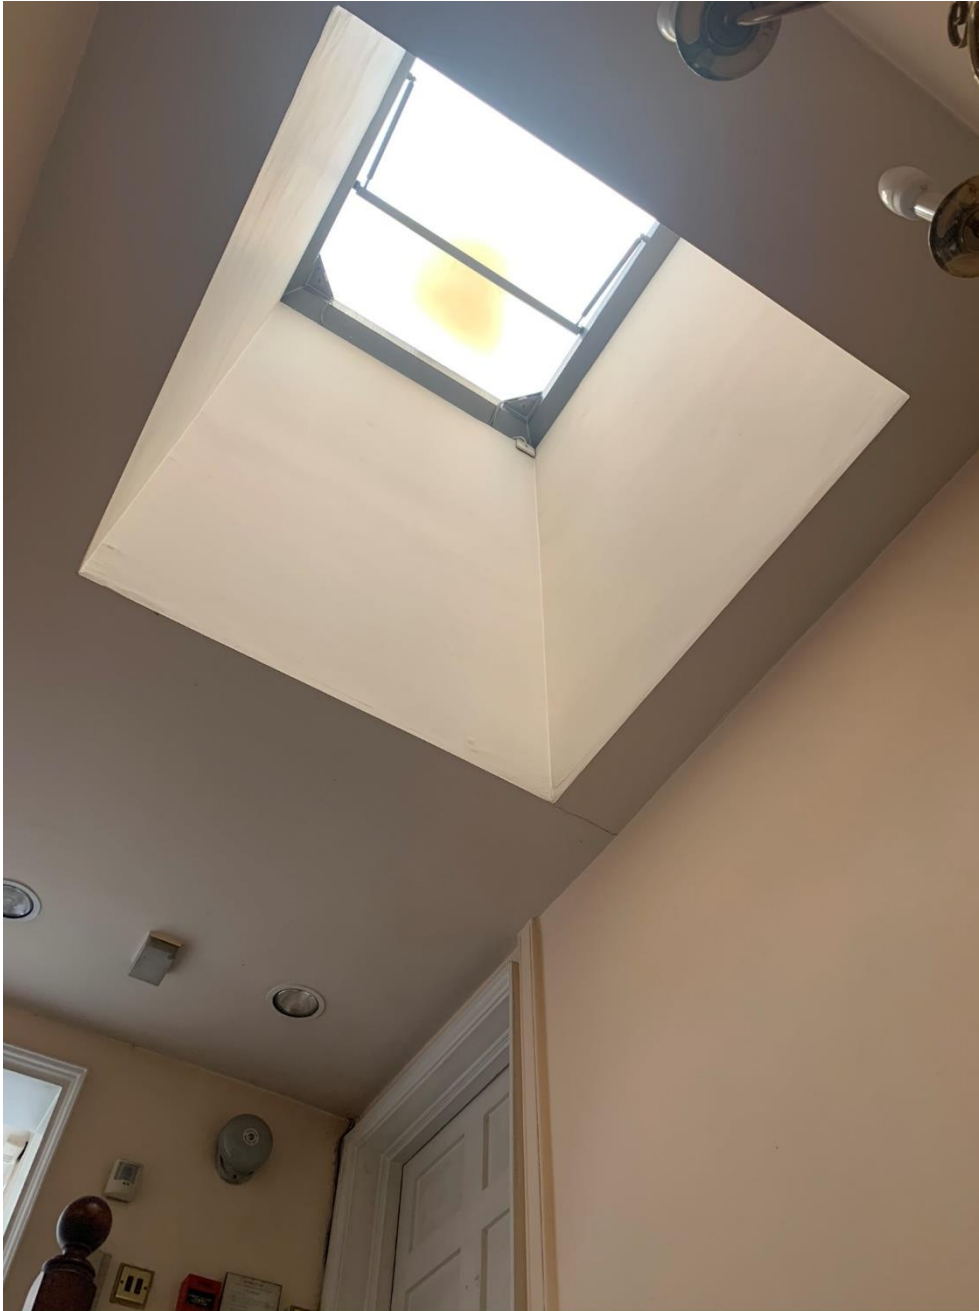
4.1 View from stair 03 up towards rather poor existing rooflight. Rooflight shows signs of one time connection to the fire alarm for smoke clearance.

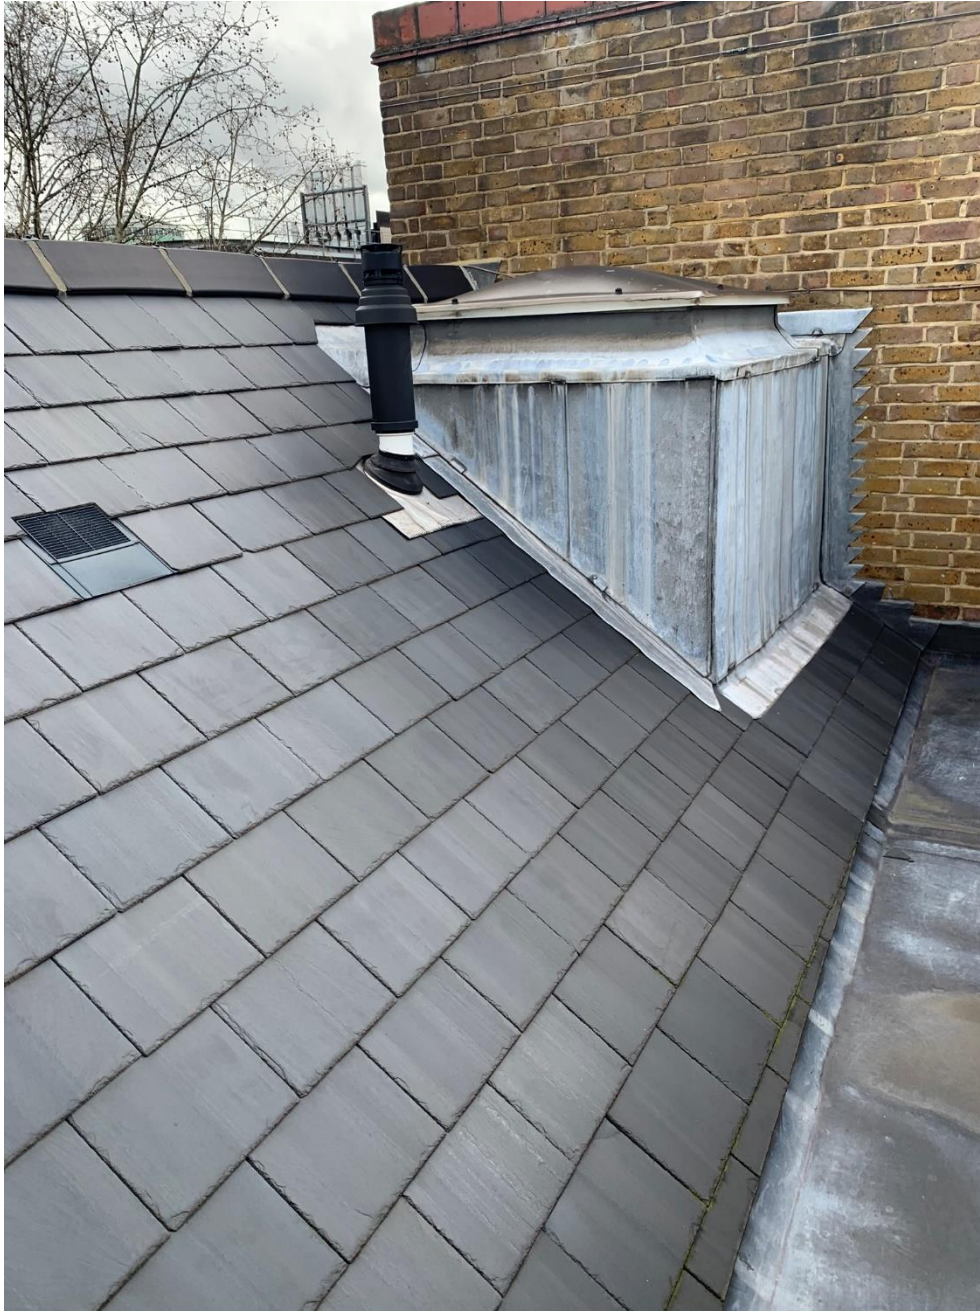
4.2 Exterior external view of the skylight which is concealed behind the roof parapet and party wall chimney to No.9 Bedford Square. Lead shroud to be retained, repaired and made good once new skylight is installed:
