# Hestur Limited

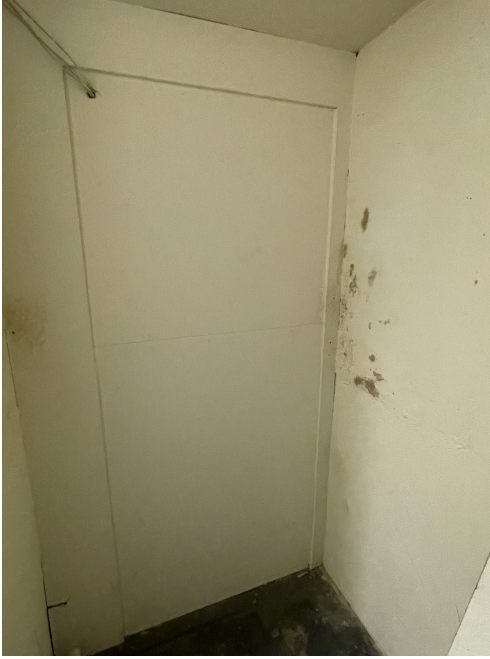
Photograph 7

Existing timber infill to former opening to be removed to allow treatment of damp and replaced.

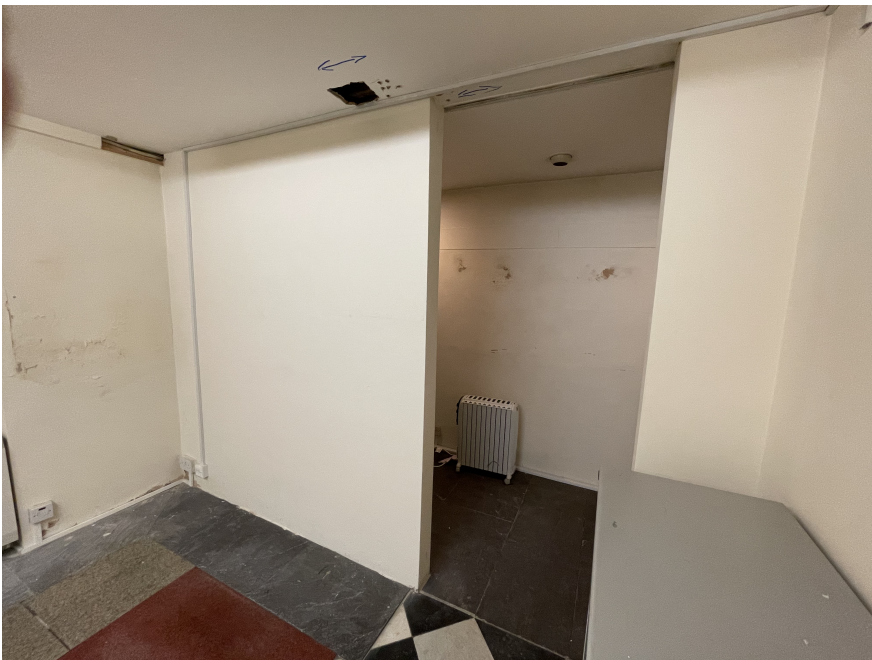
Photograph 8

Wall to be removed
