Crown Preservation

Survey report

Date 30.09.19

Property 81 Albany Street London NW1

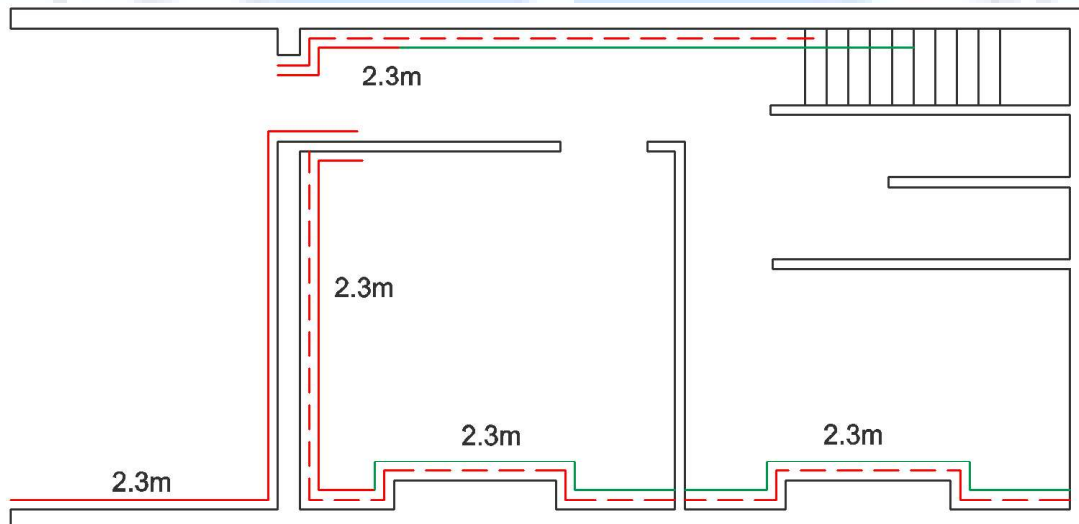
Basement

At the time of the inspection, with the aid of an electronic moisture meter, readings were taken at intermittent points to the walls, these readings suggested rising dampness and dampness from other sources, in the walls as designated on the attached Sketch.

The rising dampness appears to be due to the apparent absence of an effective damp proof course.

Hygroscopic salt action in the wall plaster At the time of our survey we noted the wall plaster had been contaminated with Hygroscopic salts, these salts have migrated to the surface of the wall plaster via the rising damp and damp at high level from other sources in the walls, which have the ability to pick out moisture from the atmosphere during inclement weather and condense it into water.

Install a chemical damp proof course (DPC) to the area indicated on the attached plan by the red dotted line, supplemented via a vertical damp proof course using dry zone injection cream to form continuity and protect against abutting structures. The dry zone (DPC) will provide a permanent barrier to the treated walls stopping further rise of moisture from the foundations and provide a dry wall. Dry zone cream has **73%** active ingredient for stopping rising dampness as opposed the traditional chemical injected damp proof course which can have as little as **6%** active ingredient the remainder being water.

Remove the skirting boards. The wall plaster marked in green is to be cut back to bare brick work at least 1000 mm high or to the heights indicated on the drawing and the rubble discarded.

Apply waterproof render as described below to the walls marked in green as on the enclosed drawing not less than 1 meter in height or to the heights indicated on the drawing, incorporating Sika water proofing additive.

The area marked in red is to be hacked off full height and a 4 coat sika tanking system be applied.
