**Photographic Schedule**

**5 New Square East**

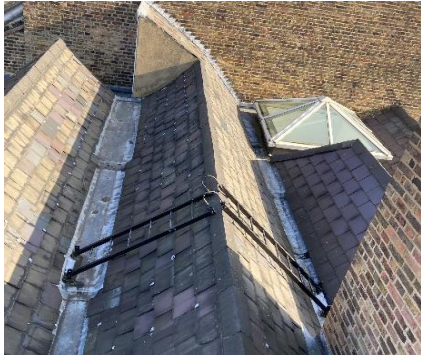
Figure 1: Roof Overview

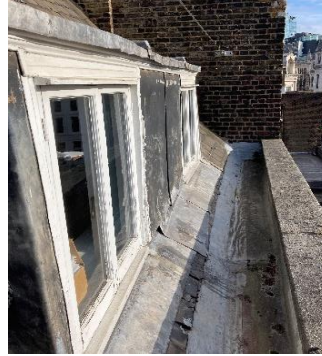
Figure 2: Rear Dormers

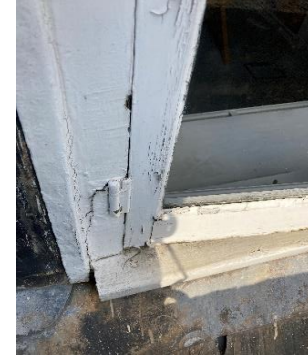
Figure 3: Rear Dormer Window

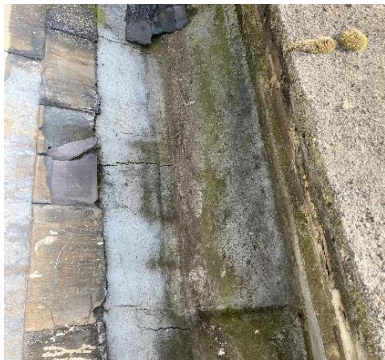
Figure 4: Parapet Gully (Rear)

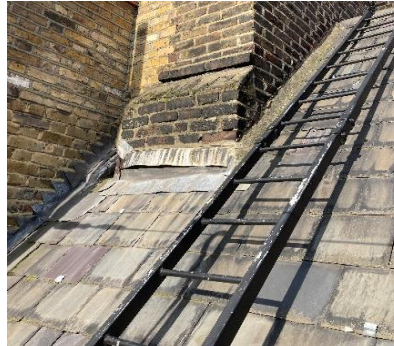
Figure 5: Roof Access Ladder

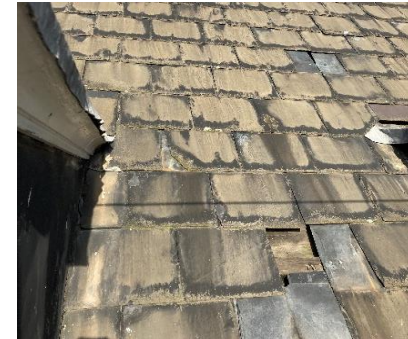
Figure 6: Existing Slates

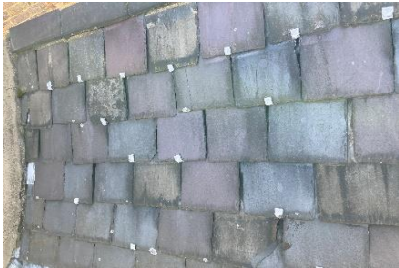
Figure 7: Existing Slates

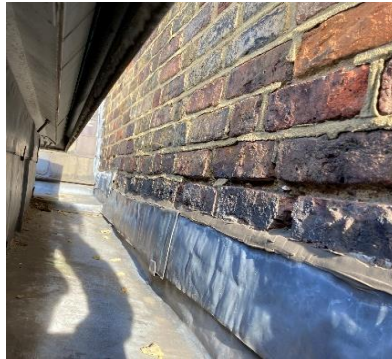
Figure 8: Existing Pointing

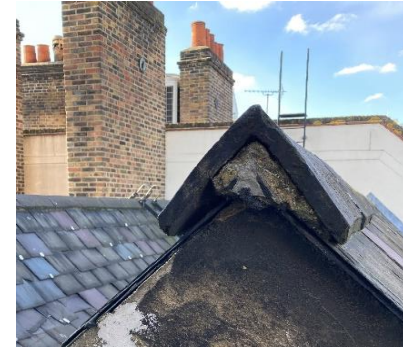
Figure 9: Loose Ridge Tile

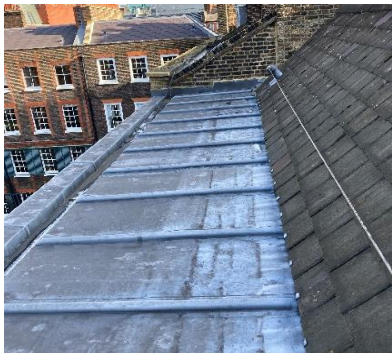
Figure 10: Lead Bays (Front)

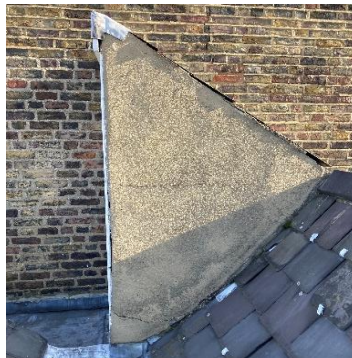
Figure 11: Roof Access Door

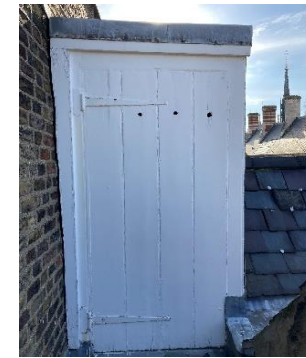
Figure 12: Painted Shut Roof Access Door

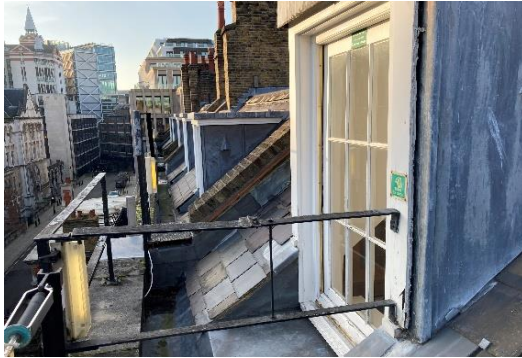
Figure 13: Defective Door Frame

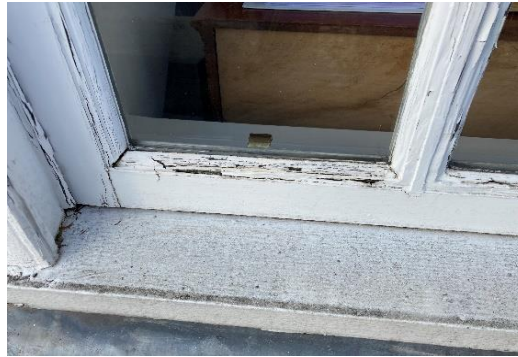
Figure 14: Defective Timber Sash Windows

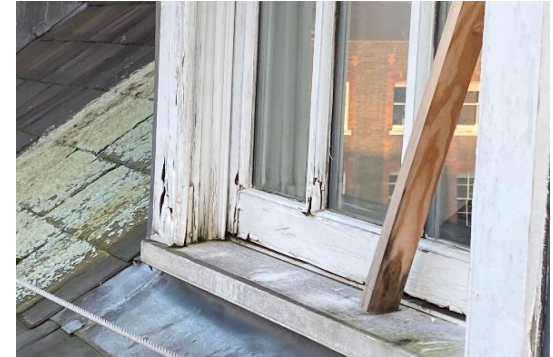
Figure 15: Defective Timber Sash Windows

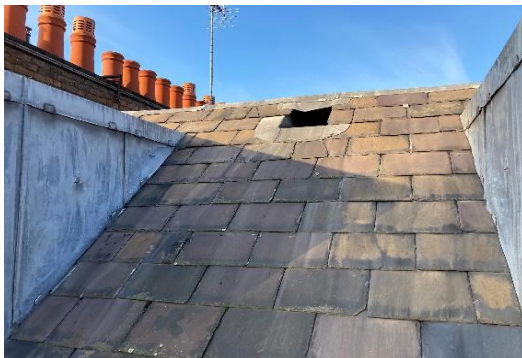
Figure 16: Existing Slates

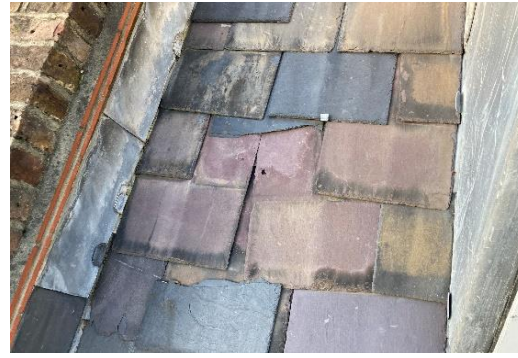
Figure 17: Existing Slates

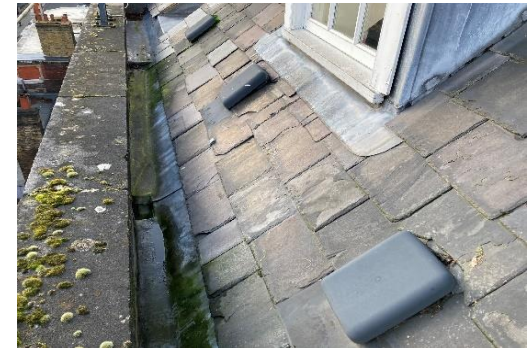
Figure 18: Existing Plastic Roof Vents

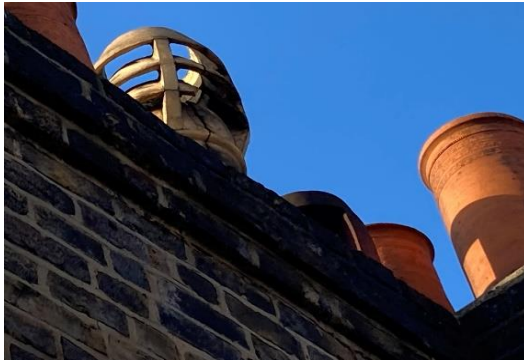
Figure 19: Cracked Chimney Cowl

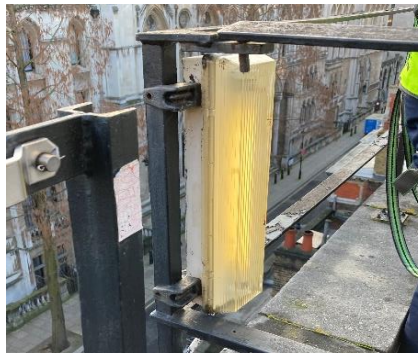
Figure 20: Existing Roof Level Lighting

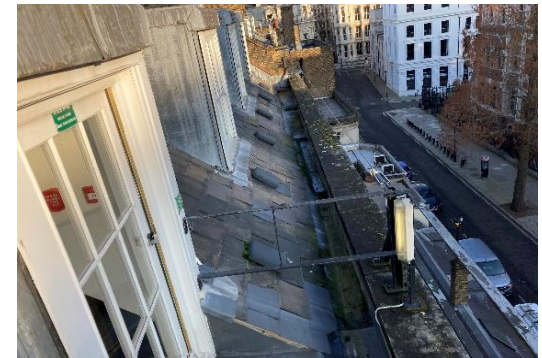
Figure 21: 5 New Square West

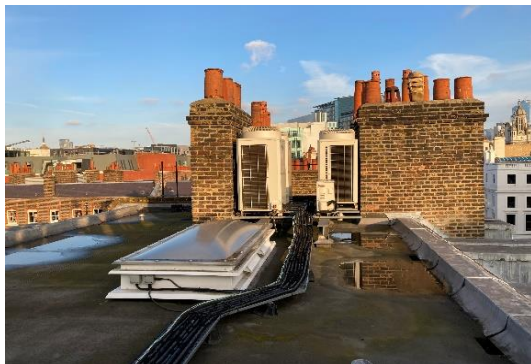
Figure 22: Flat Roof Section of Mansard

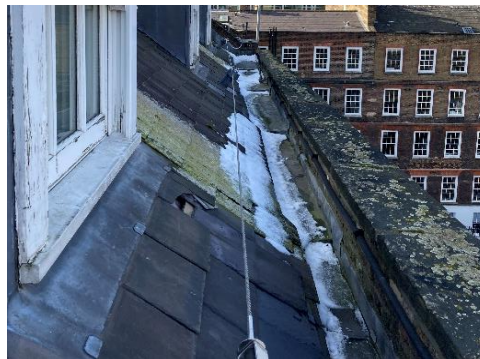
Figure 23: Parapet Gutter Front Elevation

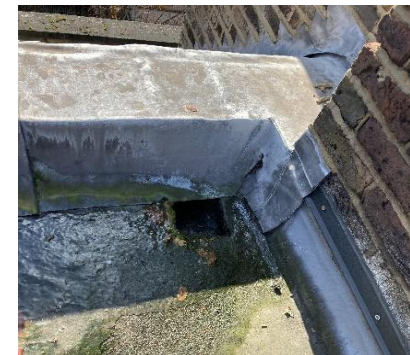
Figure 24: Existing Leadwork Condition

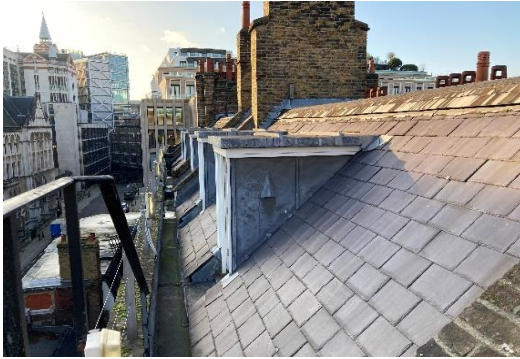
Figure 25: 6 New Square (Rear)

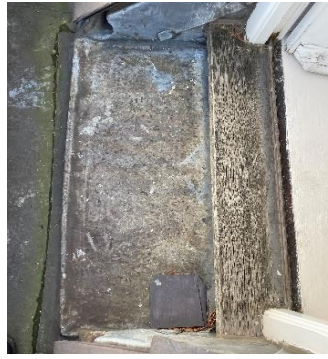
Figure 26: Door Threshold (Rear)

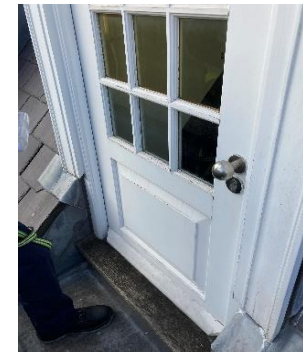
Figure 27: Defective Timber Weatherbar

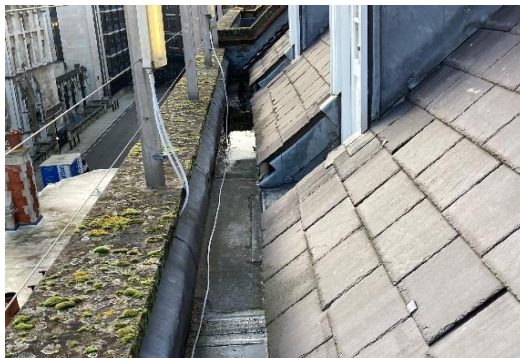
Figure 28: Existing Slates & Coping Stone

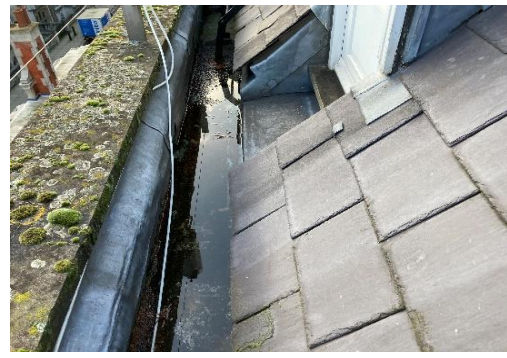
Figure 29: Ponding Water In Parapet Gutter

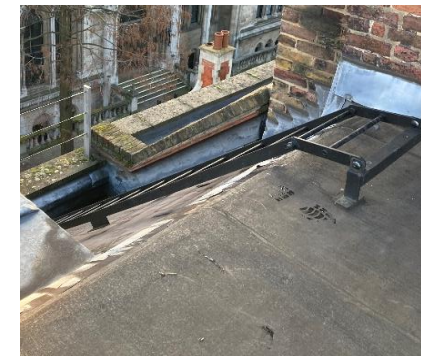
Figure 30: Condemned Roof Access Ladder

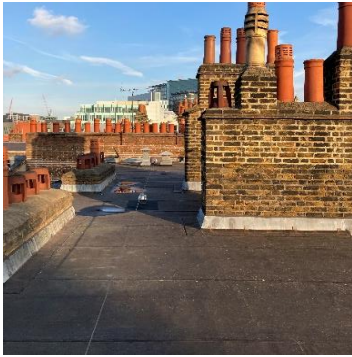
Figure 31: 6 New Square Flat Roof

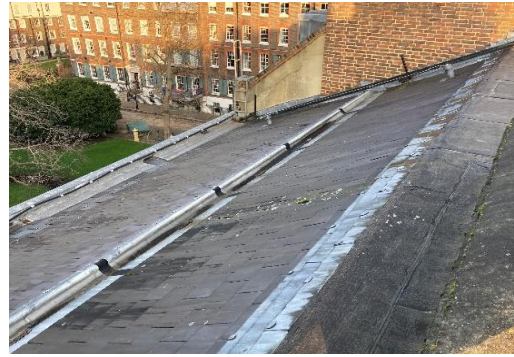
Figure 32: Shallow Pitch Roof (Front)

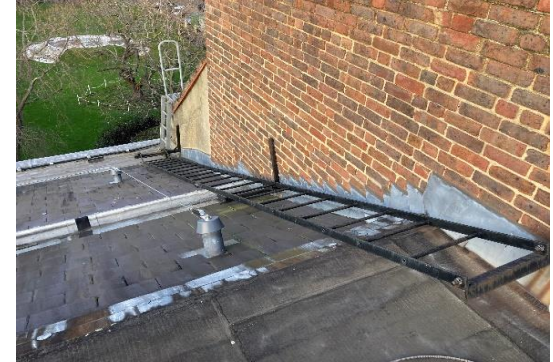
Figure 33: Condemned Roof Access Ladder

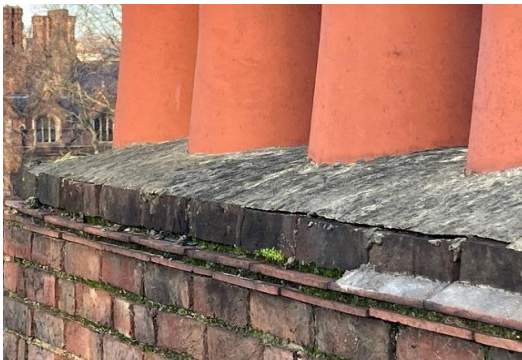
Figure 34: Defective Flaunching

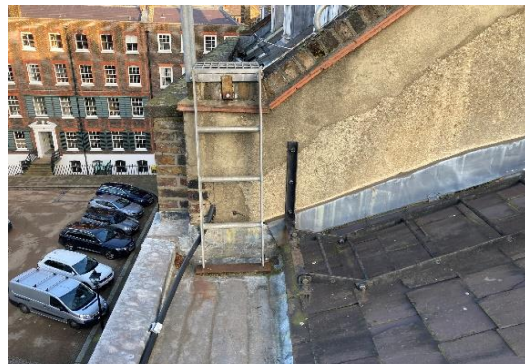
Figure 35: Condemned Roof Ladder

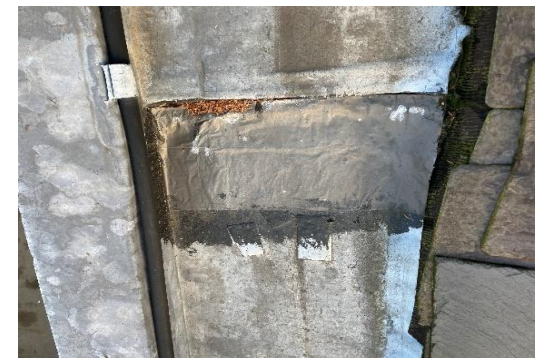
Figure 36: Flash Band Roof Repair

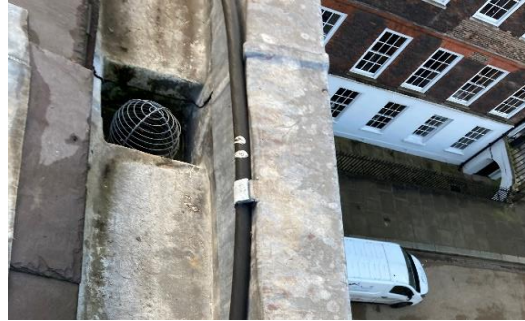
Figure 38: Broken Lead Cable Welt

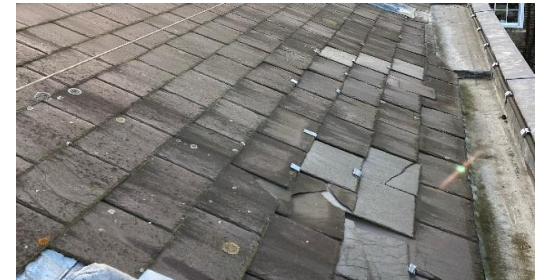
Figure 39: Existing Slates to Shallow Pitch

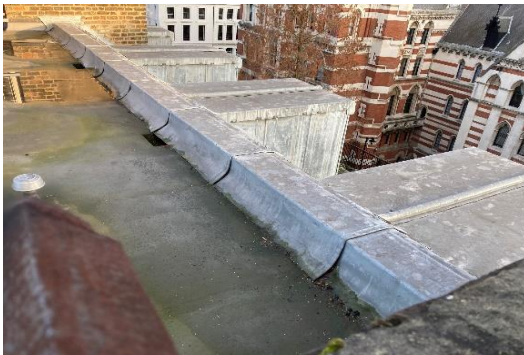
Figure 40: Leadwork to Dormers (Rear)

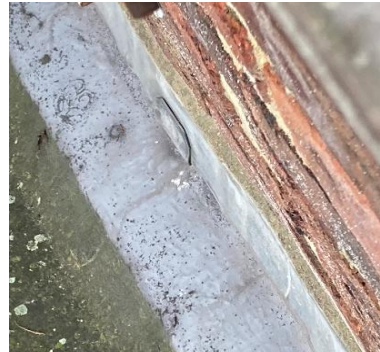
Figure 41: Acropol Repairs to Flat Roof

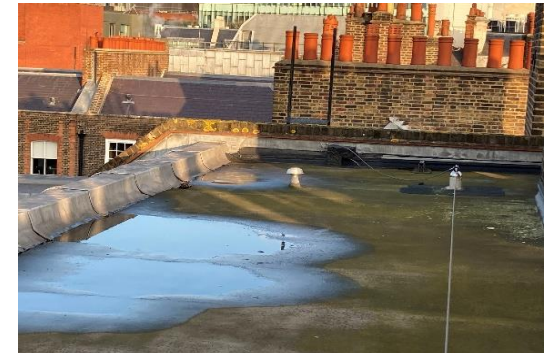
Figure 42: Ponding Water on Flat Roof
