# Electrical Survey

**10<sup>th</sup> March 2021**

**Electrical installation of landlords lighting**

**3 – 6 Oak Court  
Hampstead  
Camden  
London  
NW5 1QU**

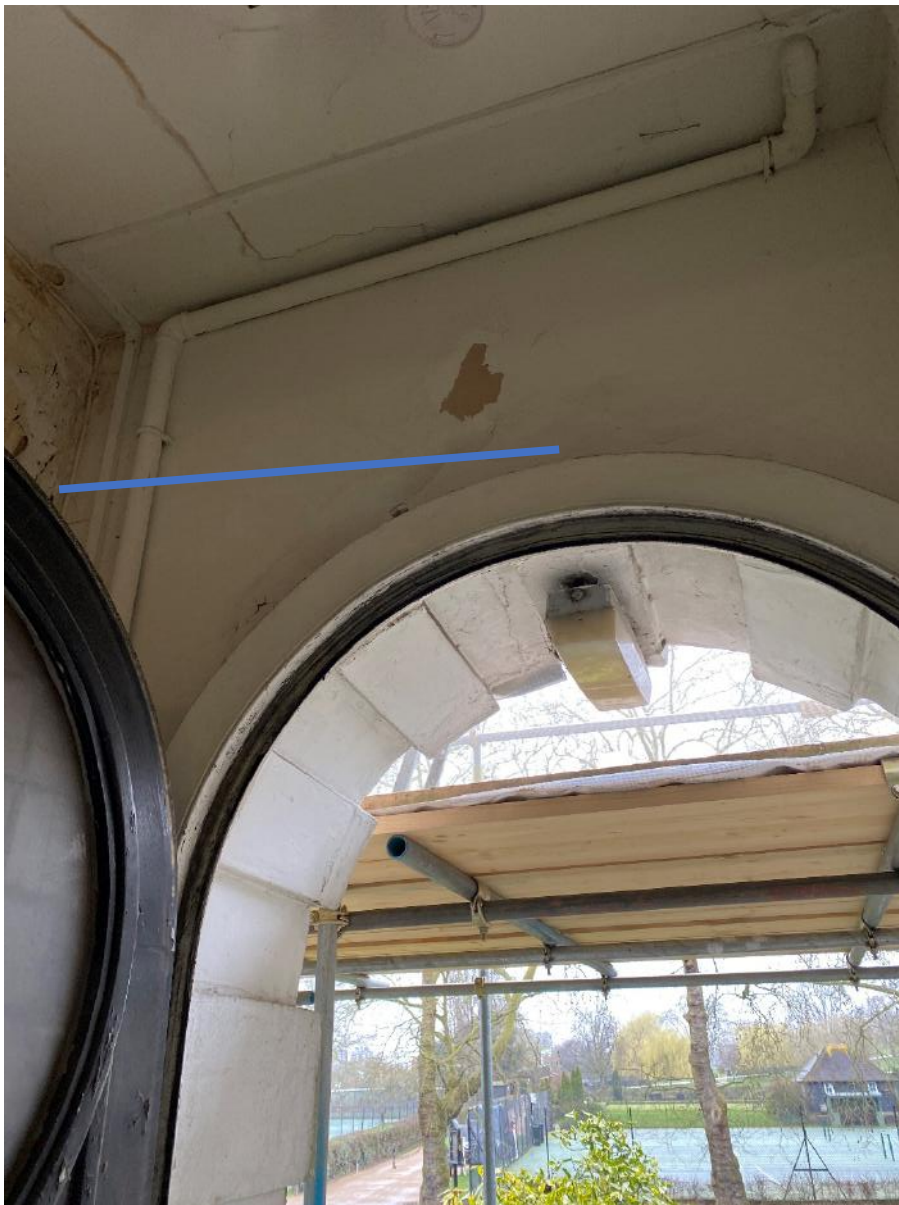
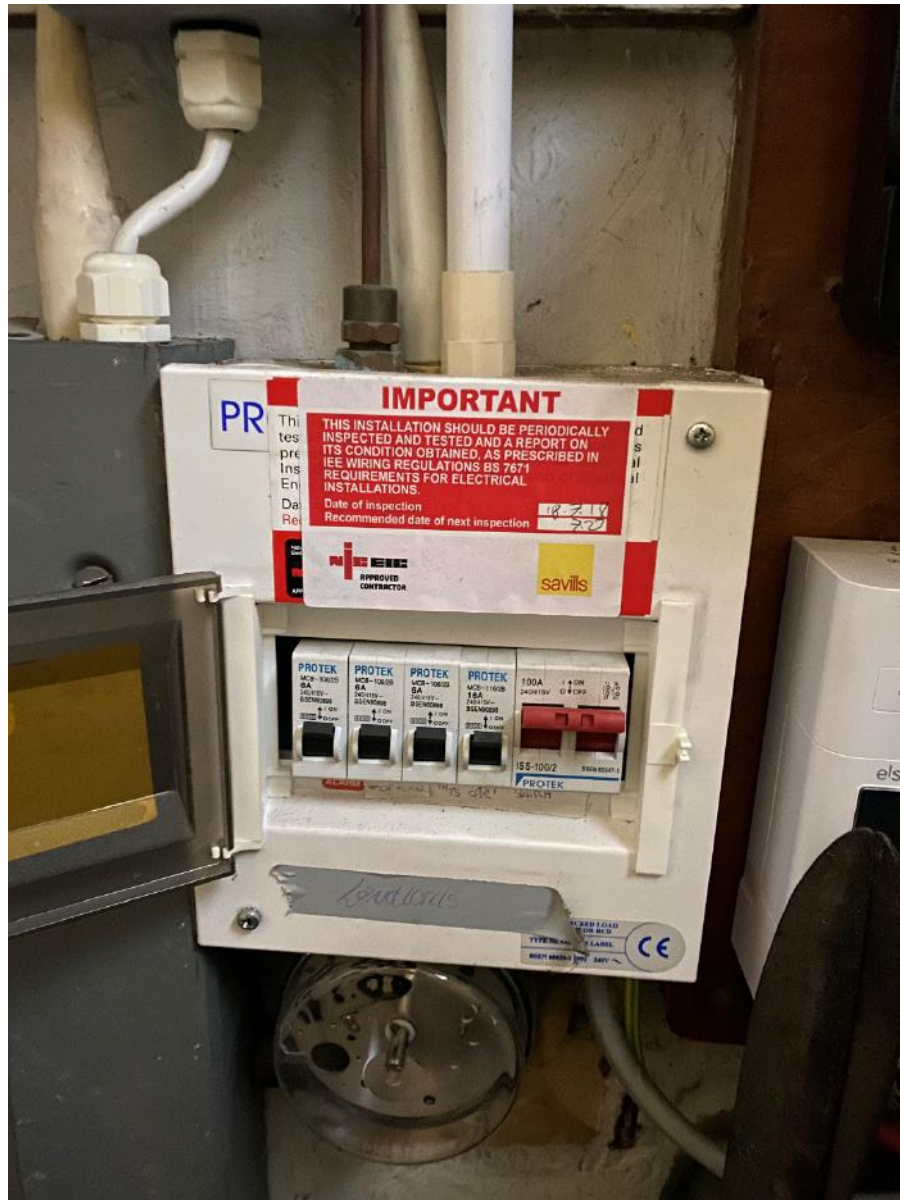
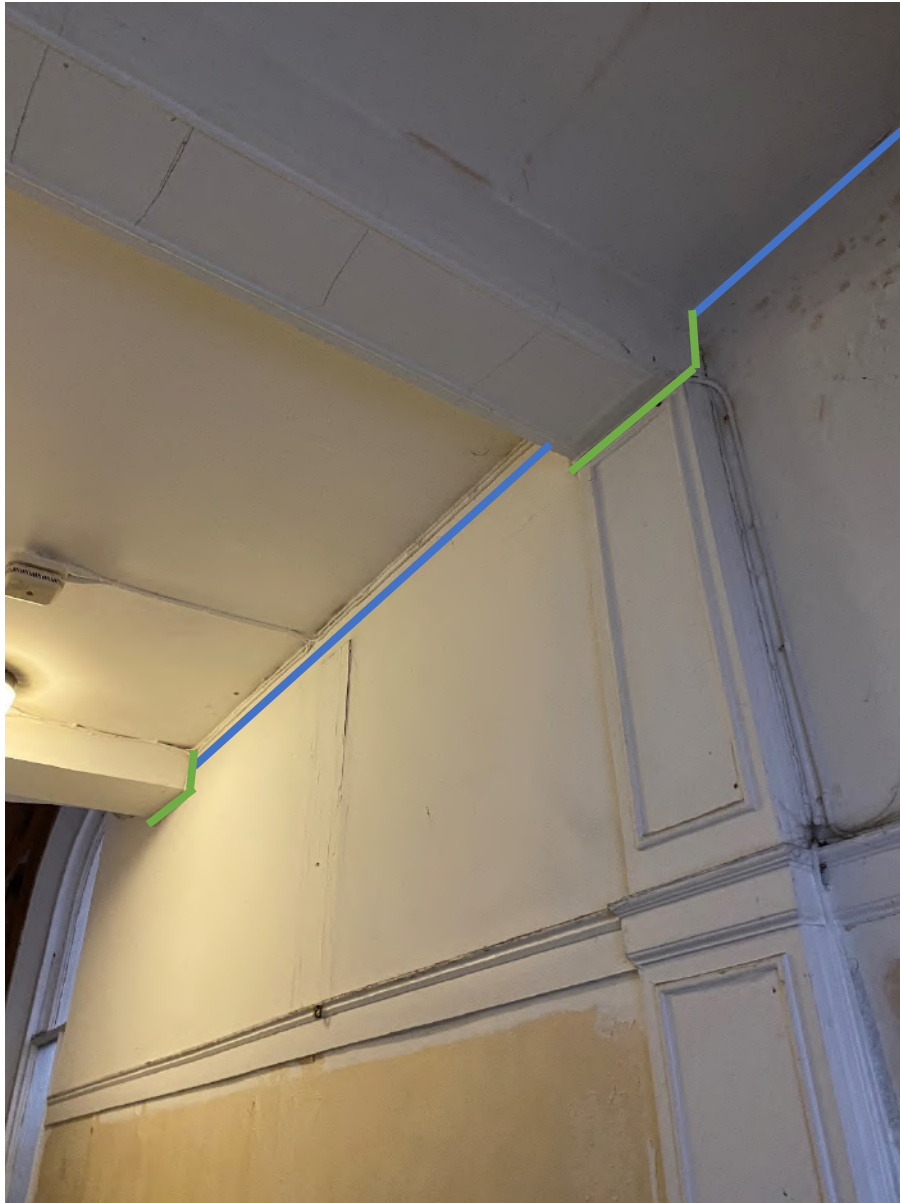
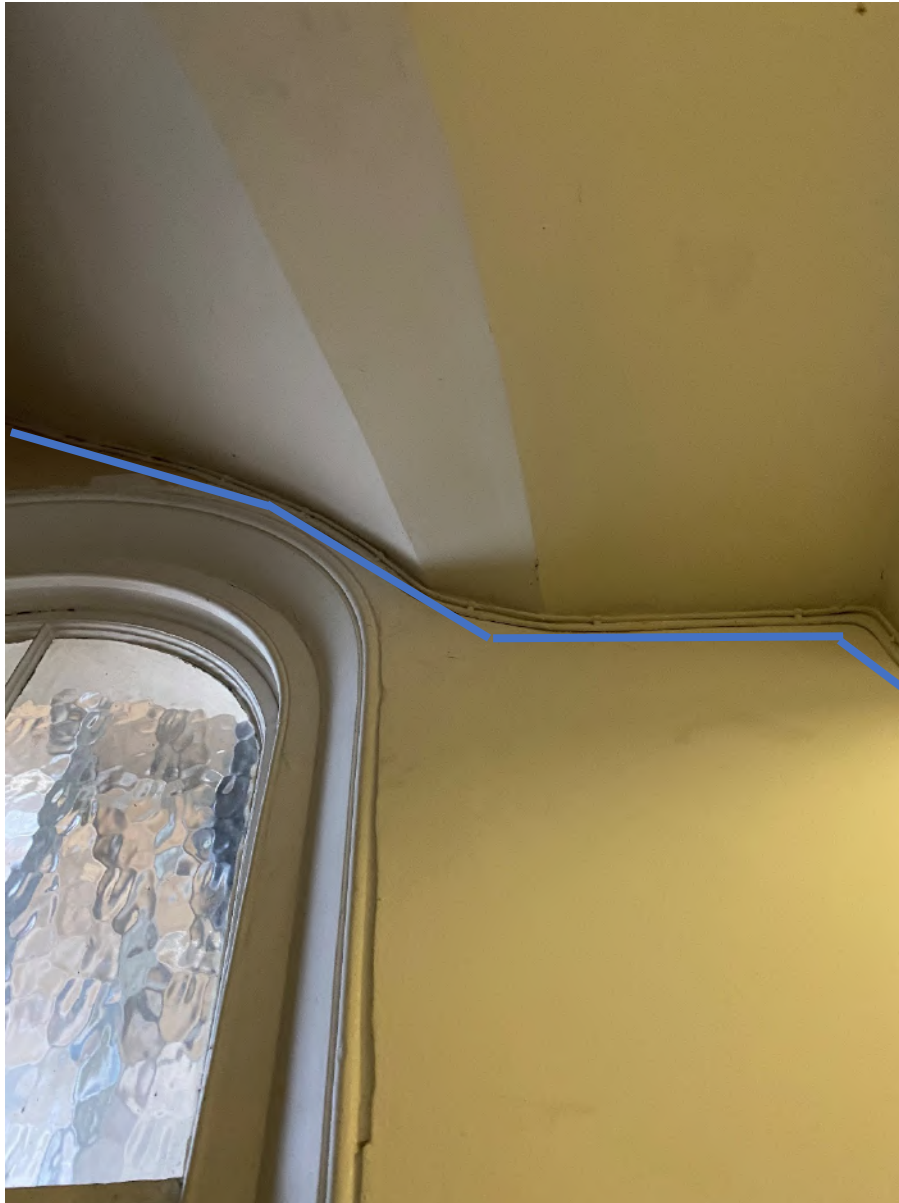
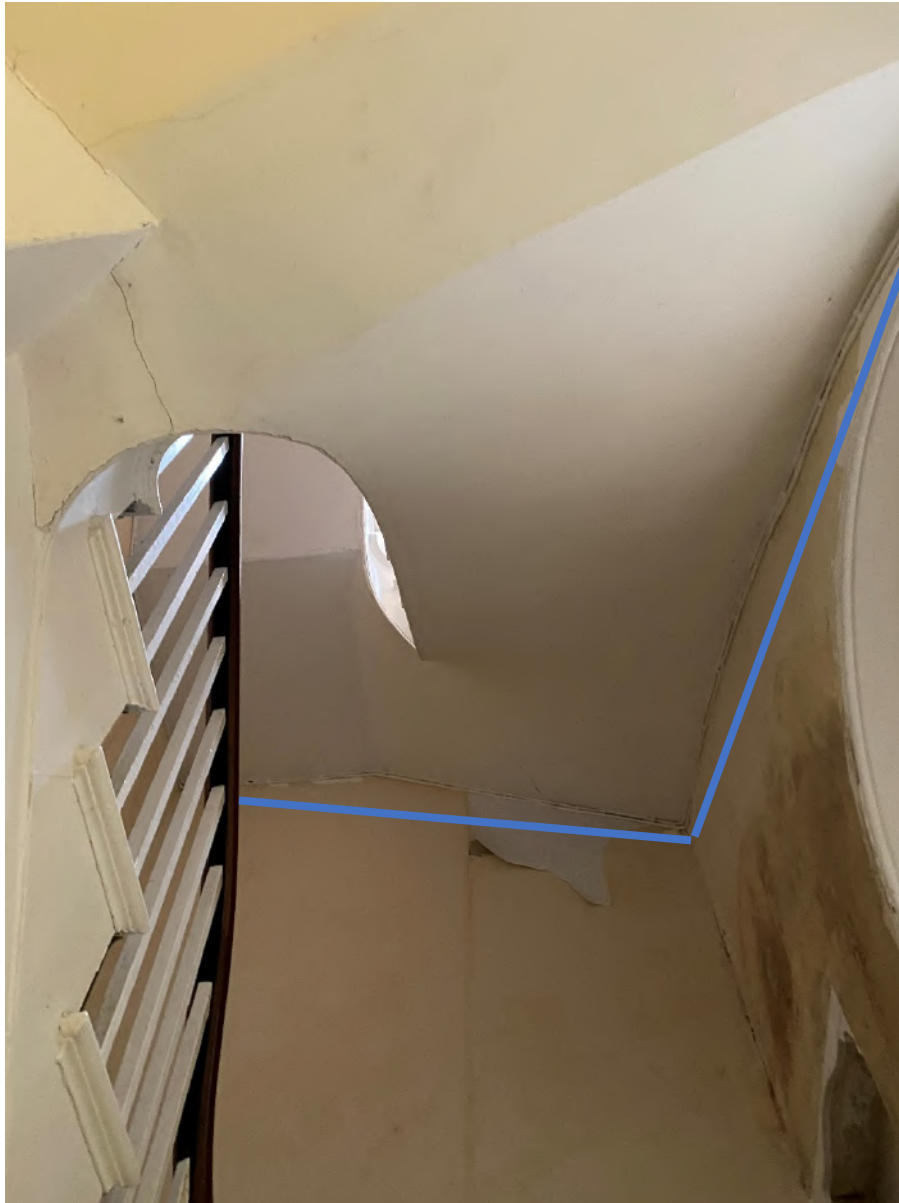
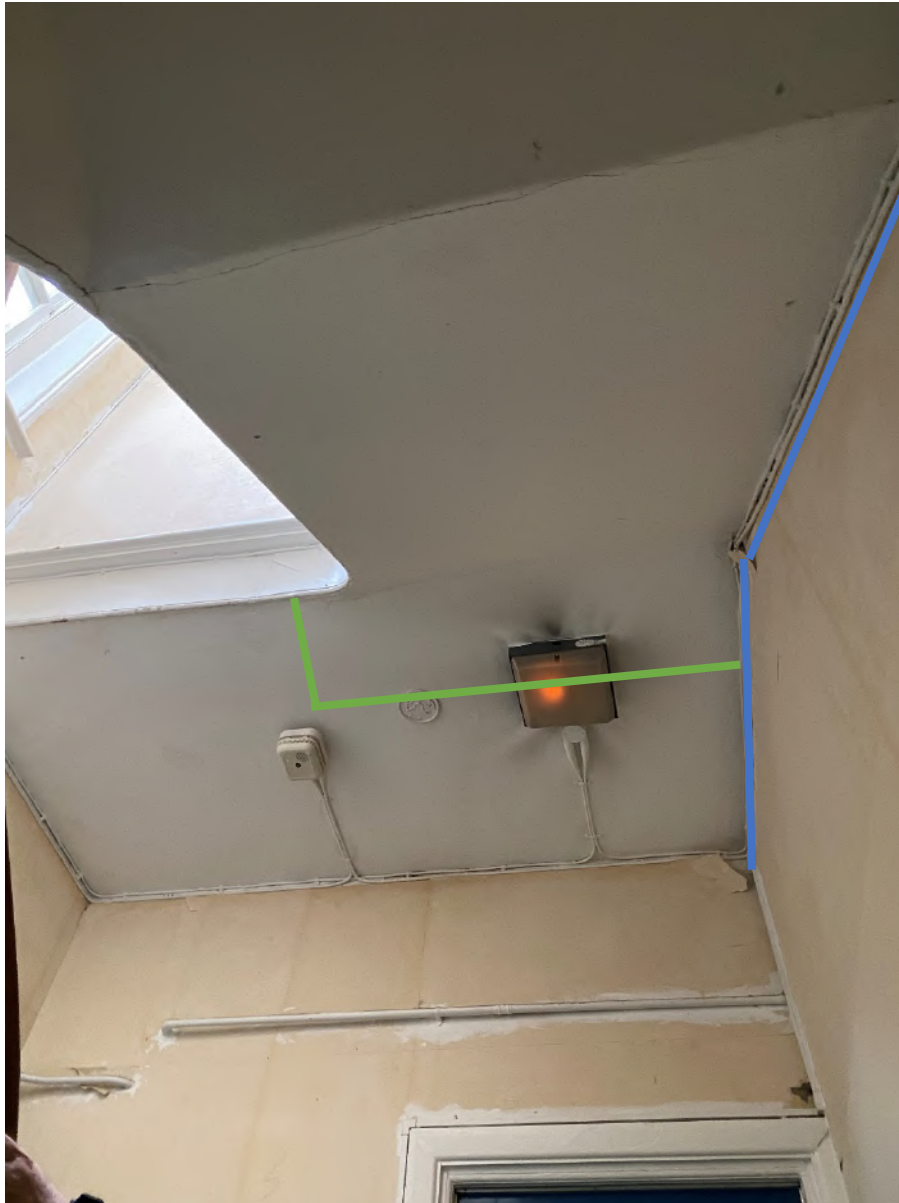
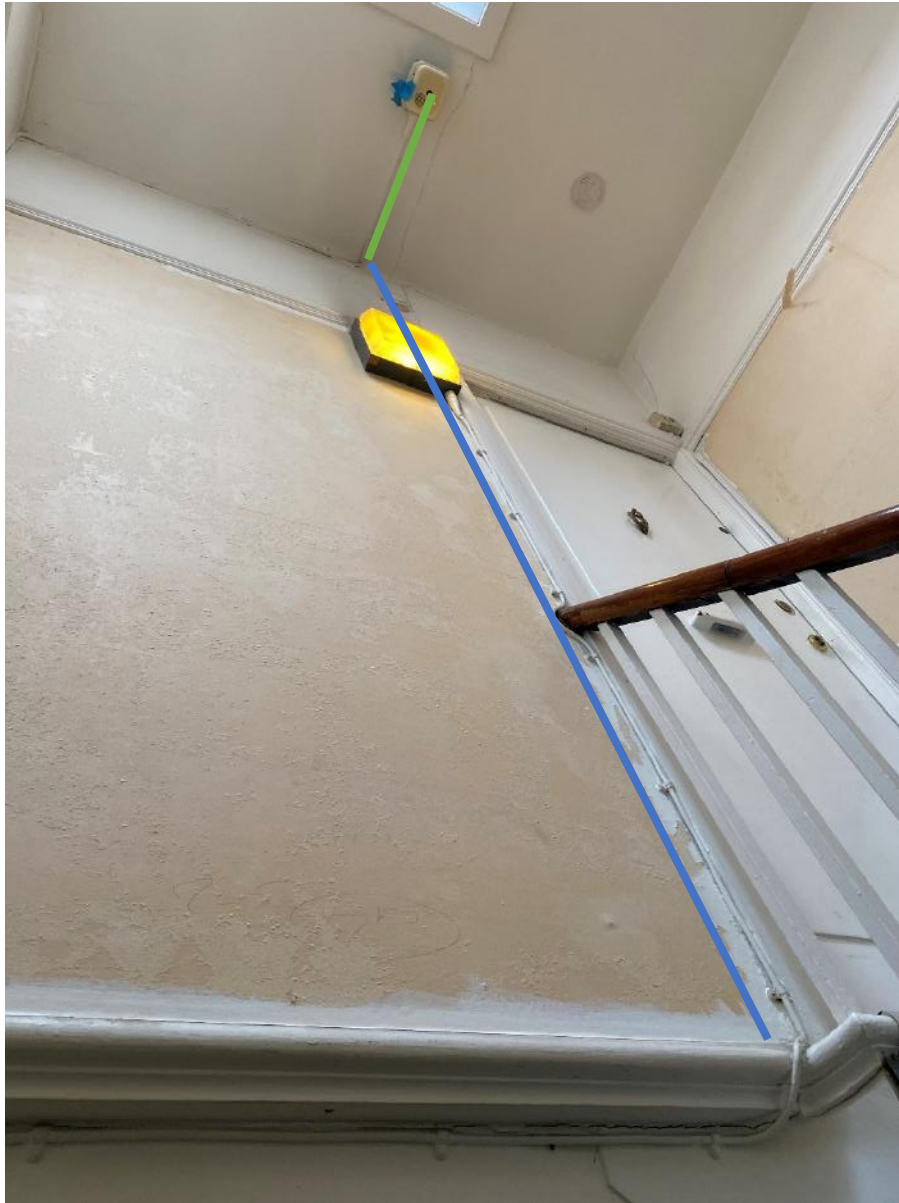
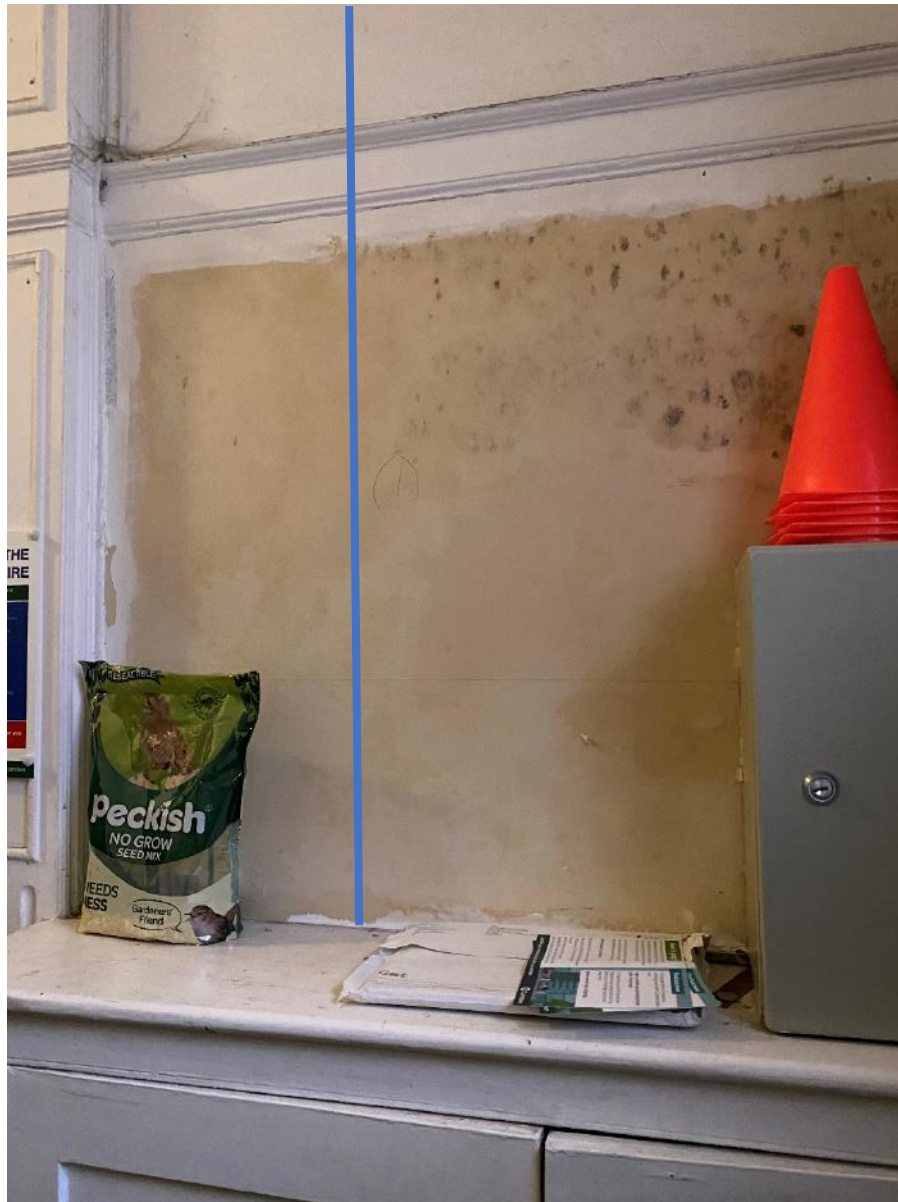
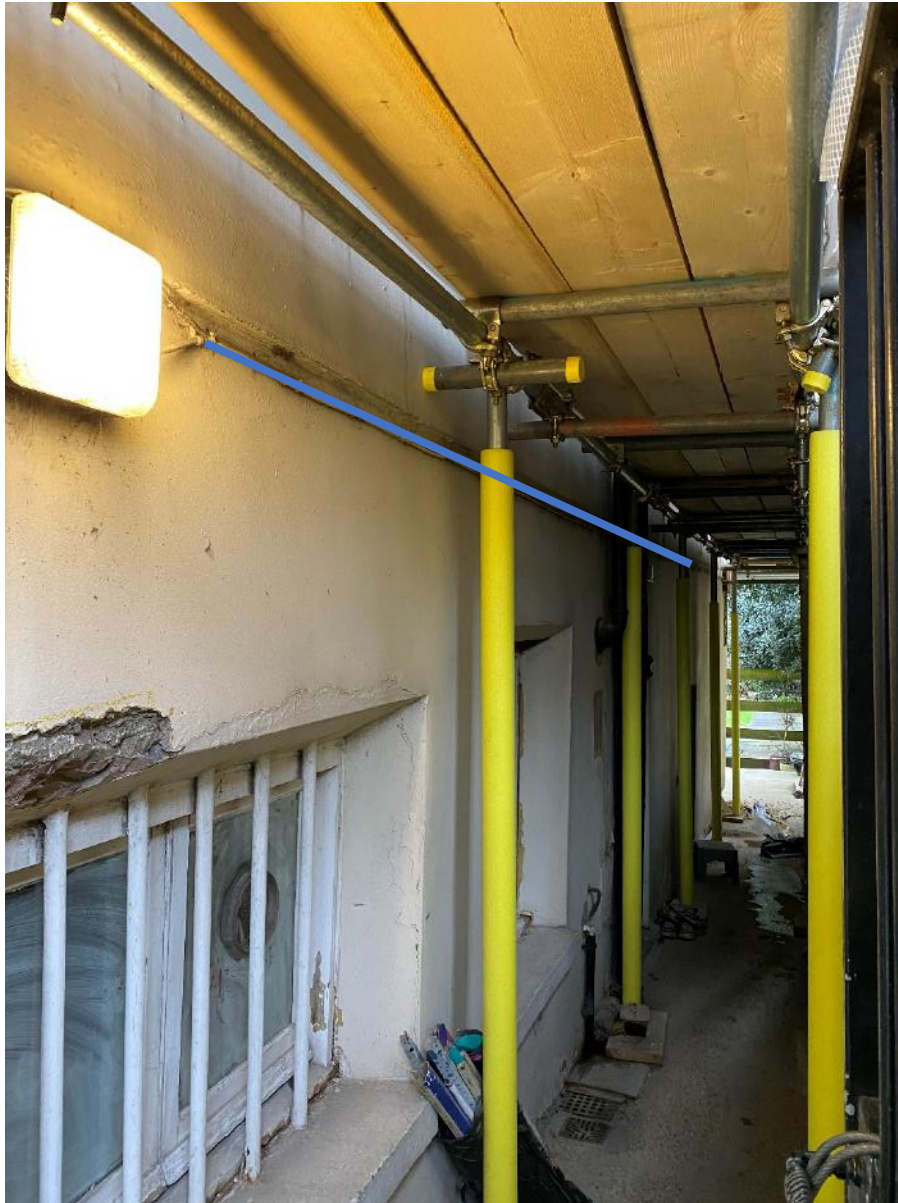
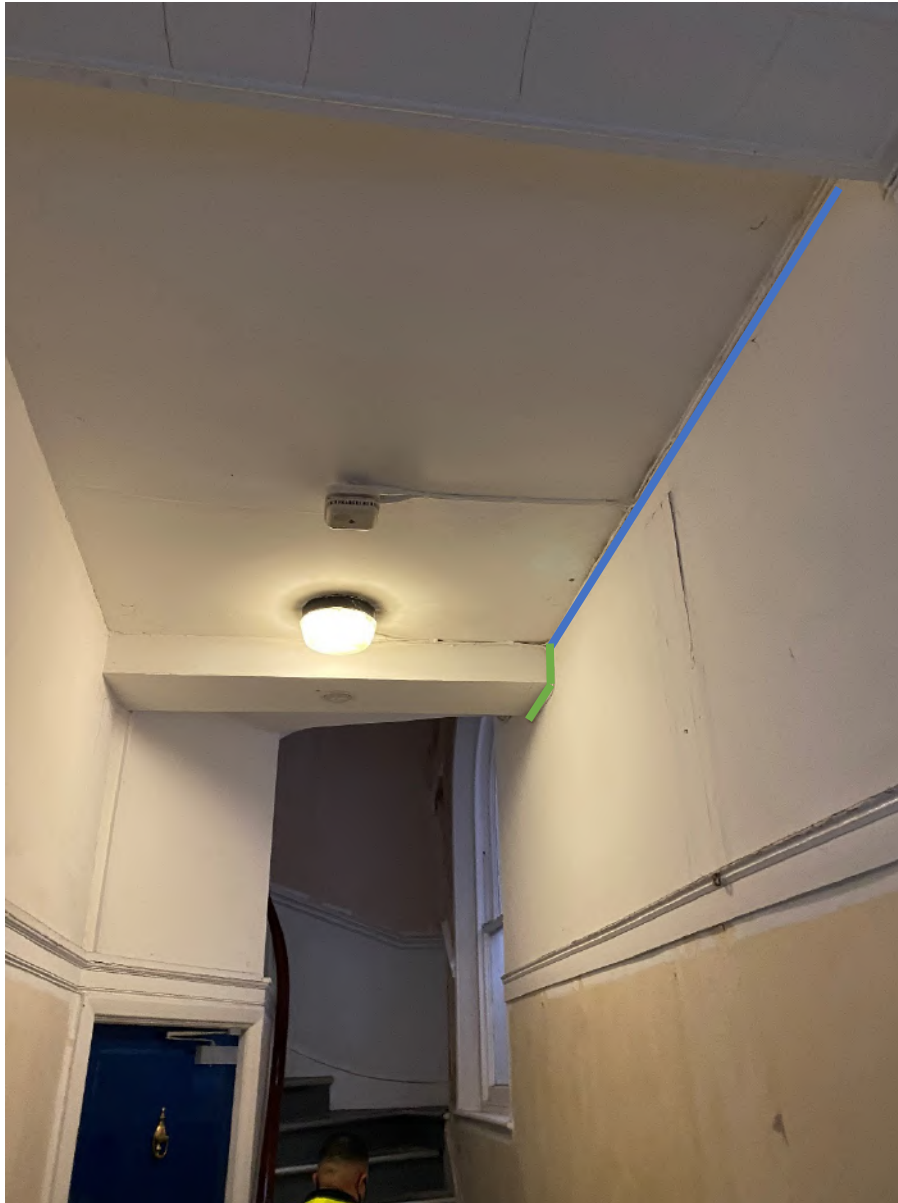
### PHOTOS 3 & 6

Chased cables in wall

Surface mounted MT2 trunking

Chased/fished if possible then MT2 if not achievable
