## 2038: 37 Doughty Street **Upper Ground Floor Front Room**

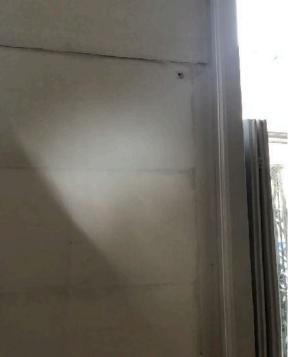
Upper Ground Floor front room showing evidence of damp between windows

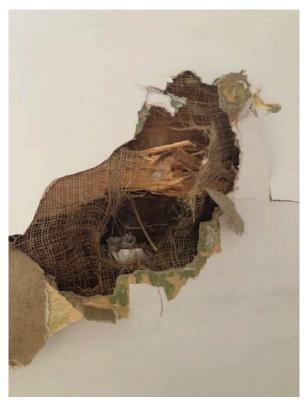
An investigation hole undertaken to the wall showing a void between wall line and brickwork
