## Friends & Drayton House – Roofing and External Refurbishment Works

### Supporting Information

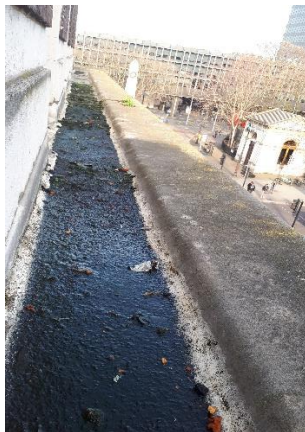
Existing asphalt finish on main cornice to external elevations showing gutter detail.

The specification allows for renewing the existing asphalt gutter on the main cornices; however, we are seeking listed building consent to overlay the asphalt with a cold liquid applied system. This will eliminate having to remove the existing asphalt and gutter detail, potentially damaging the stonework underneath. The liquid system allows for a drip detail at the edge of the cornice which will protect the stonework by stopping excess water from running down the elevation and saturating and staining the stonework. See supporting photographs below:

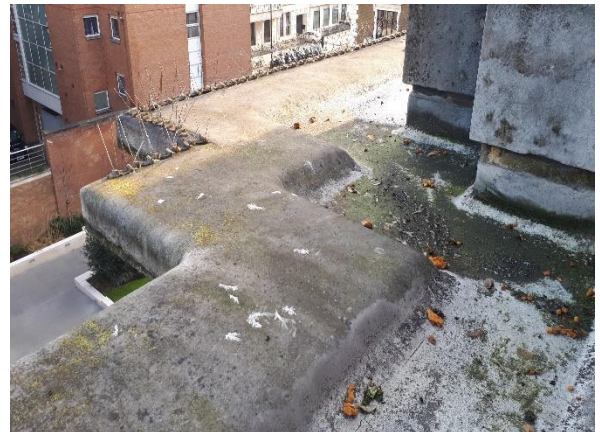
Existing asphalt finish on main cornice to external elevations showing gutter detail.

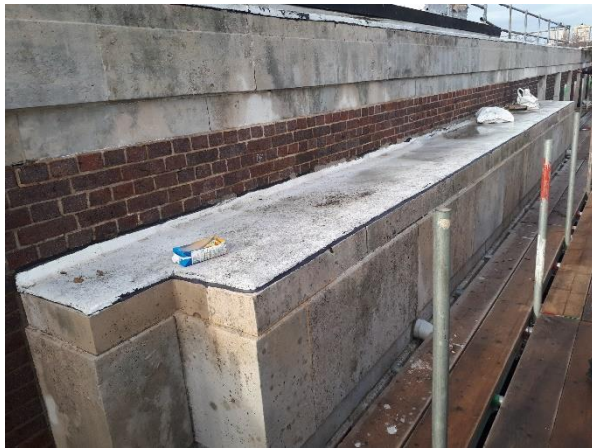
Existing asphalt finish on cornice above portico on garden elevation.

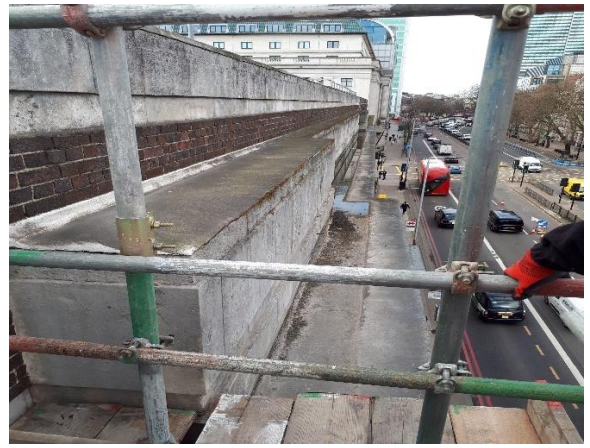
Existing asphalt finish on cornice above portico on Euston road elevation.

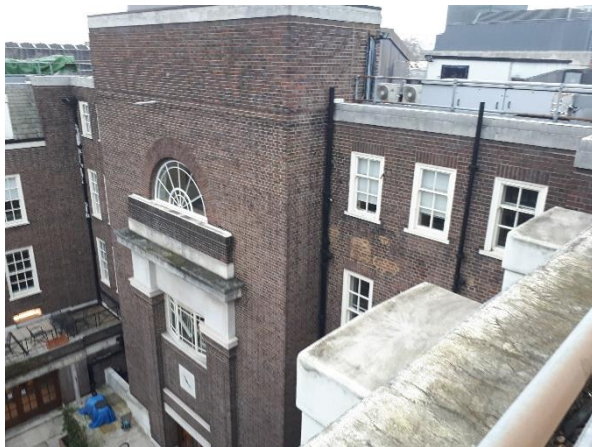
Existing asphalt finish to brick edge detail below semi-circular window within the courtyard.

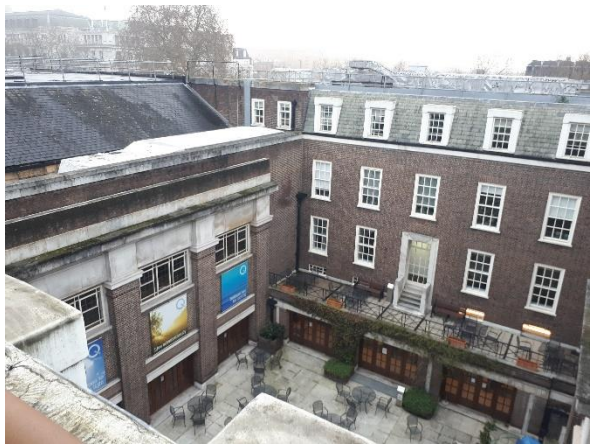
Existing asphalt finish to brick edge detail at third floor level to south-west elevation within the courtyard.

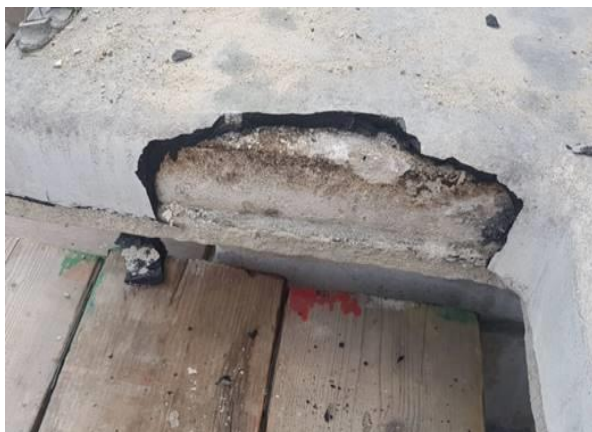
Photo showing thickness of existing asphalt to be removed and stonework under (if the liquid system is not supported).

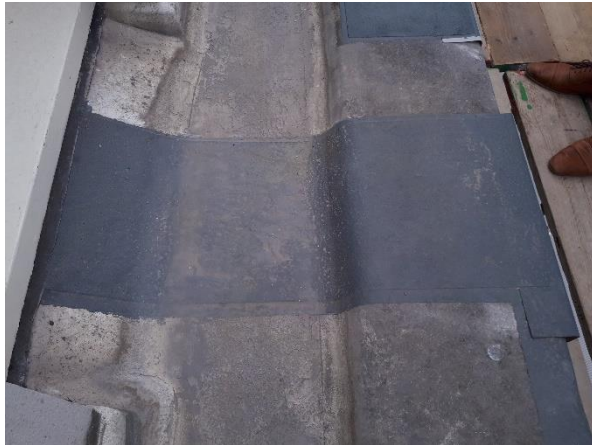
Sample of overlay on existing asphalt cornice with a cold applied liquid system.

Note: the liquid system is a 2-component high performance, PMMA based resin built up with a coat of primer, reinforcement fleece and waterproofing layer. It is a seamless application that will be applied over the exiting asphalt cornices. We believe this system will be less invasive than renewing the existing asphalt.

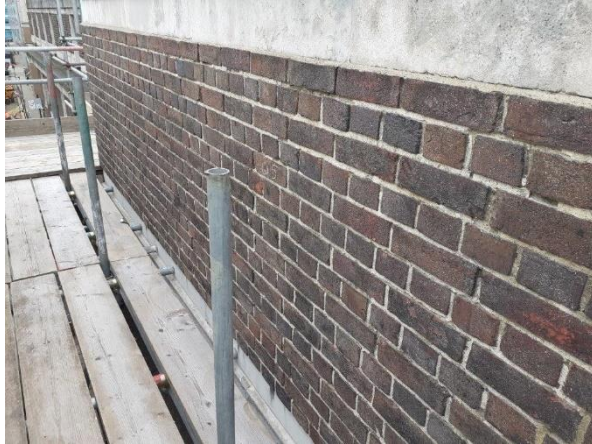
Existing defective pointing to external elevation.

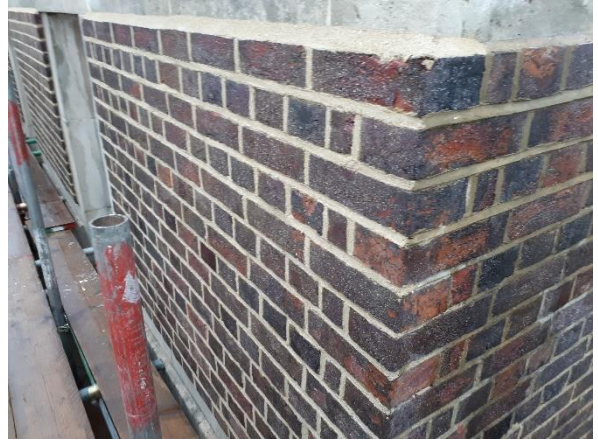
New pointing to external elevation.

2. Repointing stonework and brickwork – We have taken care to ensure the mortar mixes are appropriate and match the existing fines, method, colour etc. The pointing has been applied with care. There are no oversized joints or weather struck detail. See below photographs for re-pointing works and stone repairs undertaken.

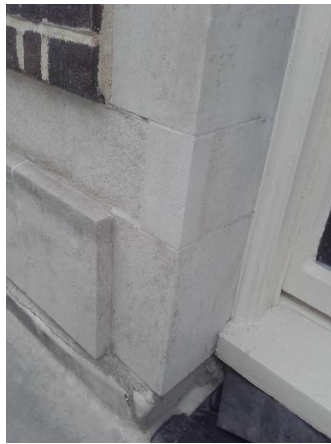
Repair and repointing to stone window reveal.

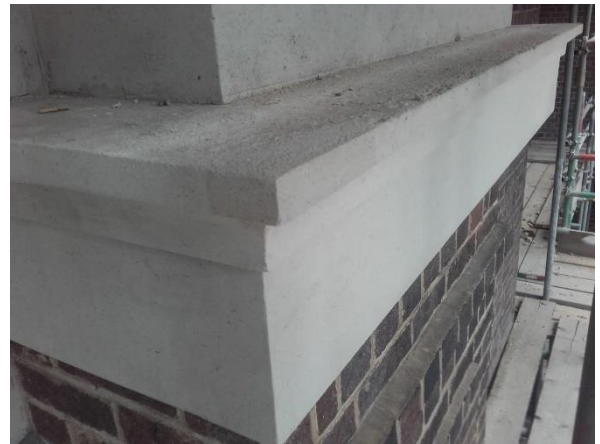
Repair and repointing to corner of stone cornice.

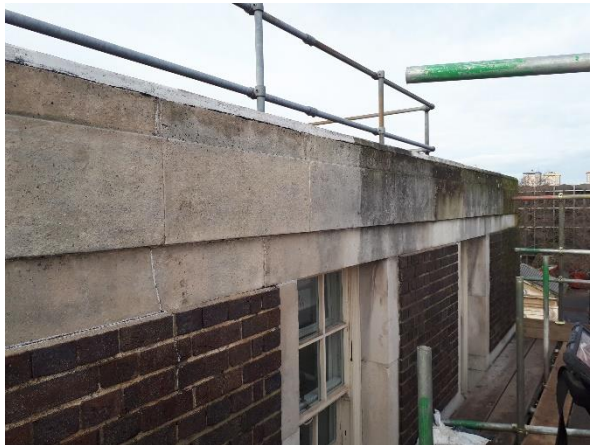
Cleaning to stonework at roof level. Photograph shows the difference between the soiled and clean stone.

3. Cleaning of brickwork and stonework – The Therma Tech system has been used. It uses hot water only; it does not involve cleaning with abrasive particles. Poultice has only been used in a small number of localised areas under the main cornice where heavy staining was present. See photographs below:

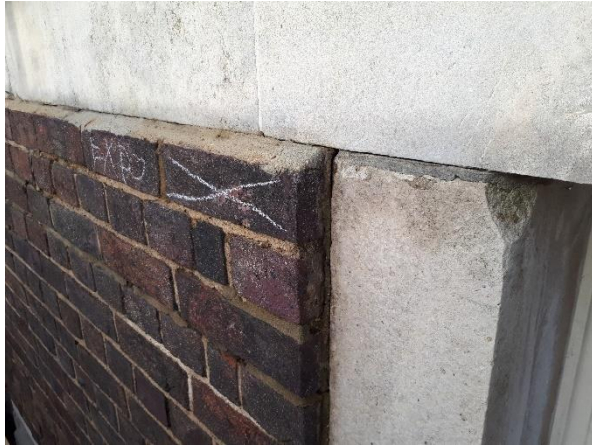
4. Structural repairs to corroded steel frame – Due to water ingress from the main roof, the steel frame behind a small number of brick panels below roof level had become corroded resulting in damage to brickwork and stone. The steel frame had expanded due to the corrosion and had pushed the brickwork out. The top four rows of bricks were removed from 5no. panels to expose the steel frame behind. The corrosion was removed, the steel work treated, and the existing bricks reinstated on the affected panels. See photographs below:

Evidence of brickwork being pushed out due to the corroded steel frame behind.

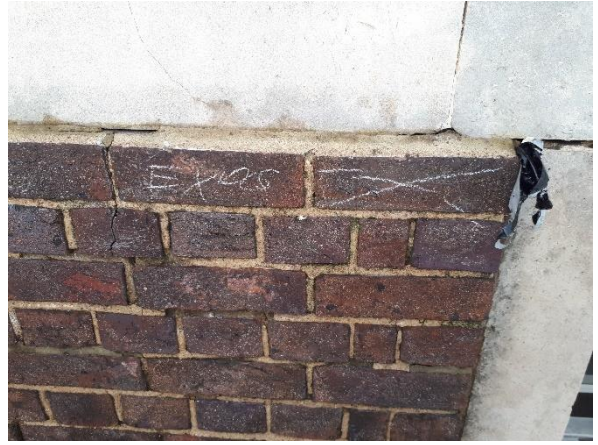
Evidence of cracked brickwork and movement due to the corroded steel frame behind.

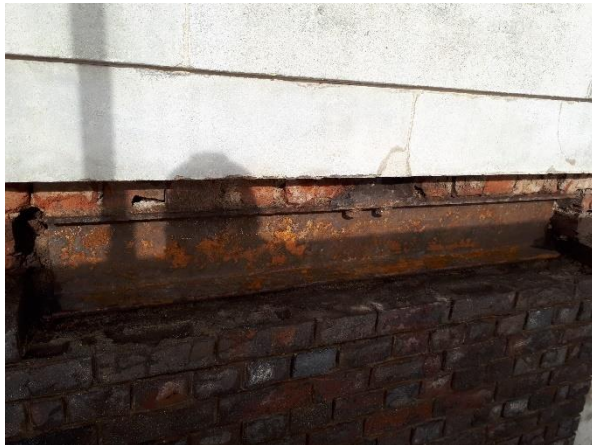
Corroded steel frame behind brick panel.

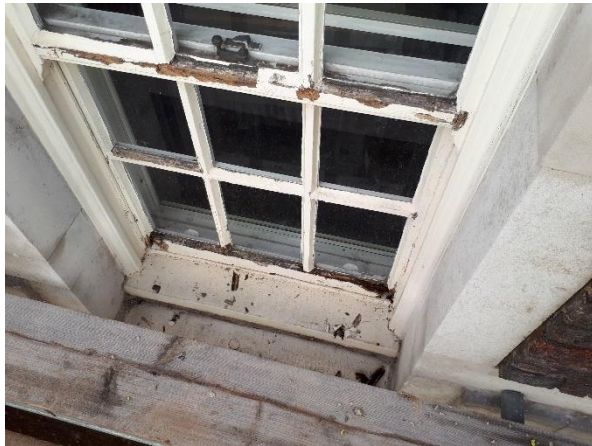
Example of extent of timer decay to sash windows at third floor level.

5. Cutting out of decayed timber to sash windows – decayed timber mainly affected a small number of windows located on the third floor (top floor) and lower ground. The sashes and surrounding framework are constructed of pine wood and the sills oak. Where timber was decayed excessively, we have undertaken splice repairs using the same type of wood as the existing. We have taken care to ensure the existing profiles have been reproduced and the repairs invisible once decorated. Where minor conservation repairs have been undertaken to sash joints, this has been done using an epoxy resin to avoid having to cut out original timbers thereby retaining as much of the original material as possible. See photographs below showing the extent of timber decay and repairs undertaken:

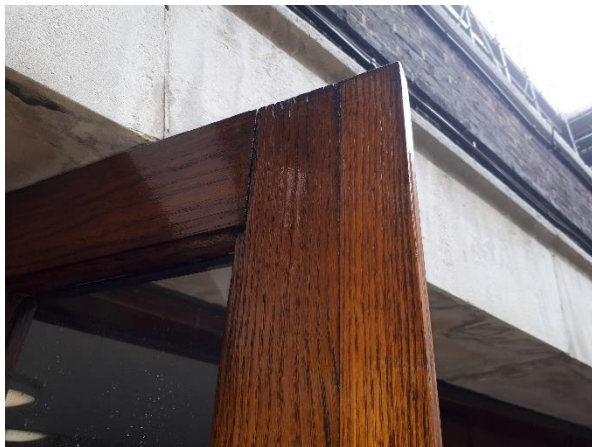
Example of open joint to existing oak door set within the internal courtyard.

6. Repairs to timber door sets within internal courtyard – the joints to the oak door sets are beginning to open up and require repair. We propose to re-glue the existing timbers where opened up. If localised splice repairs are required, we will match the existing timber taking care to ensure the existing profiles are reproduced. The doors will be revarnished on completion. Additional work includes removing the existing hinges, cleaning them, and re-hanging the doors to ensure fully operational. Where defective ironmongery is to be replaced, door handles for example, this will be on a like for like basis.

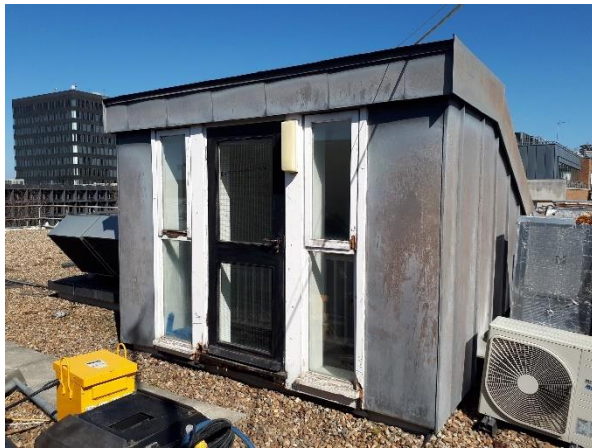
Existing rotten timber door set and single glazed side panels. Propose to replace with new double-glazed powder coated aluminium type double door set.

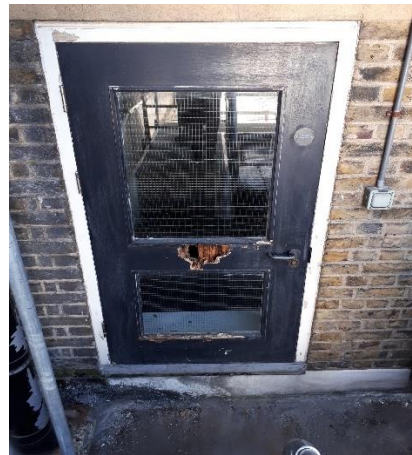
Existing rotten timber door set to roof top plant area. Propose to replace door set with new hardwood fire door. Configuration of glazing to match existing.

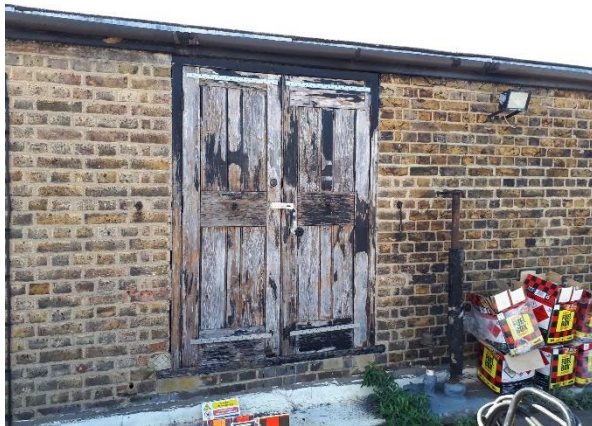
Existing rotten timber double door set to plant room at roof level. Propose to replace with new fire rated steel powder coated double door set.

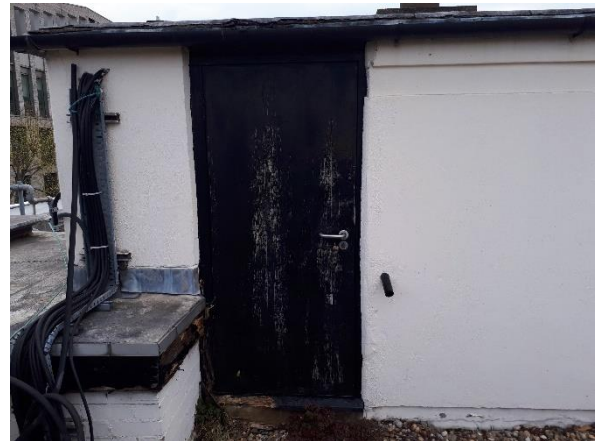
Existing rotten timber door set to plant room at roof level. Propose to replace with new fire rated steel powder coated single door set.

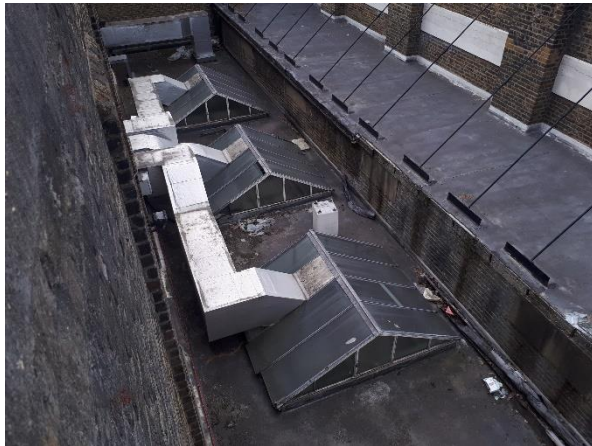
Proposal to remove 3no. roof lights within Roof 1, infill openings and overlay with a liquid waterproof covering.

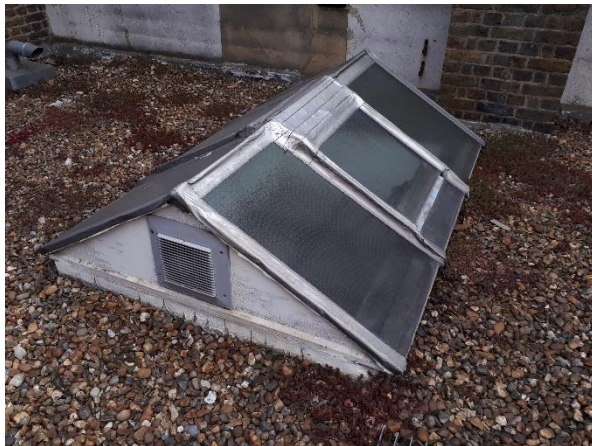
Proposal to remove 1no. roof light within Roof 4 and replace with a new modern roof light.

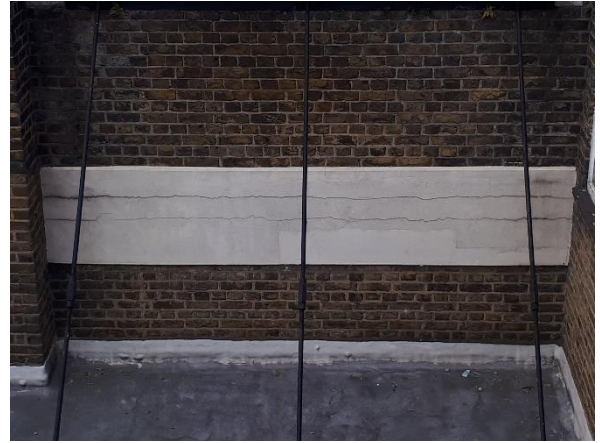
Close up showing cracked and defective render to the panels within Roof 1.

11. Structural coating to walls – The specification allows for a structural coating to be applied, however, on further investigation the panels located within Roof 1 (as identified in the photographs below) are rendered with a painted finish. We propose to hack off all defective and de-bonded render, re-rendering isolated areas and infilling any cracks. The panels will be painted with Dulux Weathershield masonry paint to match the existing colour. The brick elevations serving Roof 13 have a painted finish, which is deteriorating. We propose to prepare and redecorate with Dulux Weathershield masonry paint.

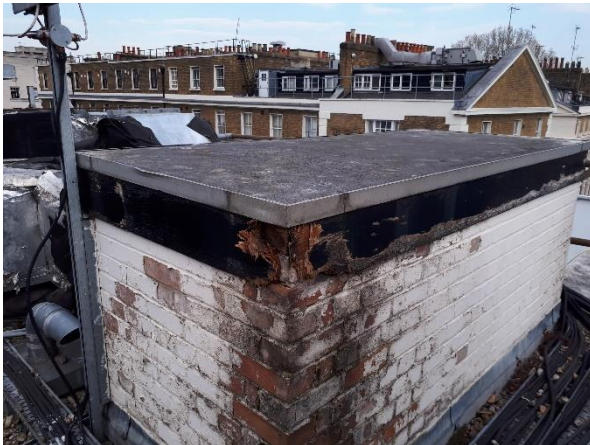
Paint finish to roof 13 deteriorating. We propose to prepare and redecorate.
