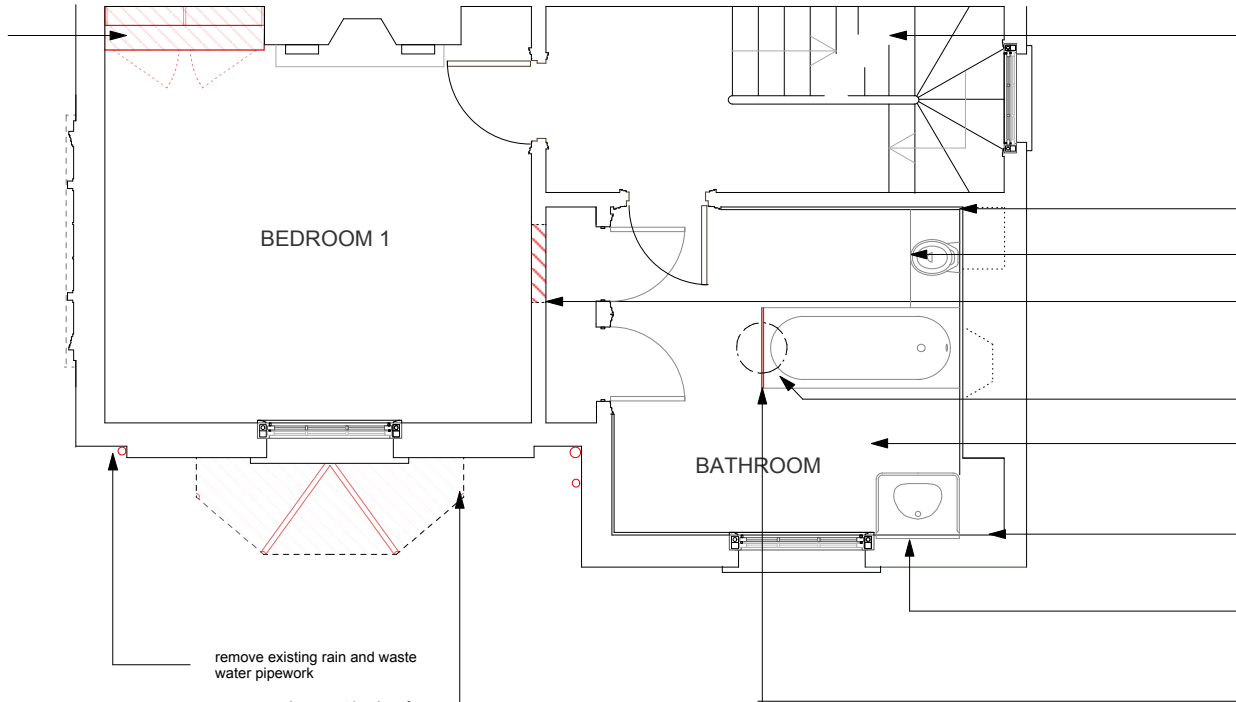
anchor stair to wall to restore structural security as evidence of separation from the supporting wall - Engineer to specify type and method of fixing once minor opening up works take place under the engineers direction

replace fractured undermounted basin and marble vanity top with equivalent 'Shanks' basin and marble, paneled casing below retained and re-used

reinststate bath surround remaking decayed end panel in material matching sides - bath to be removed from site for specialist refinishing and reinstatement, repair existing mahogany surround and refix

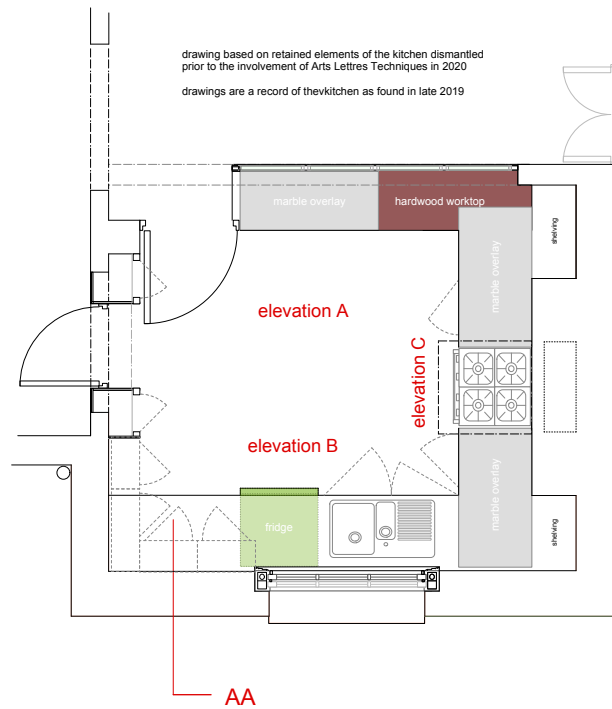
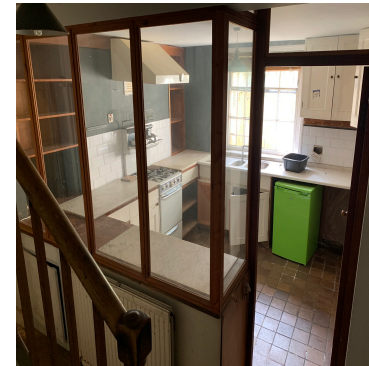
kitchen infill photographed prior to unauthorized removals 2019

1. addition of glazed screen, arch infill door and cupboards documented by Alan Bennett as expedient installation to contain kitchen smells
2. dining room view showing expedient plywood infill
3. partly white painted timber joinery
4. no fire protection or compartmentation

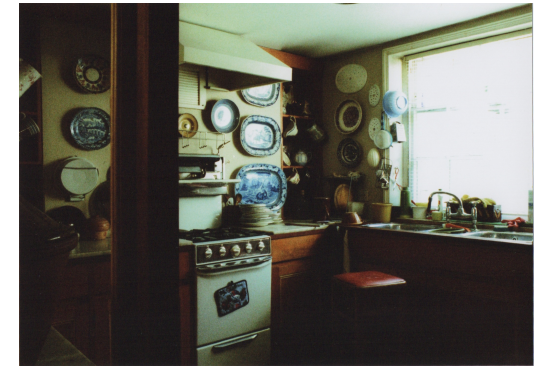
kitchen photographed prior to unauthorized removals 2019

1. replacement 2006+ 'Vola' style mixer tap with small double bowl sink
2. replacement white melamine sink worktop with two reclaimed hardwood worktops with Carrera marble overlay slabs
3. white painted timber joinery, omission of joinery adjacent to sink unit with modern green refrigerator
4. tiled walls c. 2006+ adjacent to gas cooker
