'ASBESTOS REFURBISHMENT/DEMOLITION SURVEY'

Premises:	1-3 FERDINAND PLACE Chalk Farm London NW1 8EE
On Behalf of:

Survey Reference Number	AR/20188
Survey Type	Refurbishment/Demolition Survey - (See Section 2.0)
Date of Inspection Works	22/12/2020

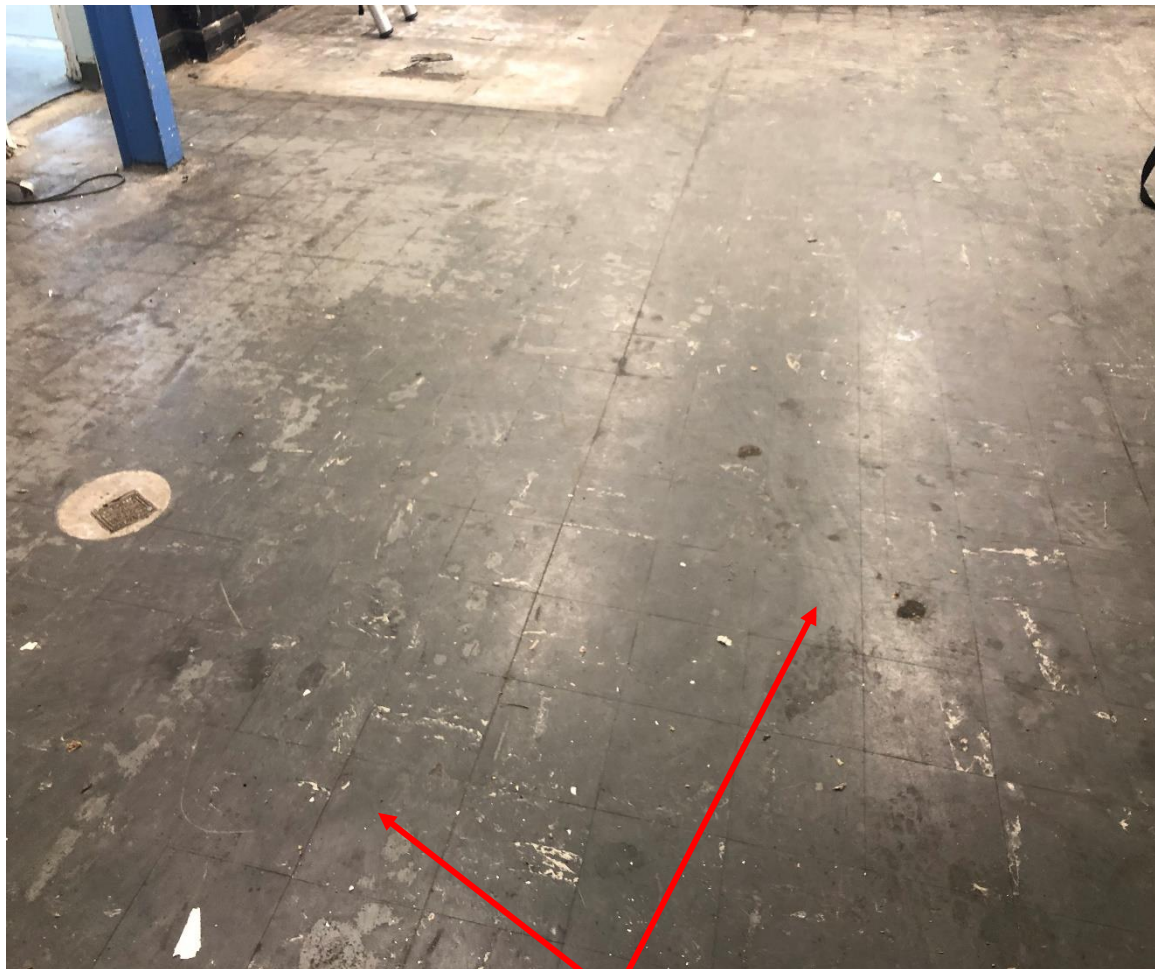
Asbestos Thermoplastic Floor Tiles with Asbestos Adhesive Backing(s) – See Recommendations

ACTION REQUIRED (FOLLOWING INSPECTION)
REMOVAL PRIOR TO FUTURE WORKS UNDER CONTROLLED CONDITIONS

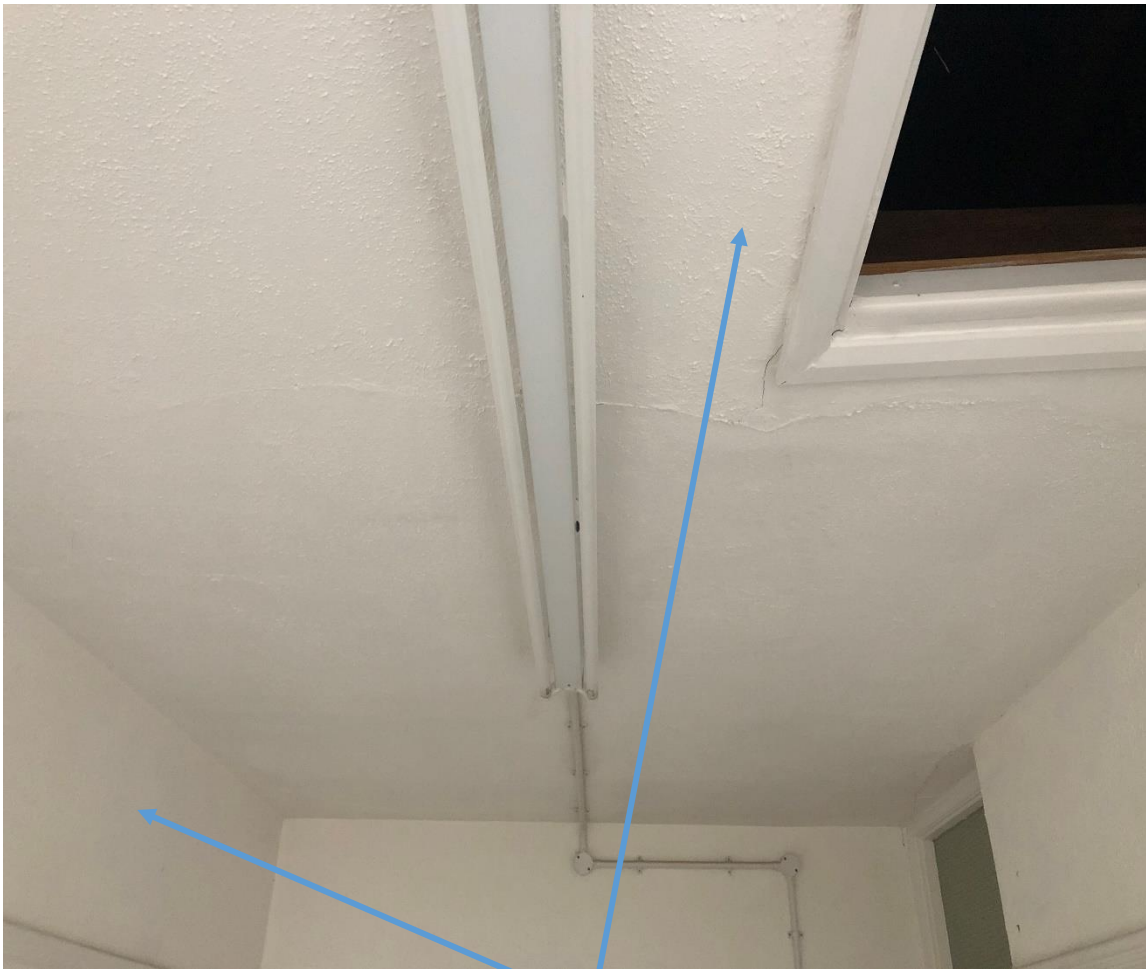
Sample Reference	S-02	Material Composition	COATINGS
Product	TEXTURED COATINGS	Asbestos Type	NON-ASBESTOS
Area	Ceiling & High-Level Wall Area(s)	Method of Identification	BULK SAMPLE
Location	LANDING	Quantity (m2/Lm)	N/A
Floor	1 ST	Accessibility	Low
ASBESTOS	NO

*Textured Ceiling & Wall Coatings - (Sample S-02)
– No Asbestos Detected in Sample(s) Taken – No
Further Action Required*

ACTION REQUIRED (FOLLOWING INSPECTION)
NO FURTHER ACTION REQUIRED WITH RESPECT TO THIS MATERIAL

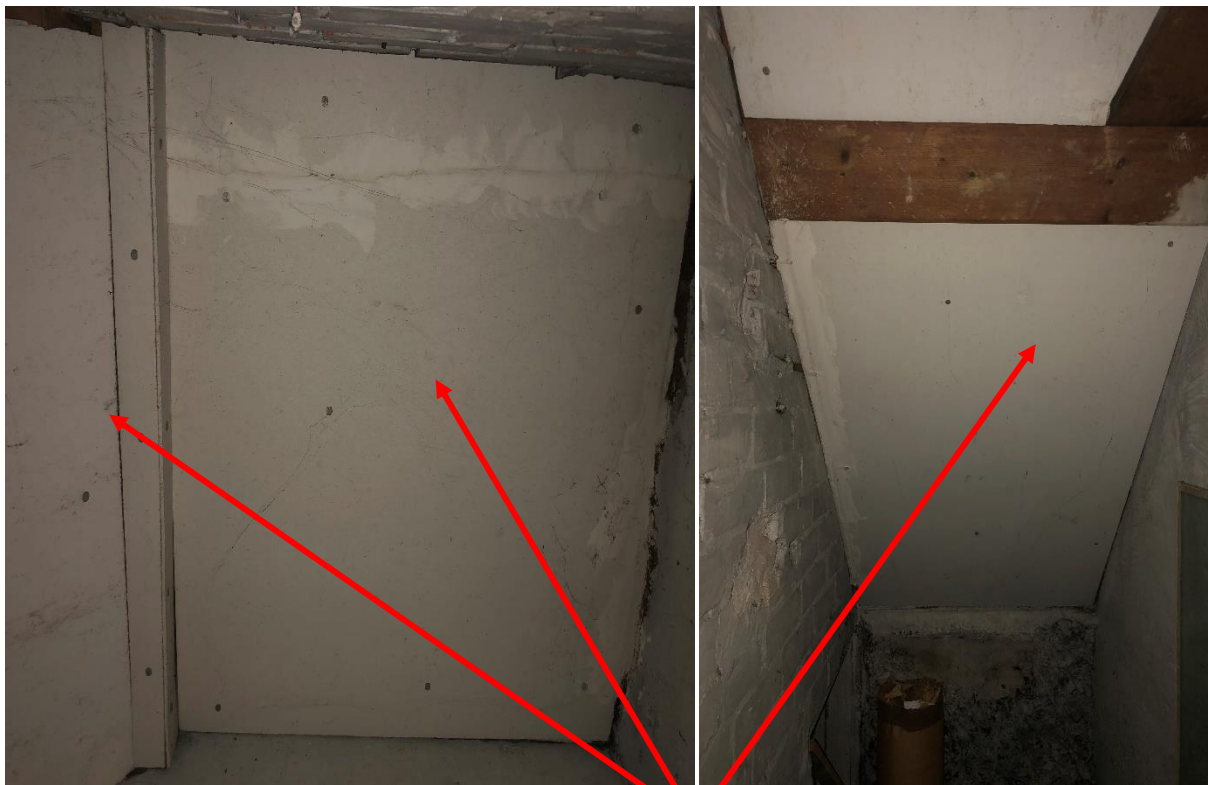
Sample Reference	S-03	Material Composition	BOARDS
Product	ASBESTOS INSULATING BOARDS	Asbestos Type	AMOSITE & CHRYSOTILE
Area	Under-Stairs	Method of Identification	BULK SAMPLE
Location	UNDER-STAIRS CUPBOARD	Quantity (m2/Lm)	5m2
Floor	GROUND	Accessibility	Medium
ASBESTOS	YES

Asbestos Insulating Board(s) – See Recommendations

AREA/MATERIAL(S)	RECOMMENDATION(S)
Ground Floor (Under-Stairs Cupboard) – Asbestos Insulating Board Liner Panel(s)	<i>Removal prior to Future Works under Fully Controlled Conditions by a Licensed Asbestos Contractor – Works subject to 14 Days Notification (Form ASB5) to Local Enforcing Authority</i>
Ground Floor (Garage Section) – Asbestos Thermoplastic Floor Tiles with Asbestos Adhesive Backing(s)	<i>Removal Prior to Future Works under Controlled Conditions Preferably by a Licensed Asbestos Contractor</i>
Ground Floor (Staff Area, Cupboard & Former WC Area – Asbestos Thermoplastic Floor Tiles with Asbestos Adhesive Backing(s)	<i>Removal Prior to Future Works under Controlled Conditions Preferably by a Licensed Asbestos Contractor</i>
Ground Floor (Former Staff WC – Electrical Cupboard) – No Access within Older Wall Mounted Electrical Unit(s)	<i>Removal Prior to Future Works under Controlled Conditions Preferably by a Licensed Asbestos Contractor</i>

ACTION REQUIRED (FOLLOWING INSPECTION)
REMOVAL PRIOR TO FUTURE WORKS UNDER FULLY CONTROLLED CONDITIONS

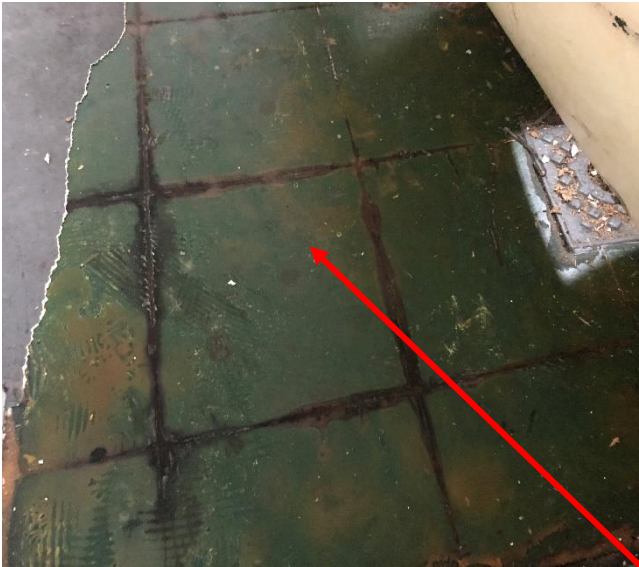
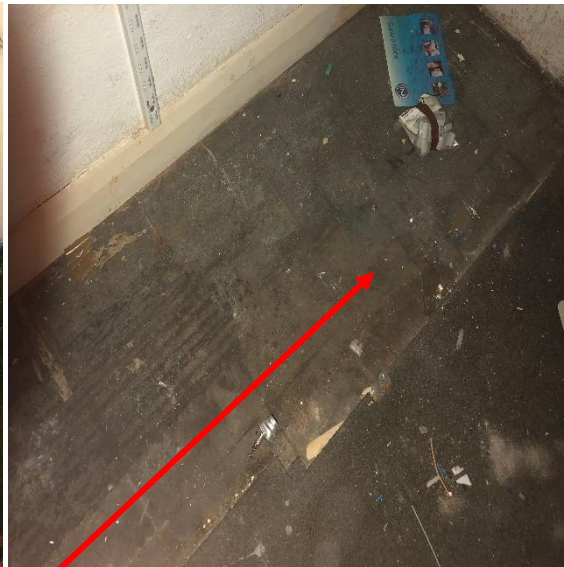
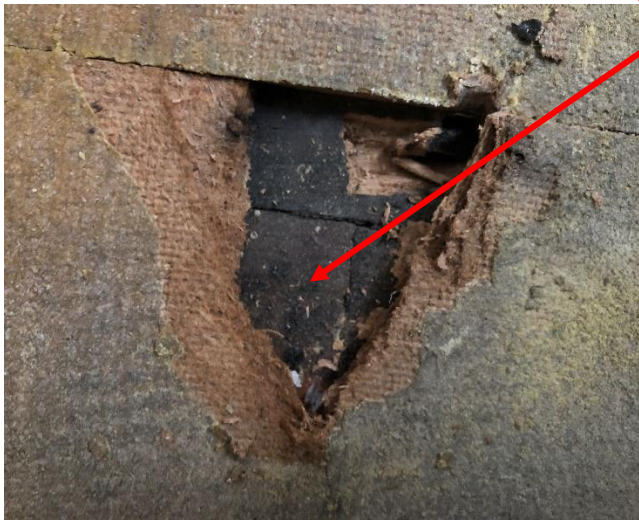
Sample Reference	S-04	Material Composition	VINYL/ADHESIVE
Product	ASBESTOS TILES & ASBESTOS ADHESIVE(S)	Asbestos Type	CHRYBOTILE
Area	Floor Area(s)	Method of Identification	BULK SAMPLE
Location	STAFF AREA, CUPBOARD & WC	Quantity (m2/Lm)	22m2
Floor	GROUND	Accessibility	High
ASBESTOS	YES

Asbestos Thermoplastic Floor Tiles with Asbestos Adhesive Backing(s) – See Recommendations

ACTION REQUIRED (FOLLOWING INSPECTION)
REMOVAL PRIOR TO FUTURE WORKS UNDER CONTROLLED CONDITIONS

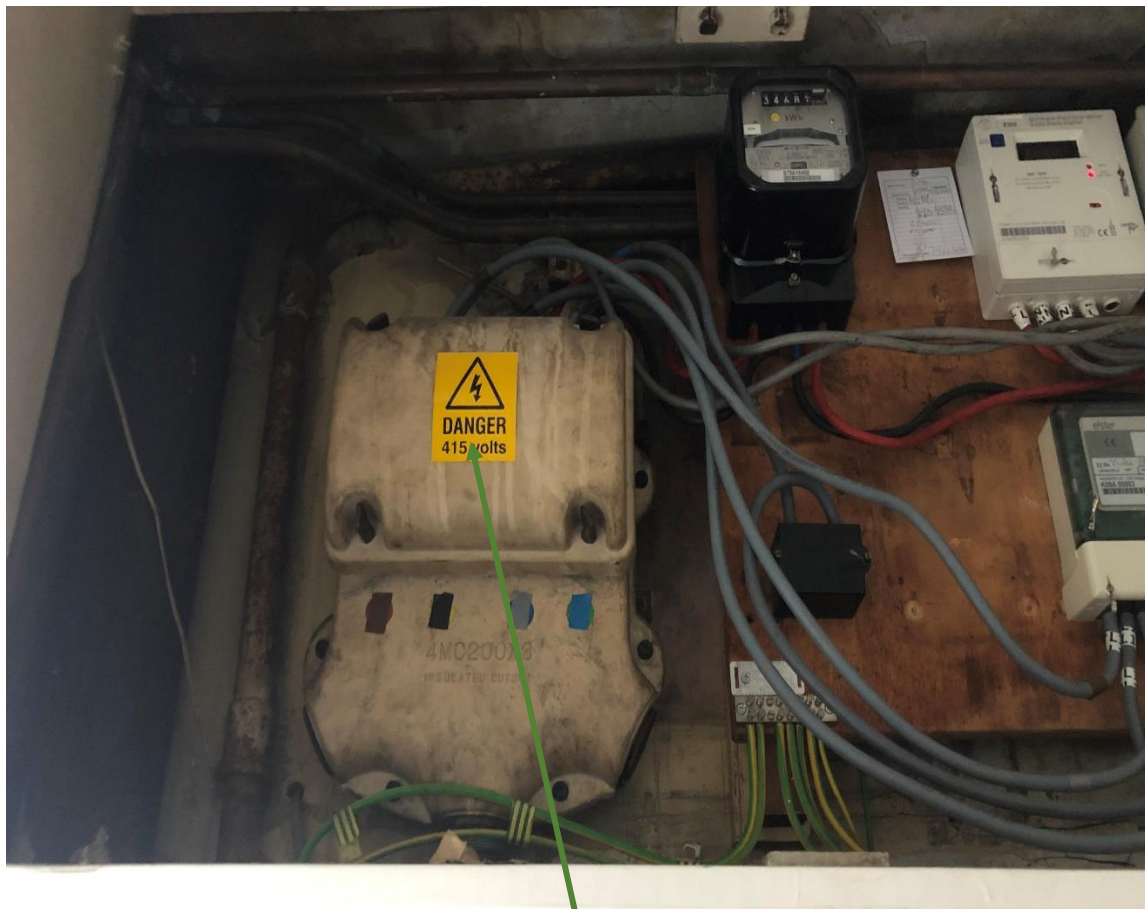
Sample Reference	N/A	Material Composition	ROPE/BRAID
Product	OLDER ELECTRICAL UNITS	Asbestos Type	POSSIBLE CONTENT
Area	Electrical Cupboard	Method of Identification	STRONGLY PRESUMED (VISUALLY IDENTIFIED)
Room	FORMER STAFF WC	Quantity (m2/Lm)	N/A
Floor	GROUND	Accessibility	Low
ASBESTOS	PRESUMED

*No Access within Older Wall Mounted Electrical Units
(Presumed to be Asbestos Containing) – See
Recommendations*

ACTION REQUIRED (FOLLOWING INSPECTION)
REMOVAL PRIOR TO FUTURE WORKS

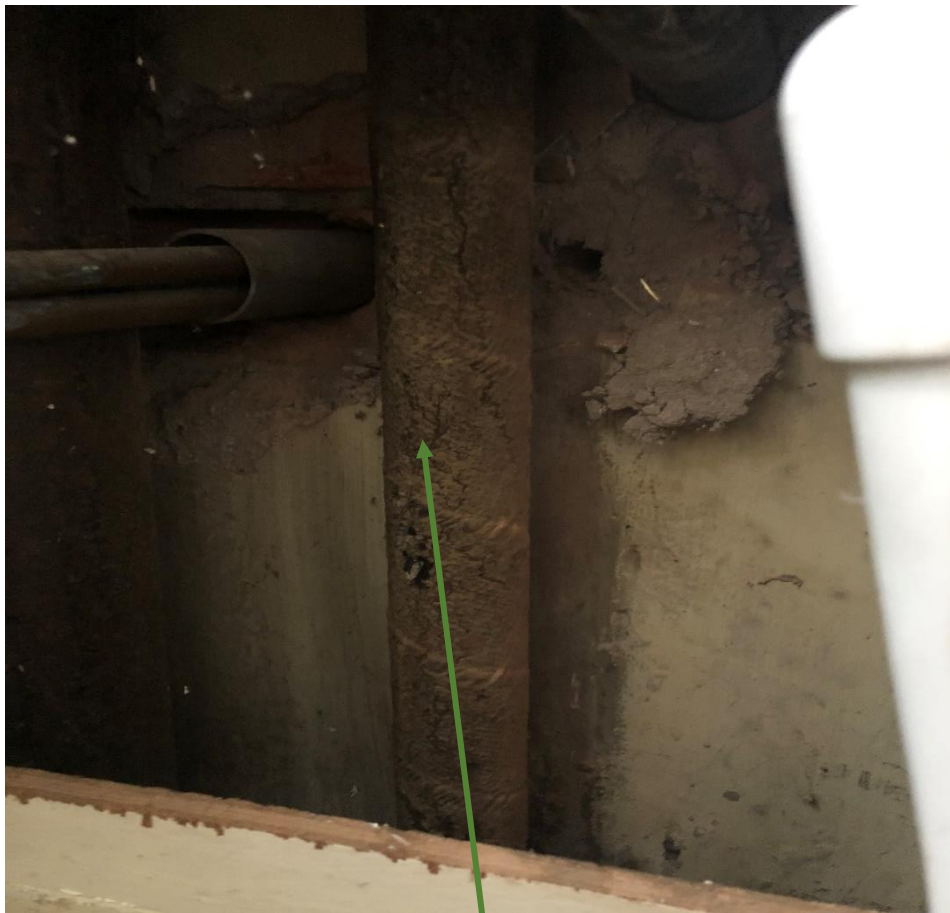
Sample Reference	N/A	Material Composition	ROPE/BRAID
Product	ELECTRICAL CABLE ARMOURING	Asbestos Type	POSSIBLE CONTENT
Area	Electrical Cupboard	Method of Identification	STRONGLY PRESUMED (VISUALLY IDENTIFIED)
Room	FORMER STAFF WC	Quantity (m2/Lm)	N/A
Floor	GROUND	Accessibility	Low
ASBESTOS	PRESUMED

*No Sampling Access to Electrical Cable Armouring
(Presumed to be Asbestos Containing) – See
Recommendations*

Ground Floor (Former Staff WC – Electrical Cupboard) – No Sampling Access to Electrical Cable Armouring	<i>Removal Prior to Future Works under Controlled Conditions Preferably by a Licensed Asbestos Contractor</i>

ACTION REQUIRED (FOLLOWING INSPECTION)
REMOVAL PRIOR TO FUTURE WORKS
