Inspection pictures

Project name :
11455 - ST PANCRAS WAY

Inspection report

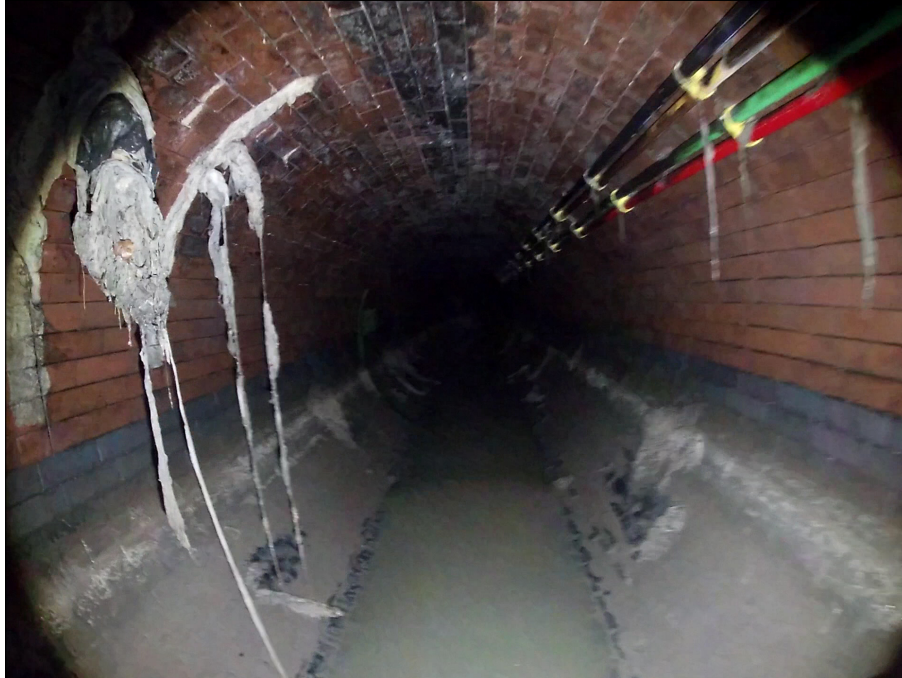
Photo: TQ29835701_D_150619_233500_-_7.jpg, Media No.: 42774, 00:04:01
 93m, Attached deposits, encrustation, from 9 to 11 o'clock, 10% cross-sectional area loss

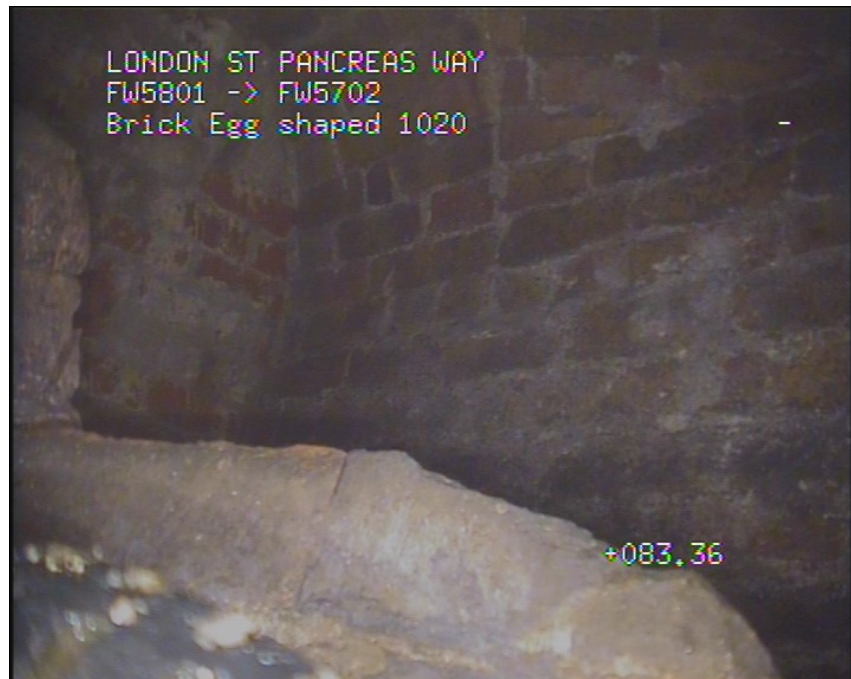
Photo: 3_3_33_A.JPG
83.36m, General remark

67.58	CN	Connection other than junction, at 2 o'clock, diameter 100mm	(Constr) 0
	82.39	REM	General remark Remarks: LAMPHOLE	(Misc) 0
	83.36	REM	General remark Remarks: POSSIBLE REDUNDANT SEWER COMING INTO RUN. PIPE HAS BEEN BRICKED UP.	(Misc) 0

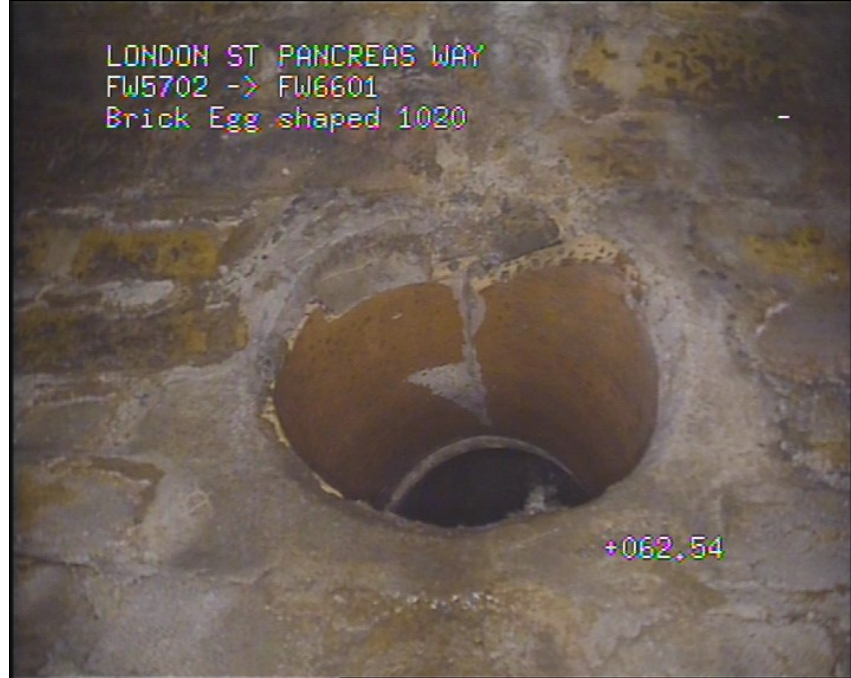
Photo: 4_4_48_A.JPG

62.54m, Connection defective, connecting pipe is damaged, at 10 o'clock, diameter 150mm

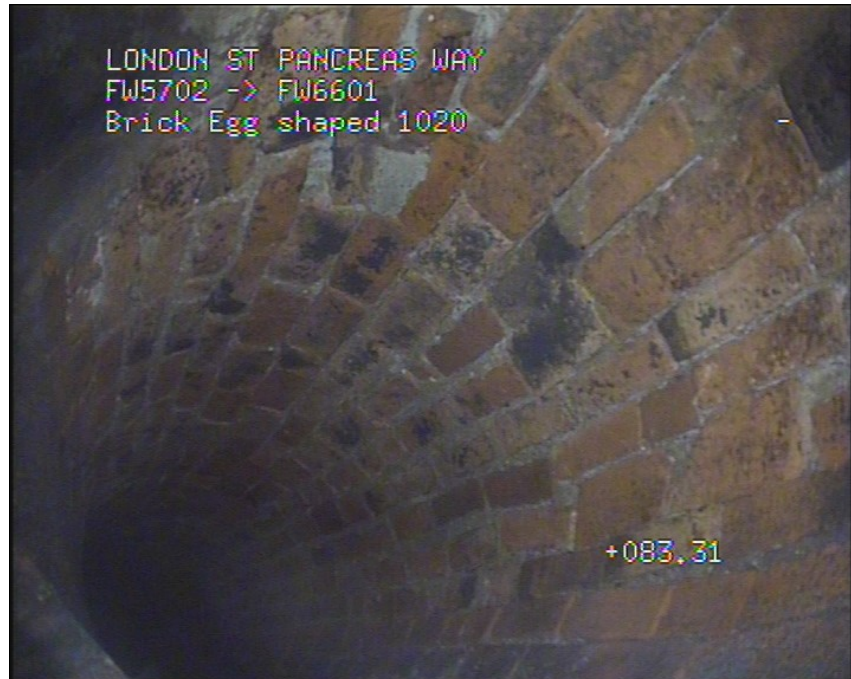
Photo: 4_4_50_A.JPG

83.31	JN	Junction, at 10 o'clock, diameter 600mm Remarks: PIPE SIZE UNKNOWN	(Constr) 0
	83.37	CN	Connection other than junction, at 2 o'clock, diameter 150mm Remarks: NRV	(Constr) 0

83.31m, Junction, at 10 o'clock, diameter 600mm
