**77 SOUTH END ROAD  
LONDON NW3 2RJ**

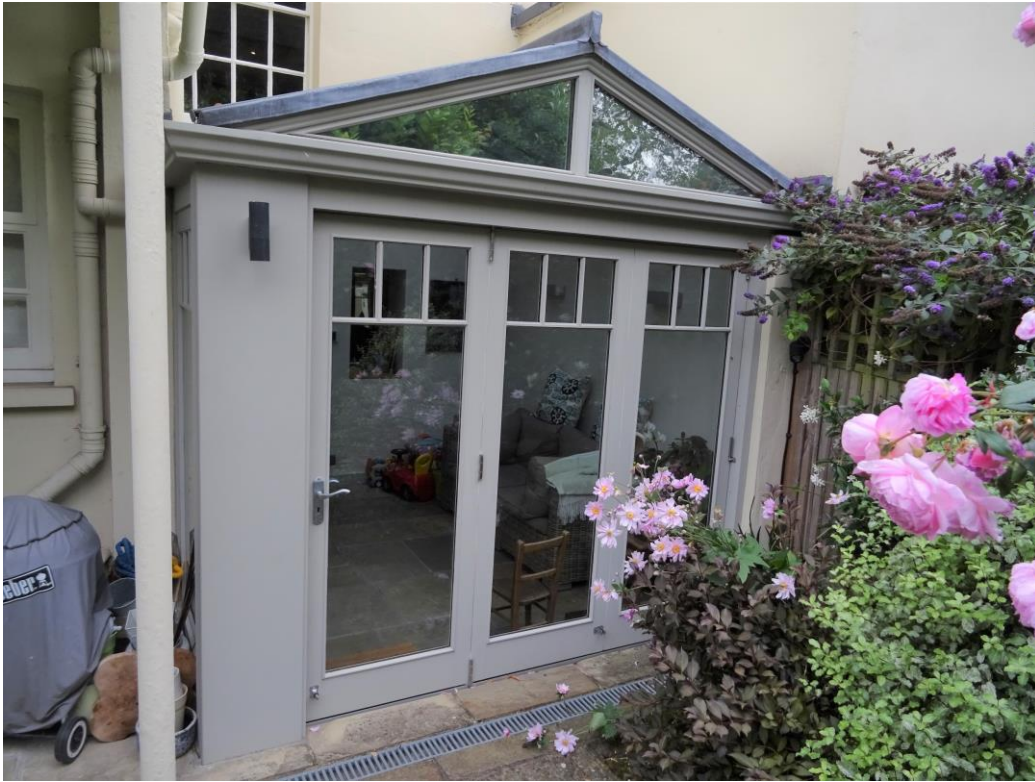
**PHOTOGRAPH 1  
THE REAR CONSERVATORY**

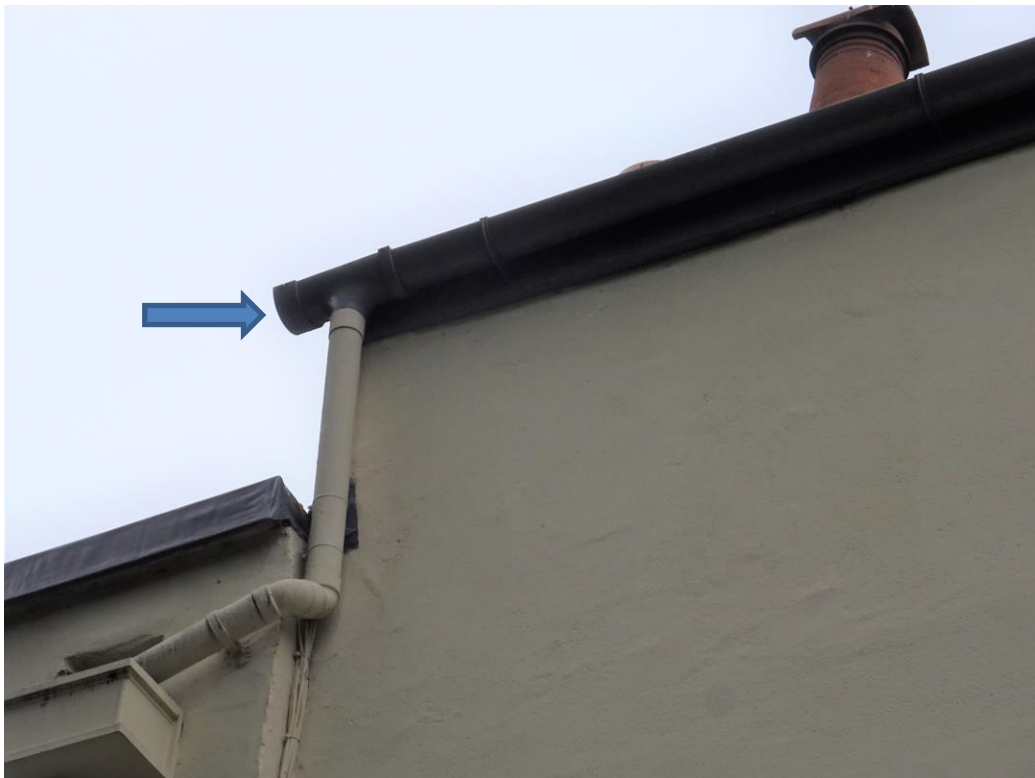
**PHOTOGRAPH 2  
PVC GUTTER AND RAINWATER PIPE**

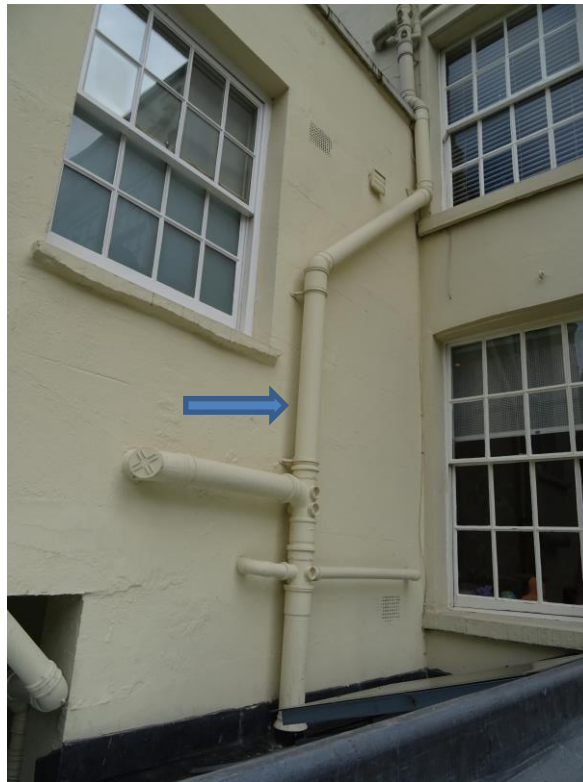
PHOTOGRAPH 3  
A PVC SOIL VENT PIPE

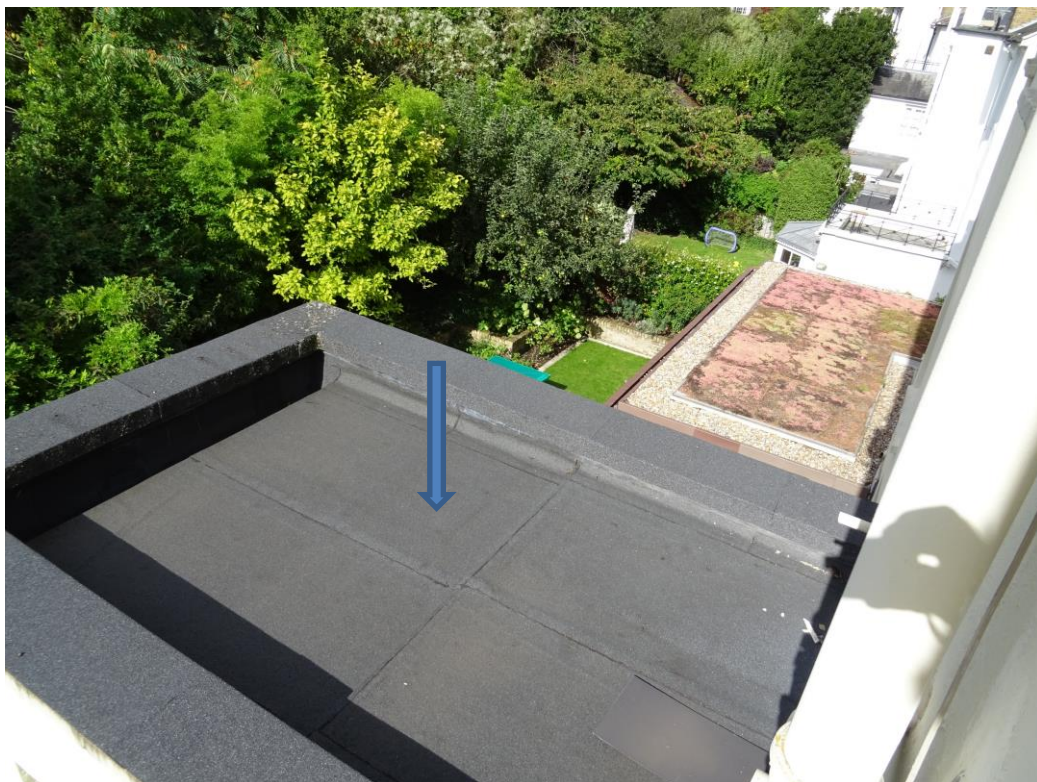
PHOTOGRAPH 4  
THE REAR ADDITION ROOF HAS BEEN COVERED WITH ROOFING FELT

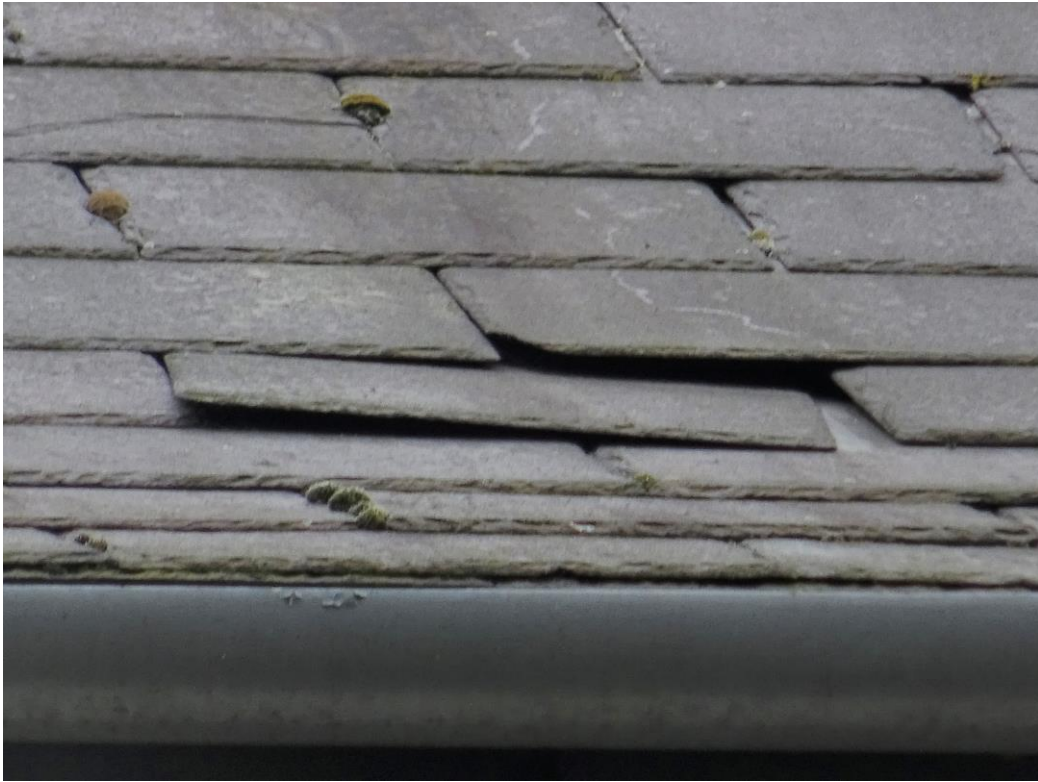
PHOTOGRAPH 5  
A LOOSE SLATE TO THE FRONT SLOPE

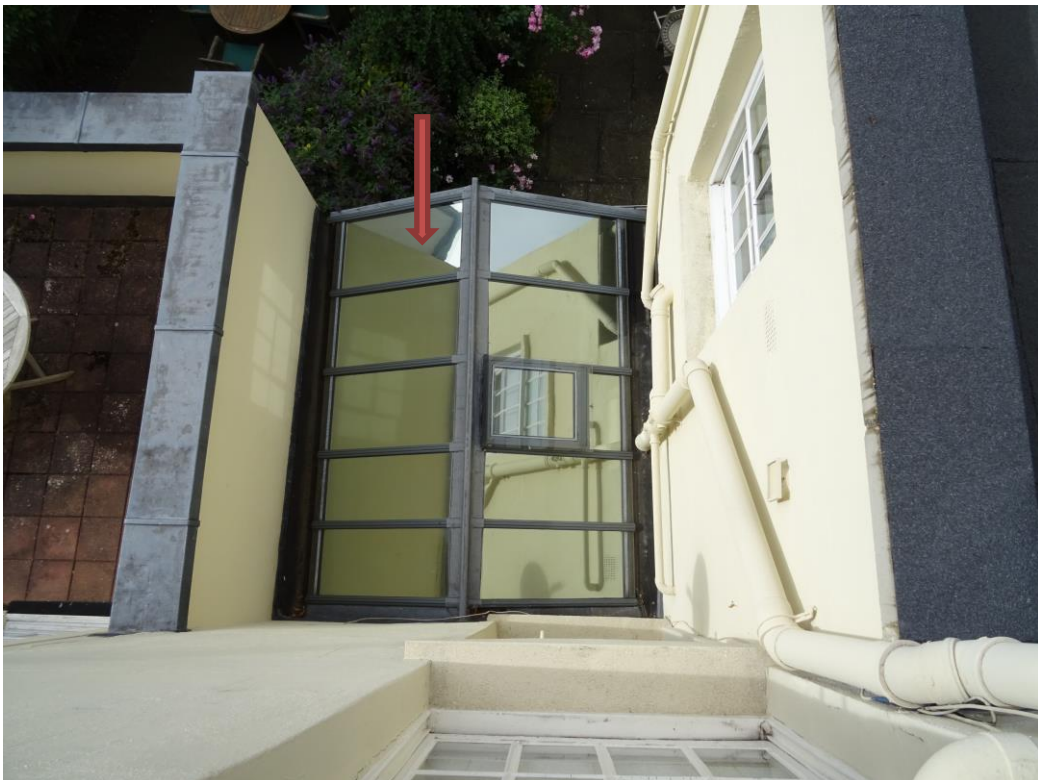
PHOTOGRAPH 6  
THE CONSERVATORY ROOF

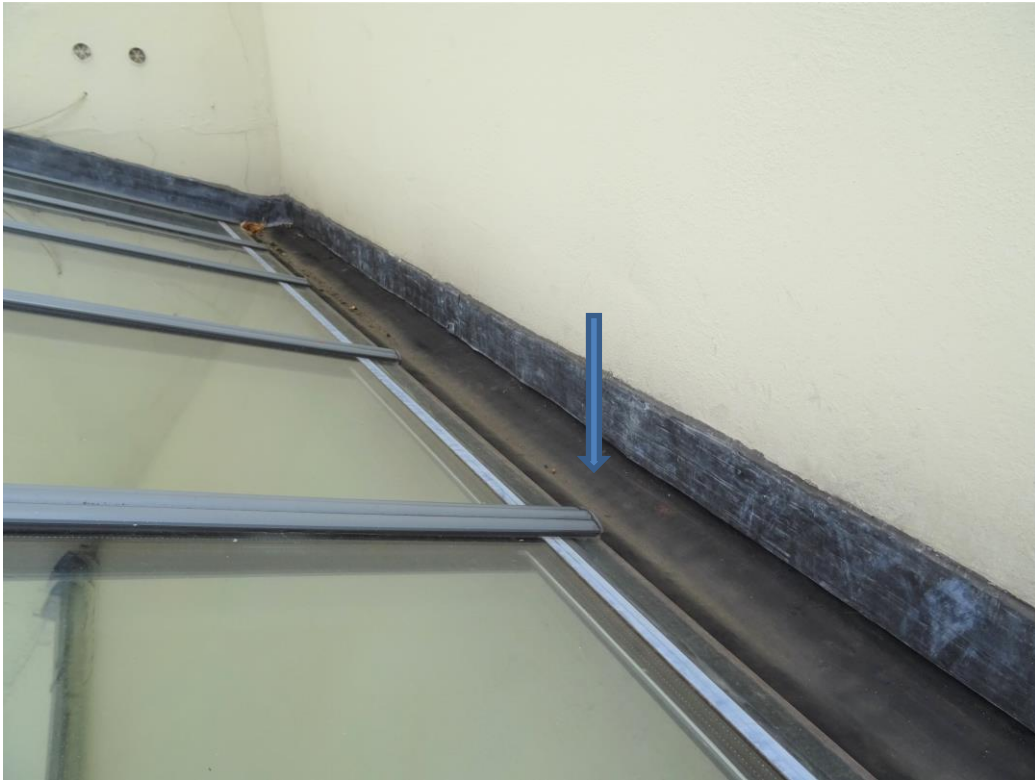
PHOTOGRAPH 7  
THERE ARE BOX GUTTERS TO EACH SIDE OF THE CONSERVATORY ROOF

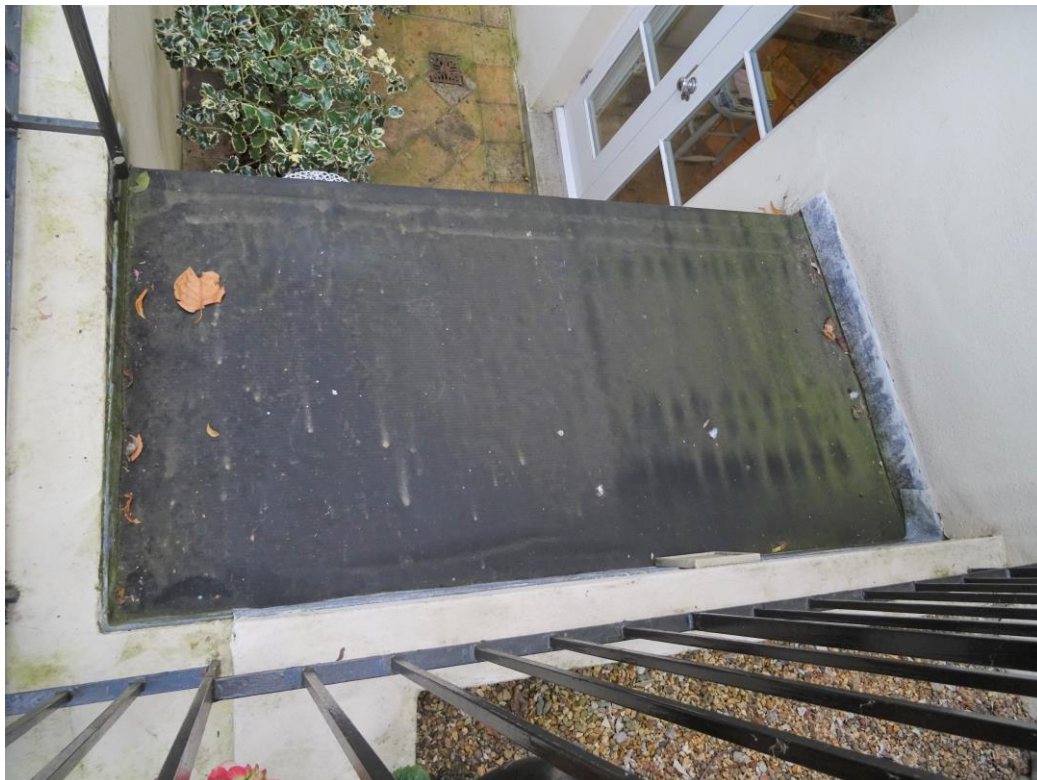
PHOTOGRAPH 8  
THE BOILER HOUSING ROOF

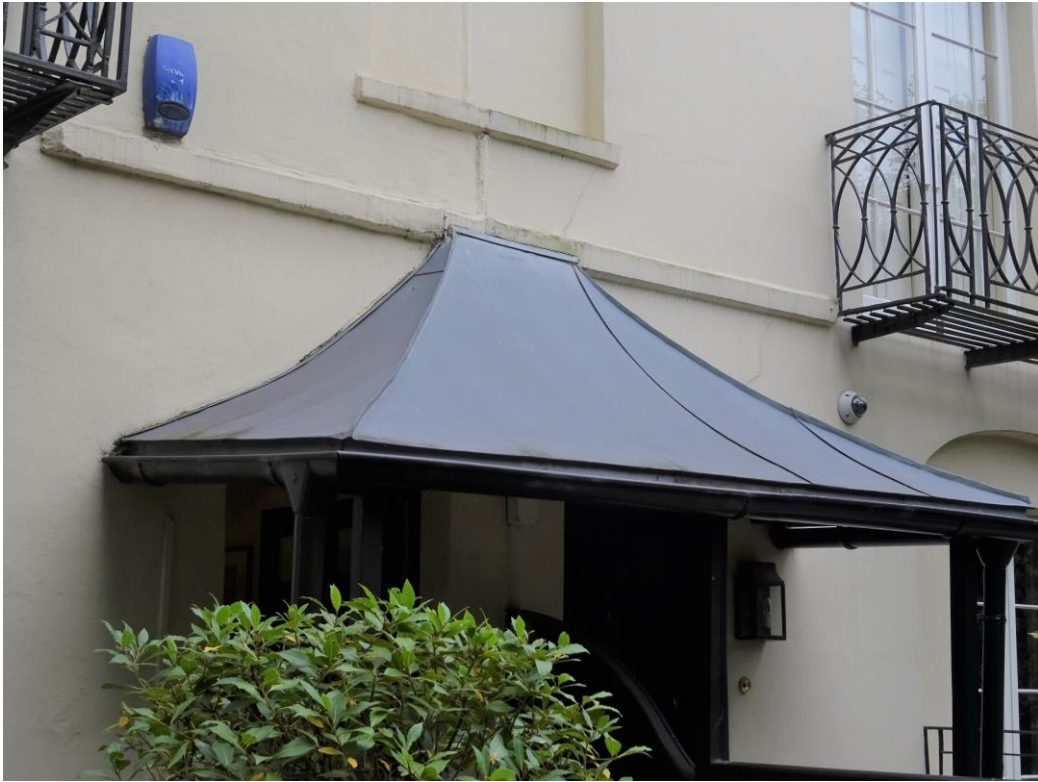
PHOTOGRAPH 9  
THE PORCH ROOF

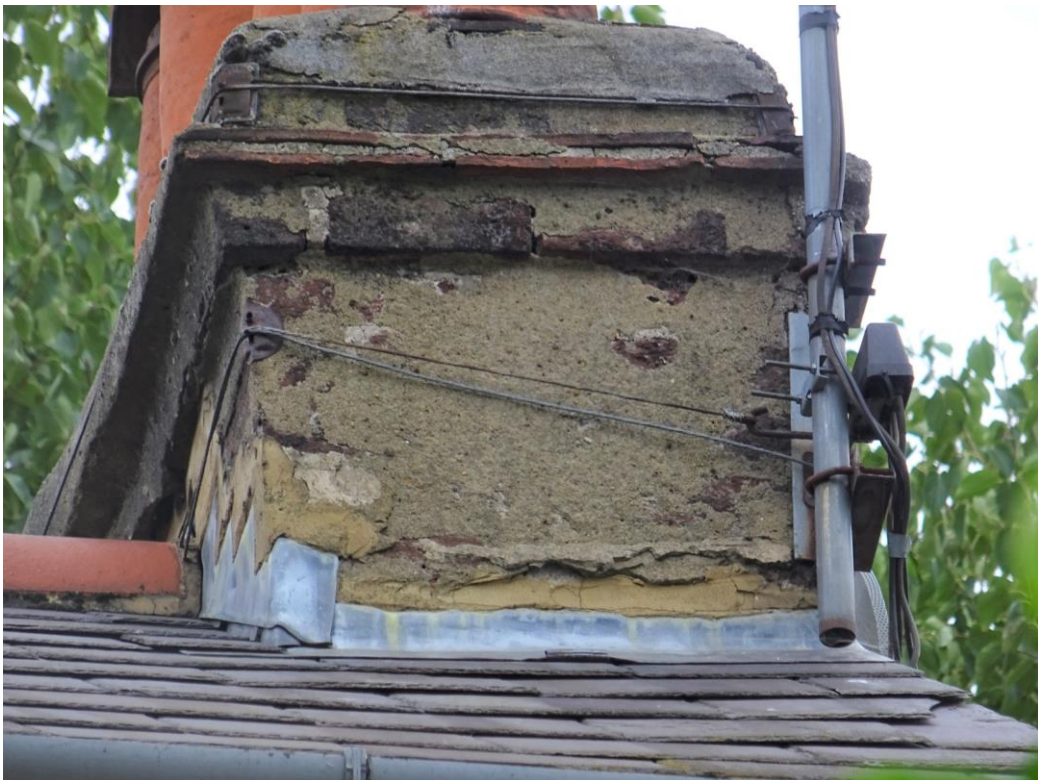
PHOTOGRAPH 10  
POOR QUALITY RENDER TO THE CHIMNEY STACK

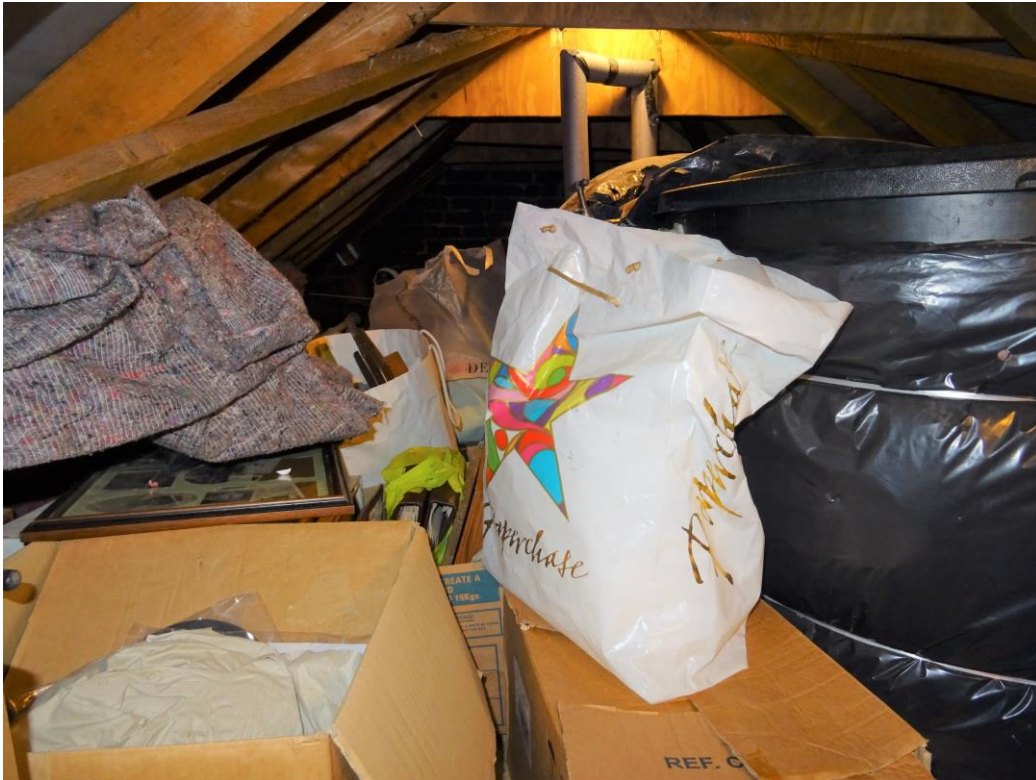
PHOTOGRAPH 11  
THE LOFTS WERE FULL OF STORED ITEMS

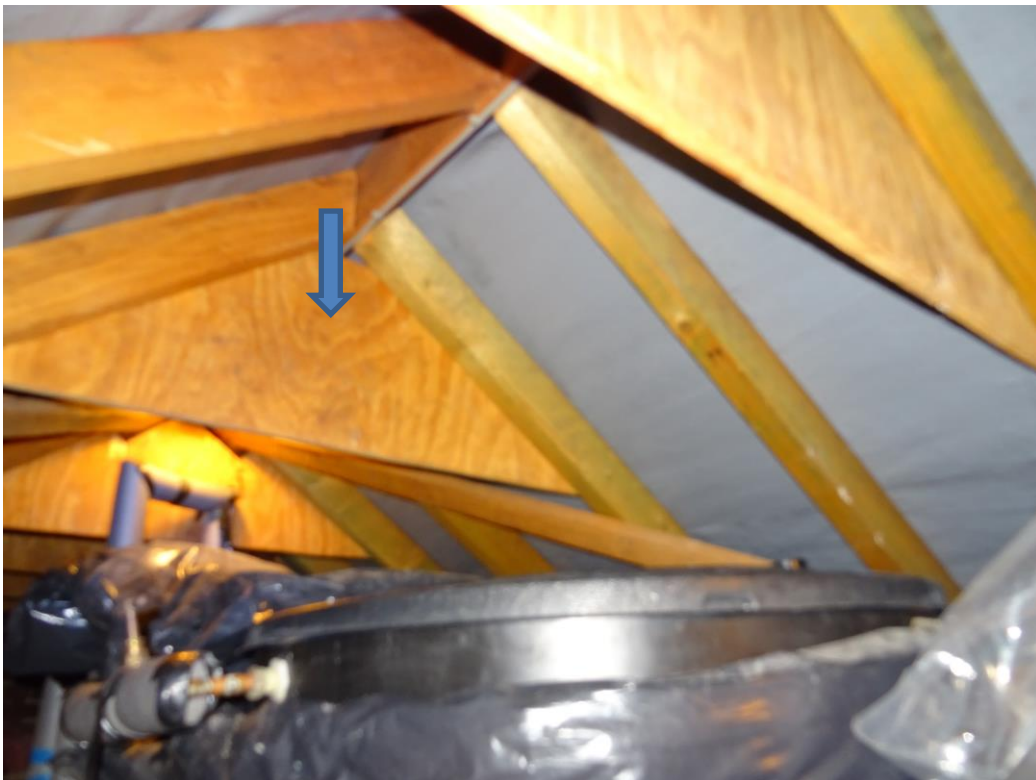
PHOTOGRAPH 12  
THE MAJORITY OF THE ROOF STRUCTURE IS NEW

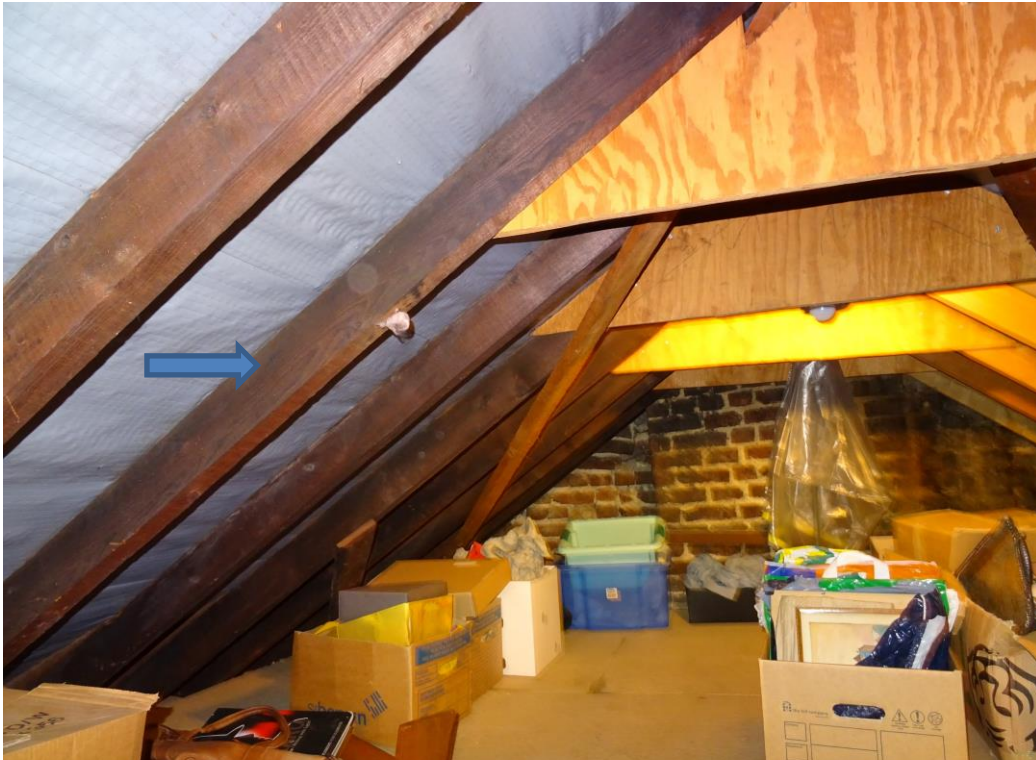
PHOTOGRAPH 13  
THE FRONT SLOPE OF THE FRONT PITCHED ROOF HAS THE ORIGINAL  
RAFTERS

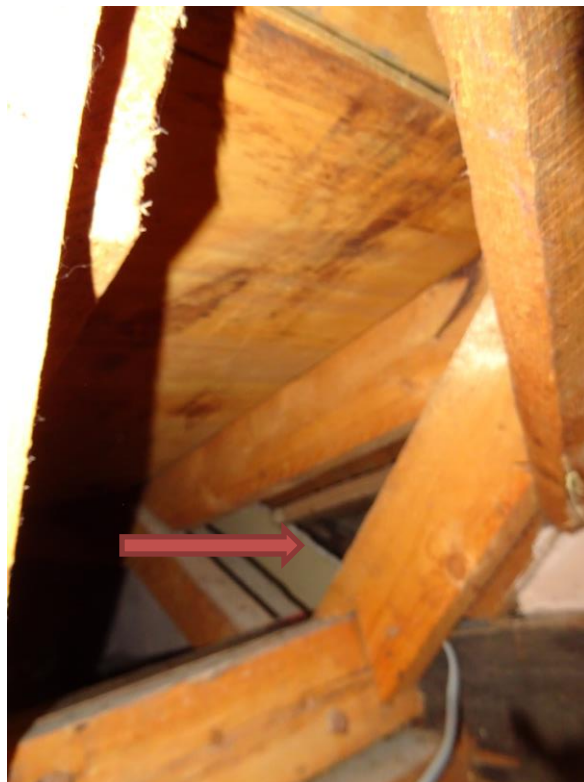
PHOTOGRAPH 14  
THERE IS A GAP IN THE RIGHT PARTY WALL BELOW THE VALLEY  
GUTTER

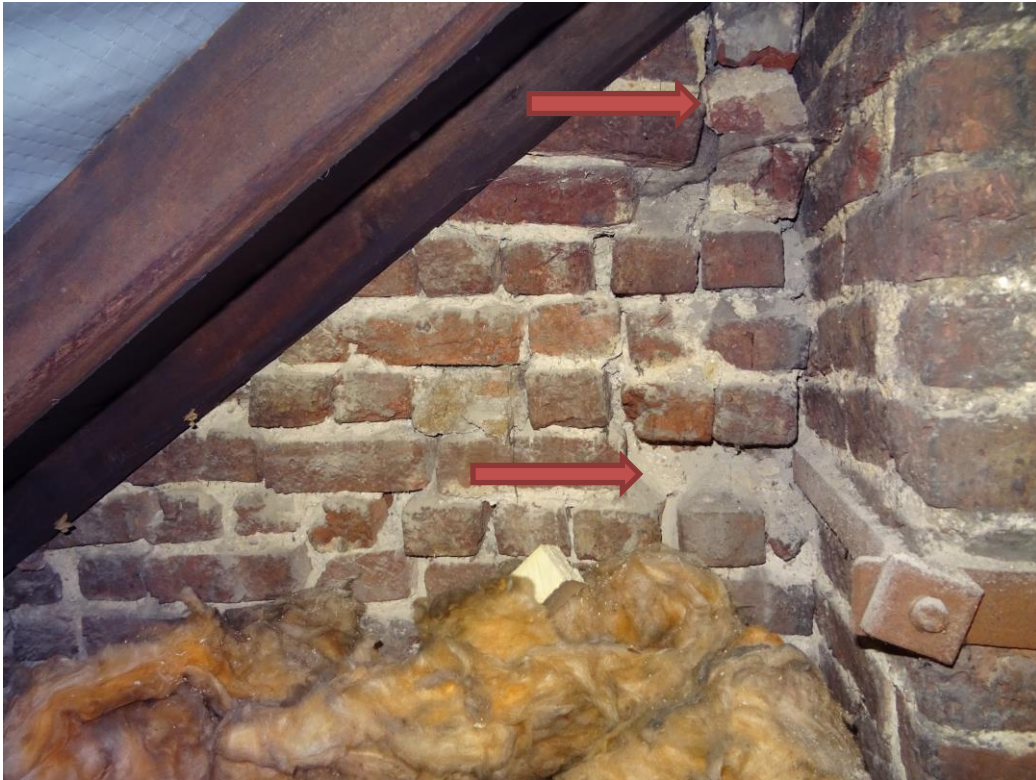
PHOTOGRAPH 15  
LOOSE BRICKS TO THE LEFT PARTY WALL

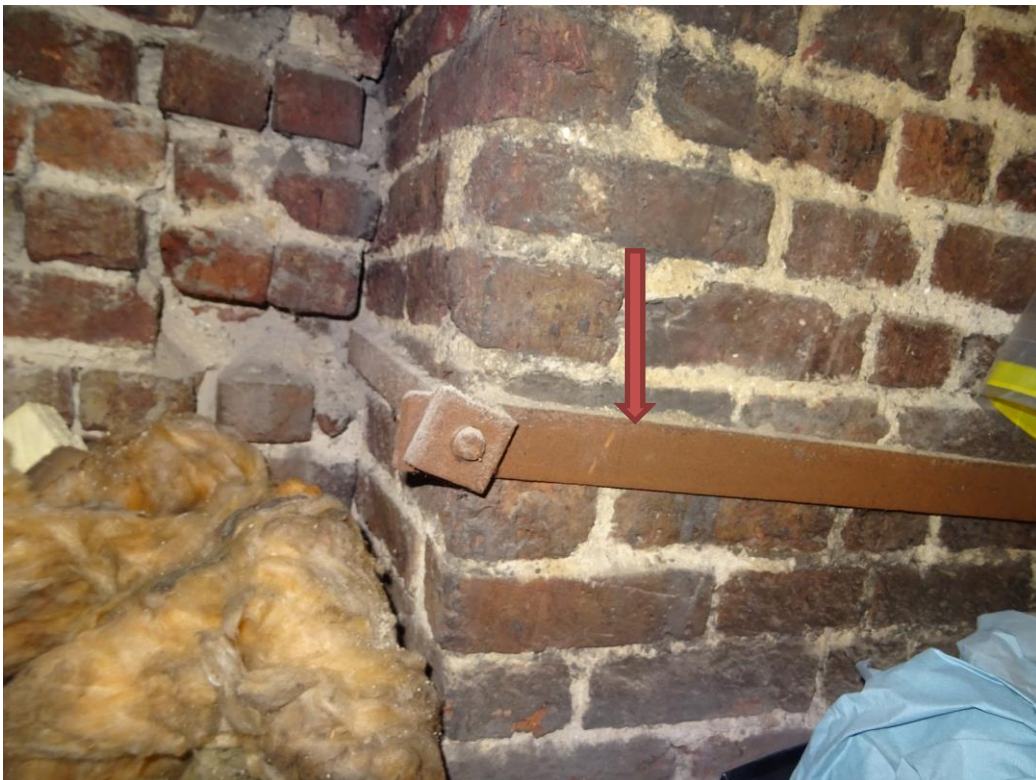
PHOTOGRAPH 16  
A METAL TIE TO THE CHIMNEY STACK

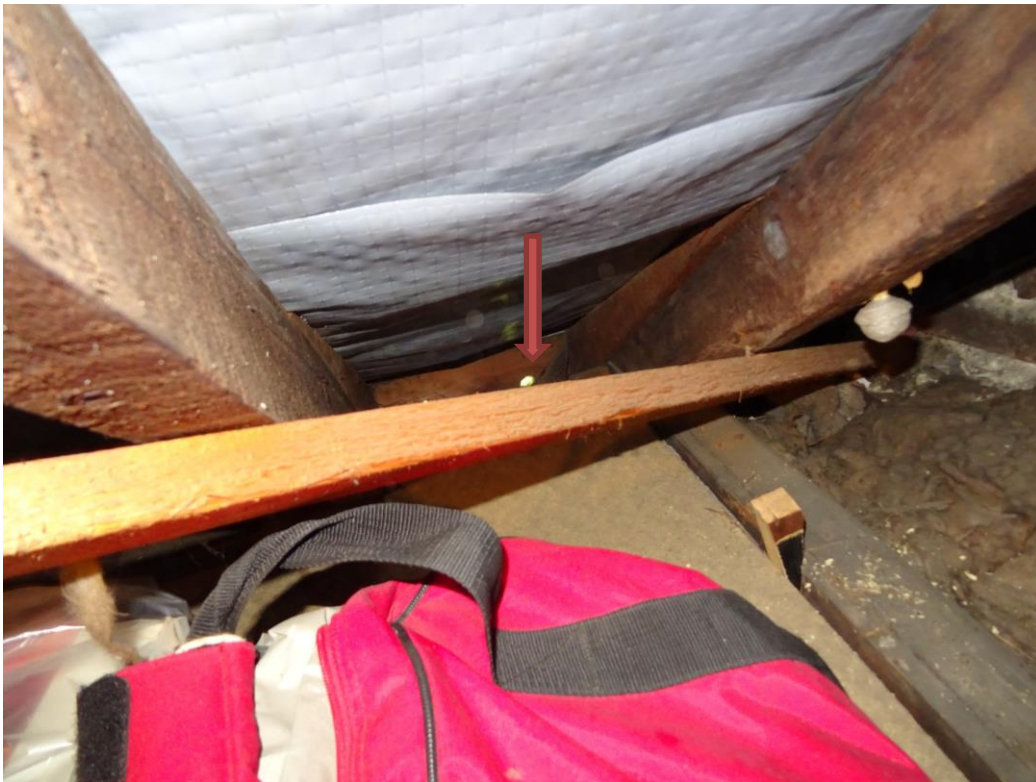
PHOTOGRAPH 17  
SMALL HOLES HAVE BEEN PROVIDED TO ALLOW FOR SOME  
VENTILATION

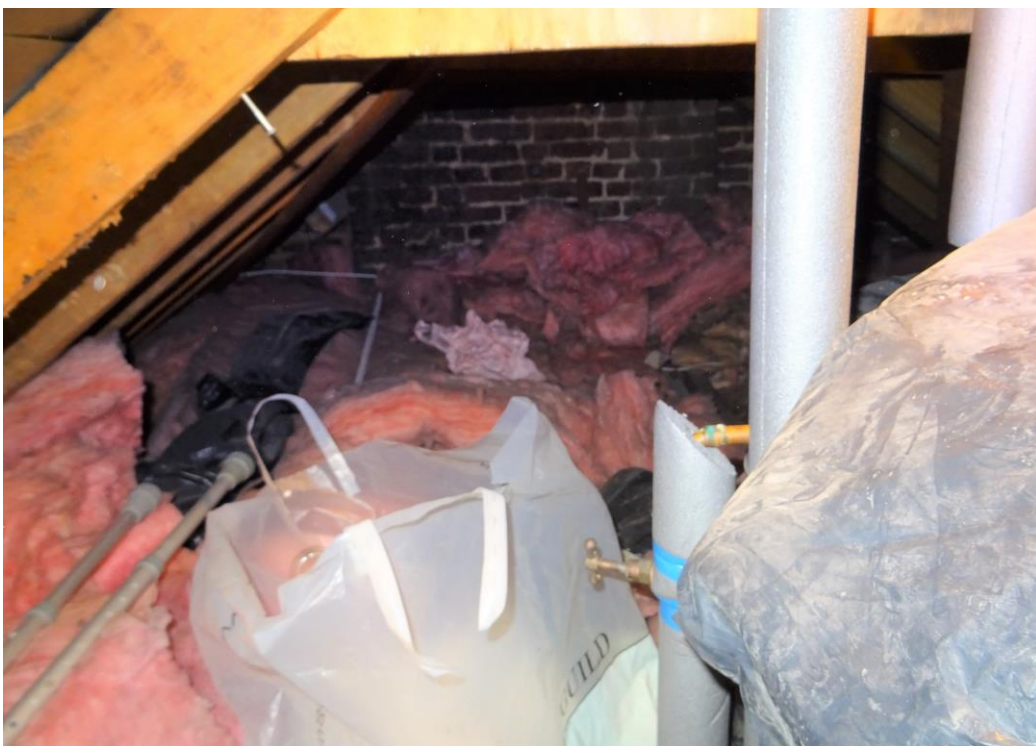
PHOTOGRAPH 18  
THE LOFT IS INSULATED

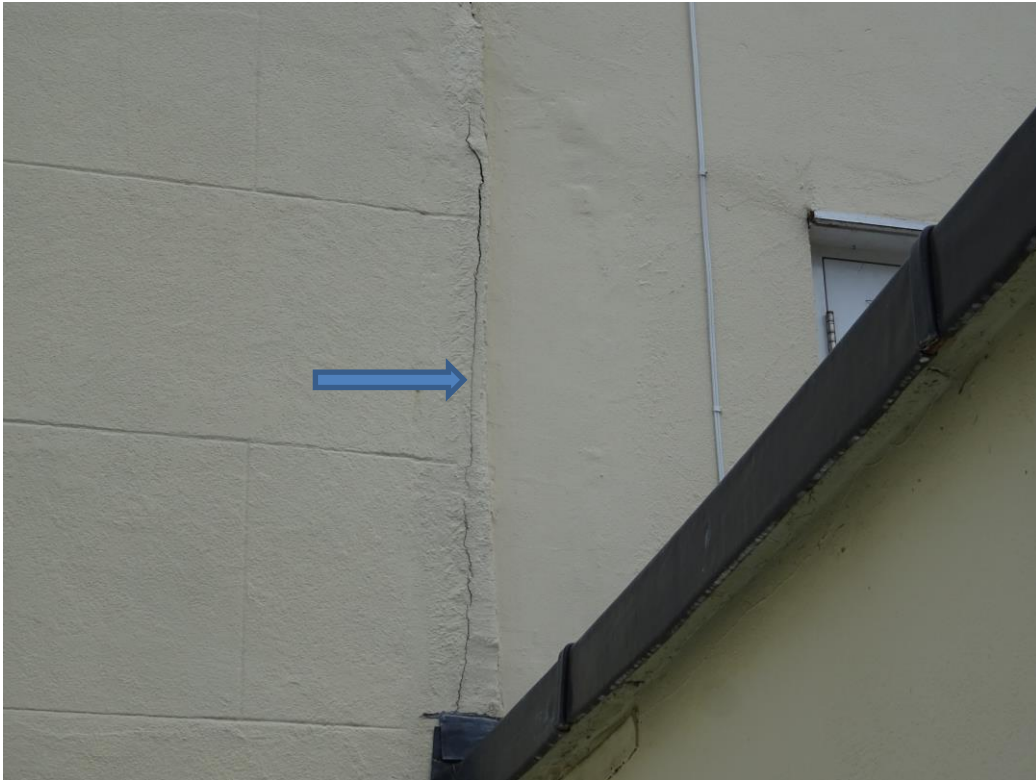
PHOTOGRAPH 19  
MINOR CRACKS TO THE REAR WALL

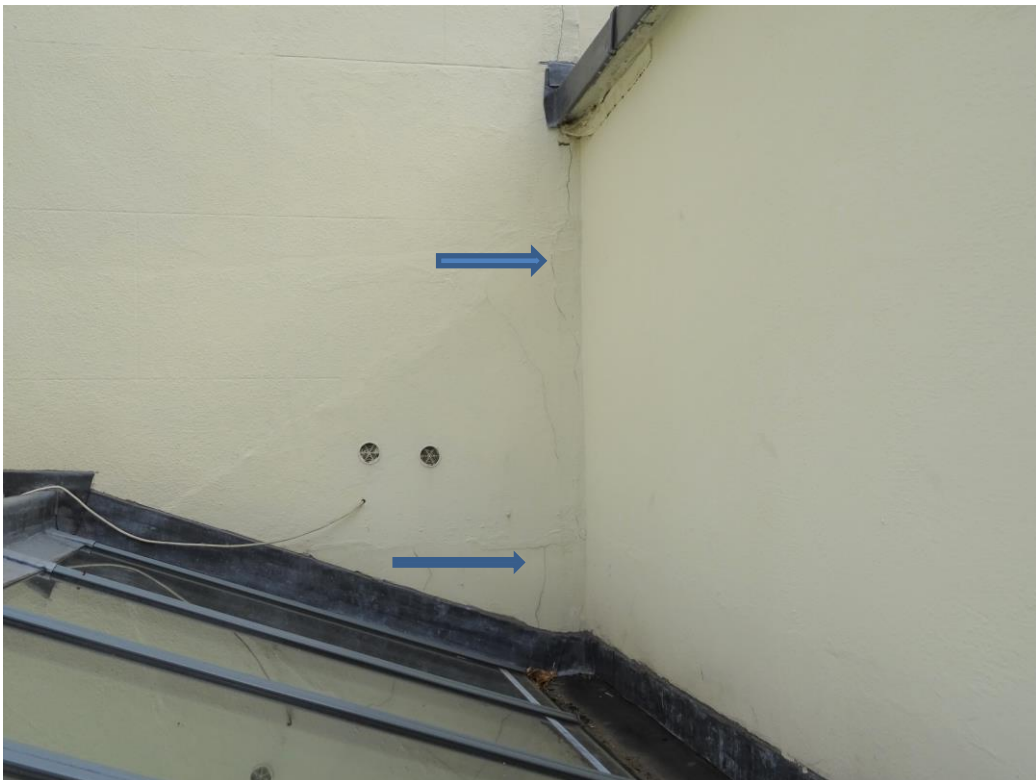
PHOTOGRAPH 20  
MINOR CRACKS TO THE REAR WALL

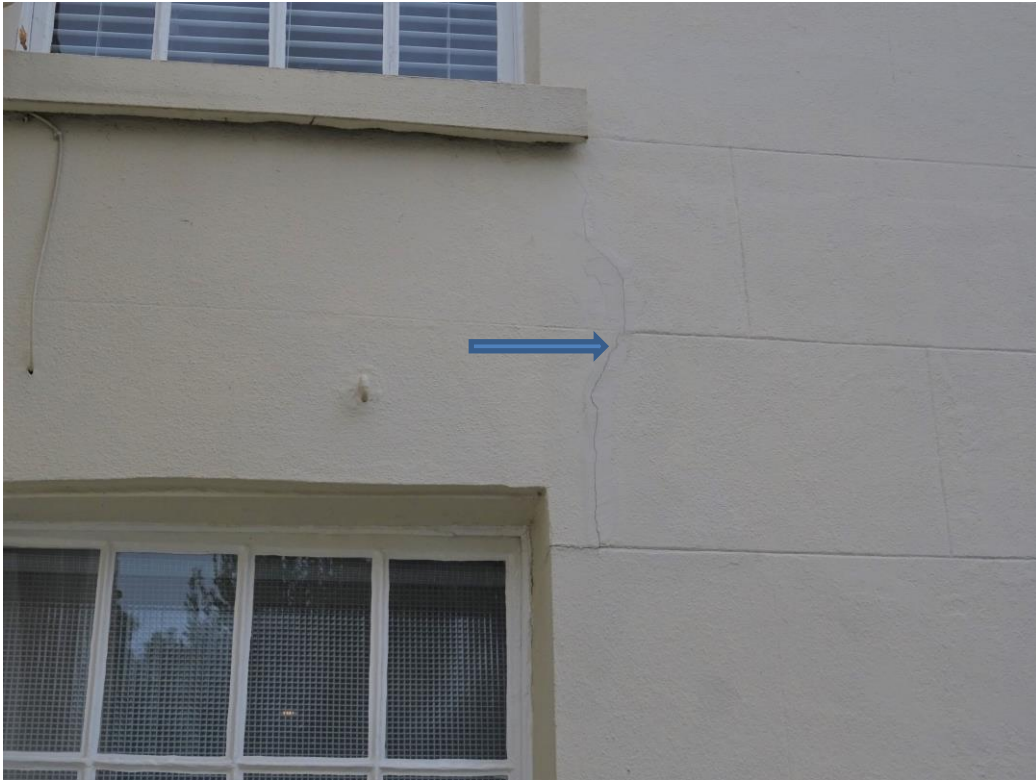
PHOTOGRAPH 21  
MINOR CRACKS TO THE REAR WALL

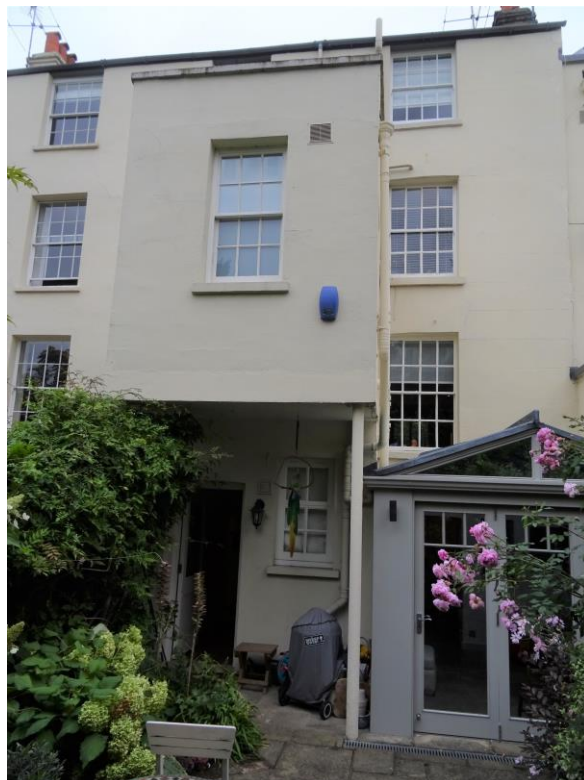
PHOTOGRAPH 22  
THE REAR ADDITION

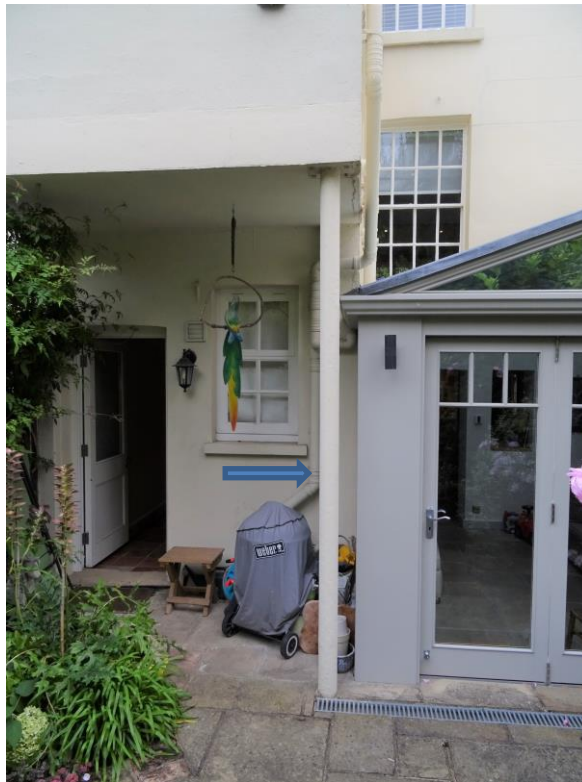
PHOTOGRAPH 23  
THE REAR ADDITION IS PARTLY SUPPORTED BY METAL COLUMNS

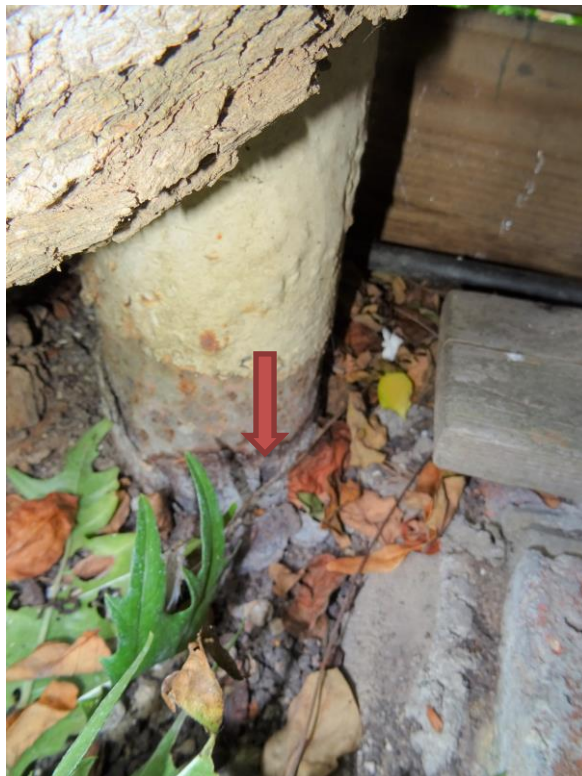
PHOTOGRAPH 24  
THE BOTTOM OF THE COLUMNS ARE CORRODING

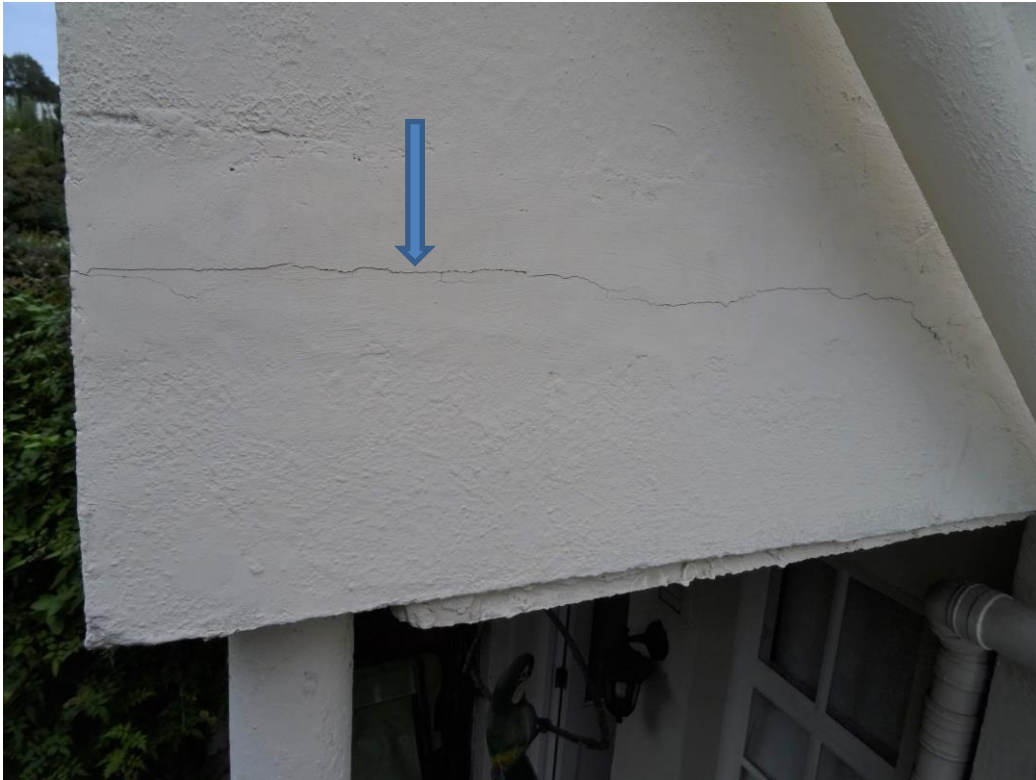
PHOTOGRAPH 25  
MINOR CRACKS FOLLOW THE OUTLINE OF THE STEEL FRAME

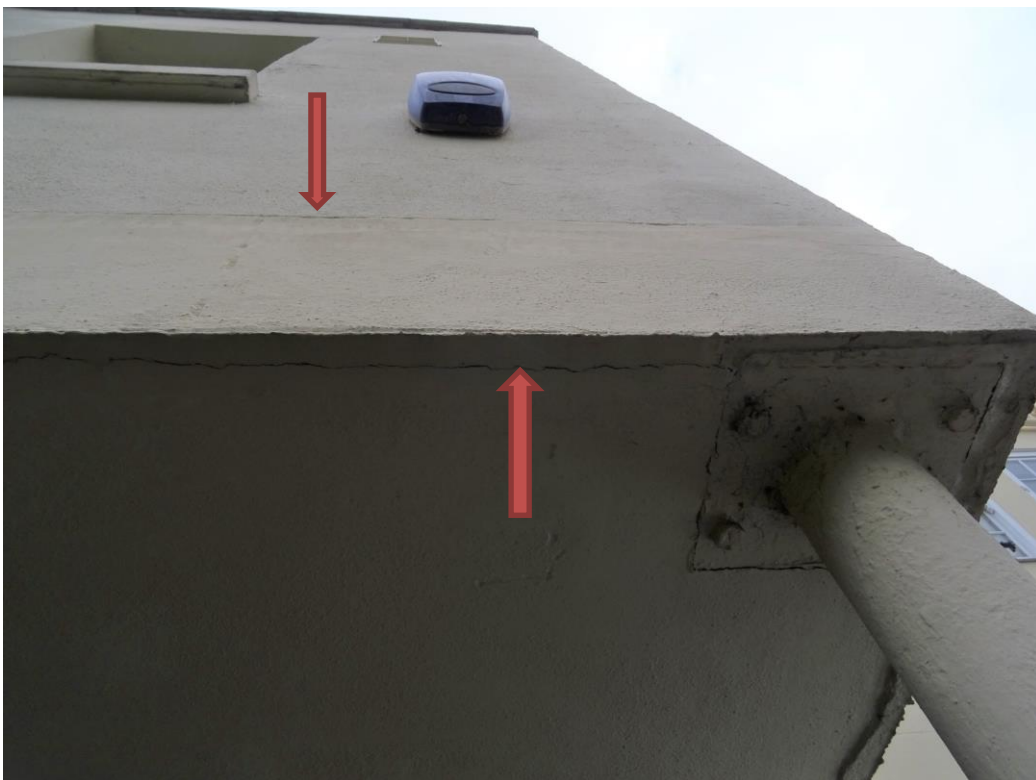
PHOTOGRAPH 26  
MINOR CRACKS FOLLOW THE OUTLINE OF THE STEEL FRAME

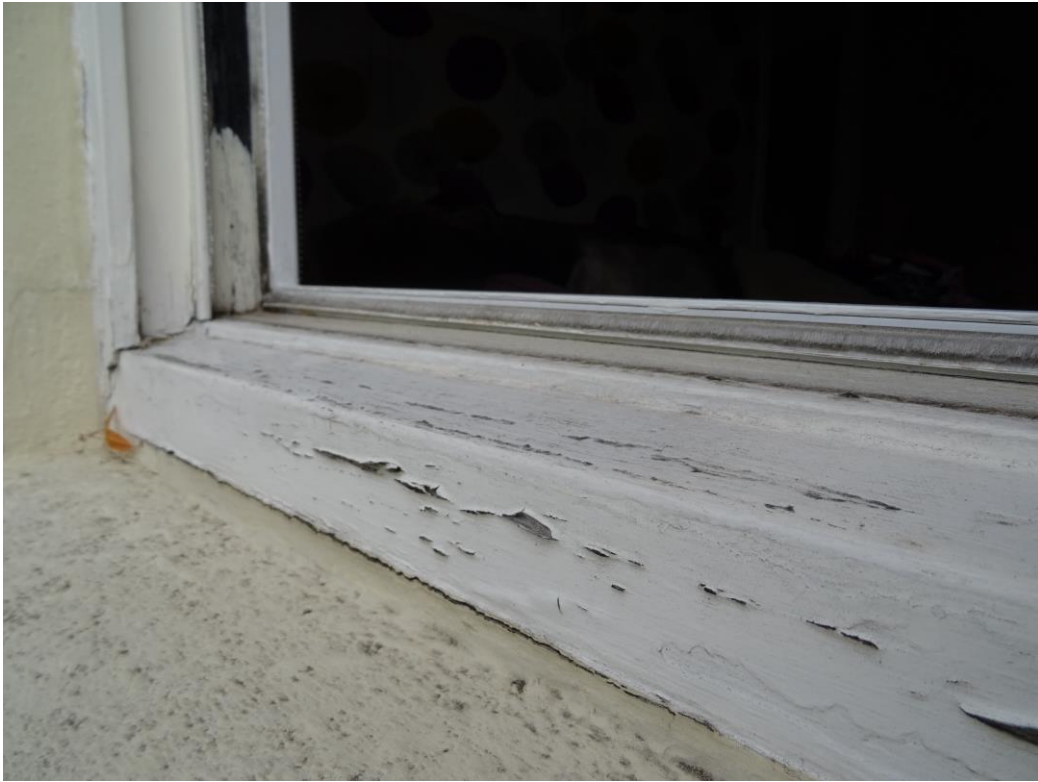
PHOTOGRAPH 27  
PEELING PAINT TO THIS WINDOW CILL

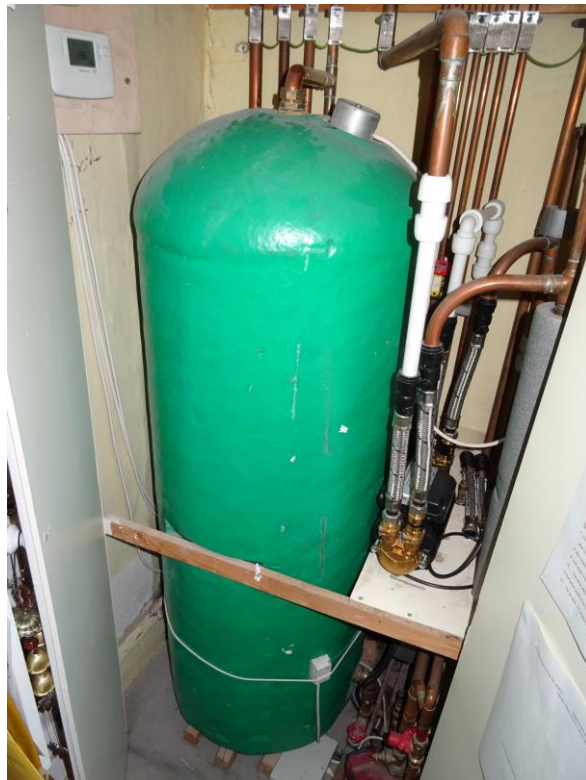
PHOTOGRAPH 28  
THE HOT WATER CYLINDER

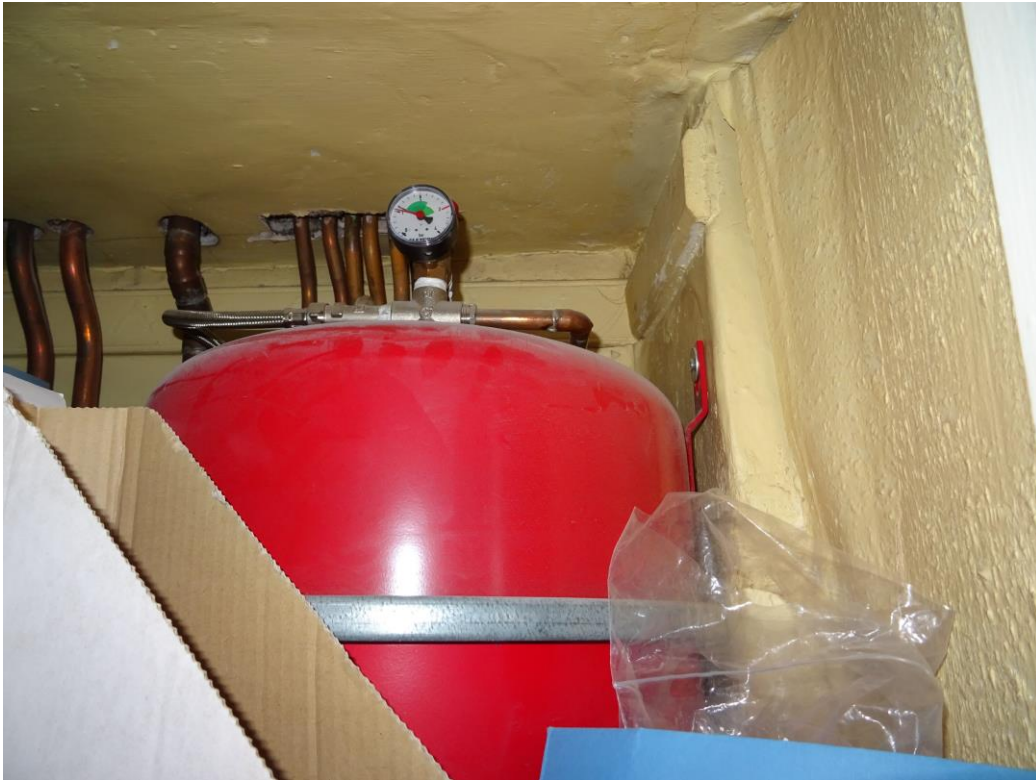
PHOTOGRAPH 29  
THE FEED/EXPANSION VESSEL

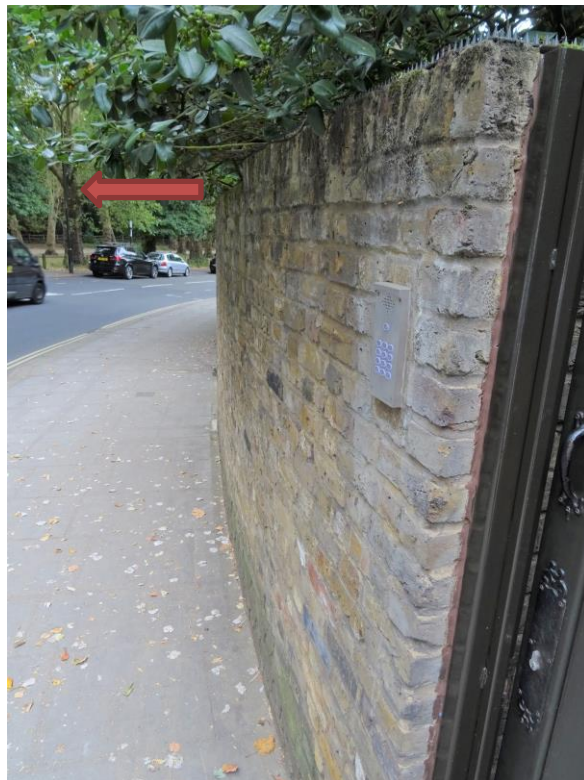
PHOTOGRAPH 30  
THE TOP OF THE FRONT BOUNDARY WALL LEANS OUT

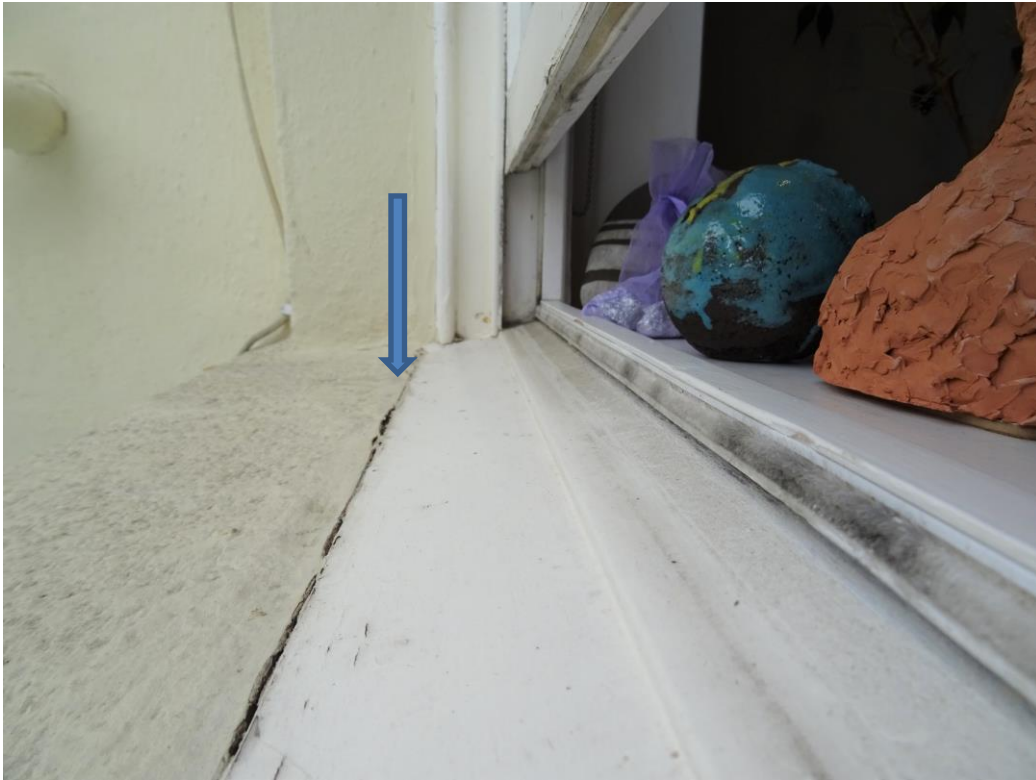
PHOTOGRAPH 31  
THE RECEPTION ROOM TIMBER WINDOW SUB-CILL IS FLUSH WITH THE  
STONE CILL
