Arboricultural Appraisal

66 Aberdare Gardens, NW6 3QD

Report Reference: 206019r_AA001_66ABRDNW6

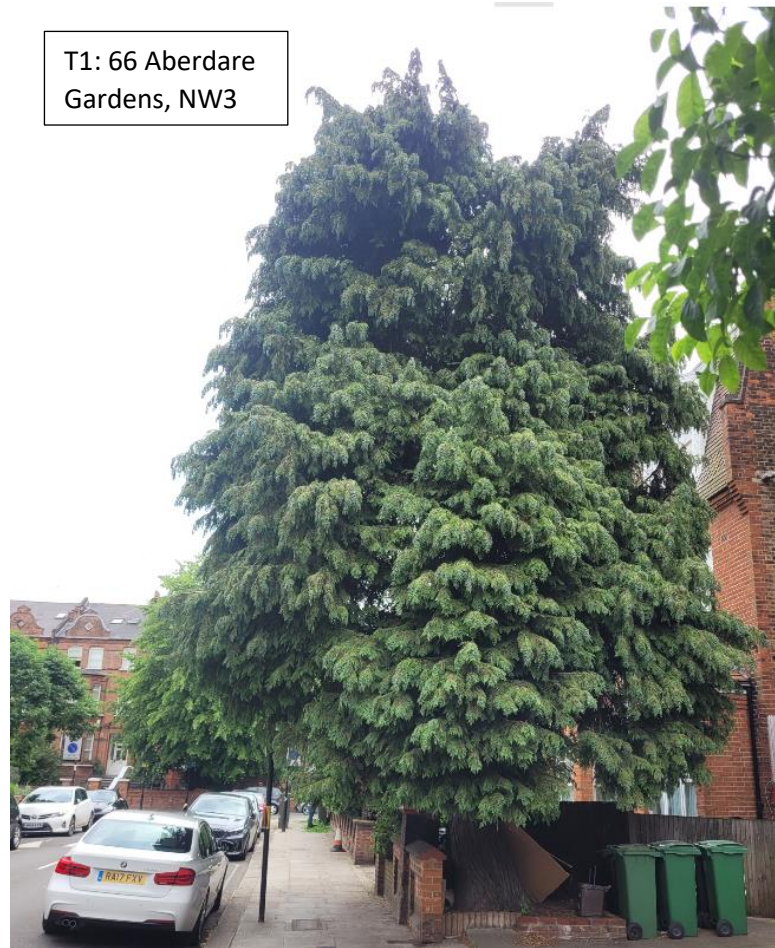
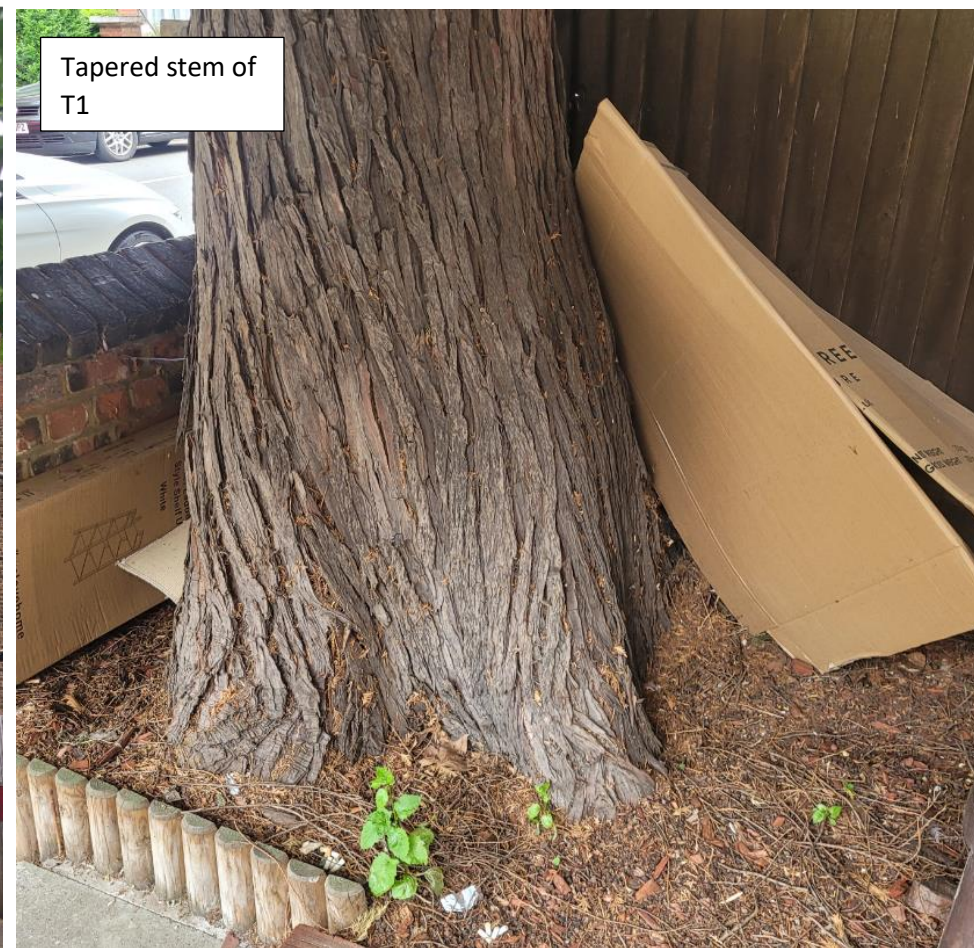
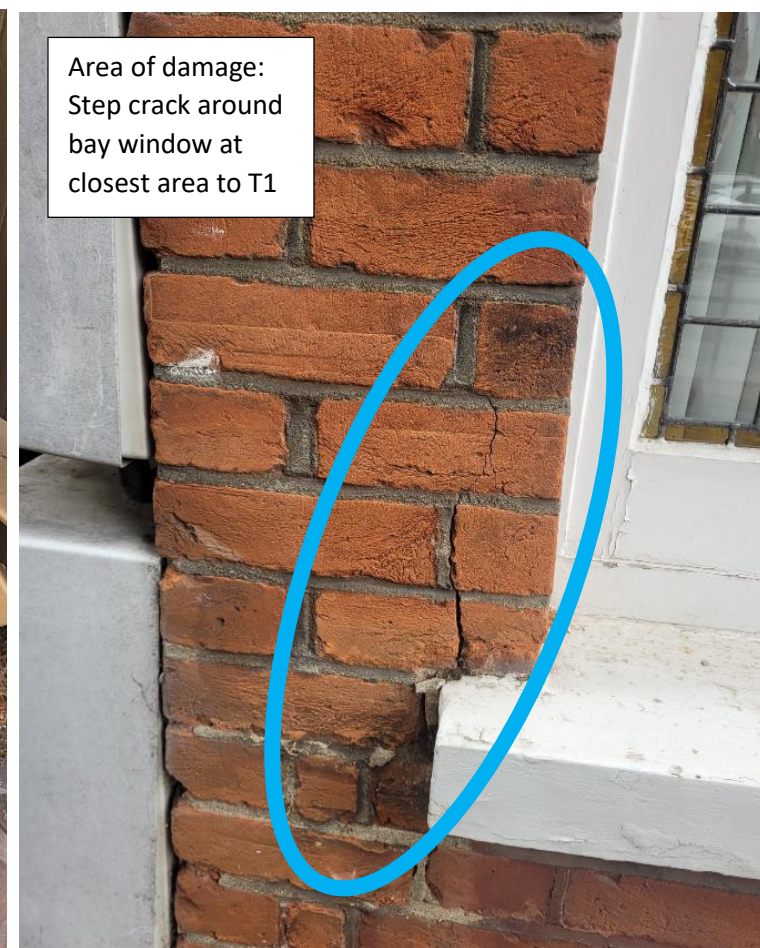
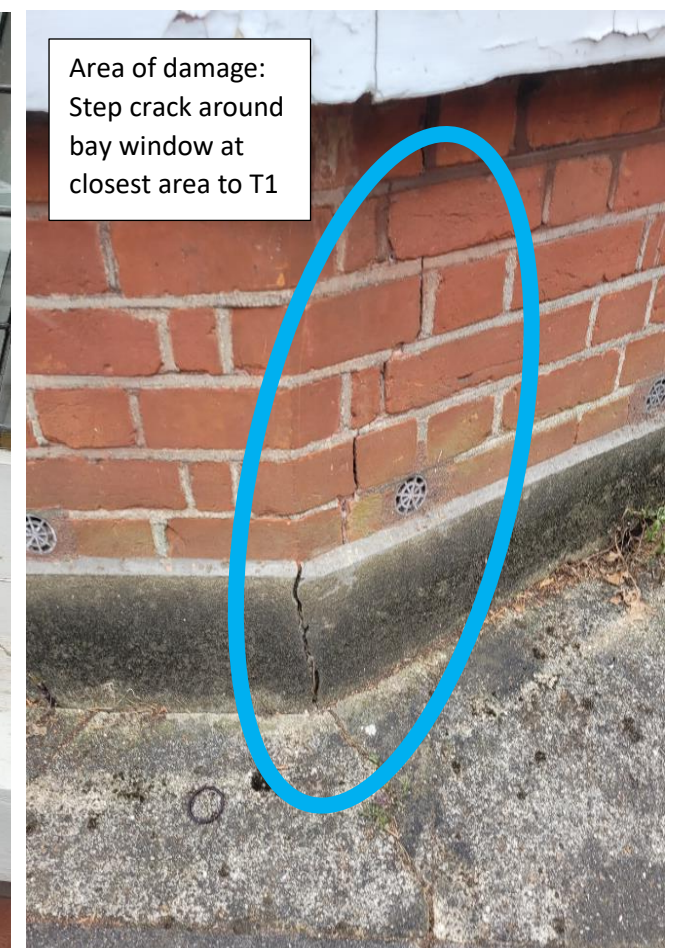
66 Aberdare Gardens, NW3														
Map REF	Species	Height (m)	DBH (est - mm)	Radial crown spread N/E/S/W (m)	Distance from property footprint / boundary (m)	Ownership	Age	Condition	Past management/comments	Observations	NHBC - Subsidence risk factor	NHBC - Area of influence	Wildlife	SULE (safe useful life expectancy, years)
T1	Leyland Cypress	14	690	4/4/4/4	4.5m	66 Aberdare Gdns	Mature	Good	Minor height reduction	Camber to driveway and cracking along the bay window	HIGH	25m	None	40-80 (with management)

TREE REFERENCE	WORKS SCHEDULE
T1	<ul style="list-style-type: none"> a) Remove and replace b) Reduce crown by 60% of volume. This translated into a 3.5m lateral and apical reduction. However, this species must be reduced back to points of regeneration, so arboricultural oversight may be required during the any operation.

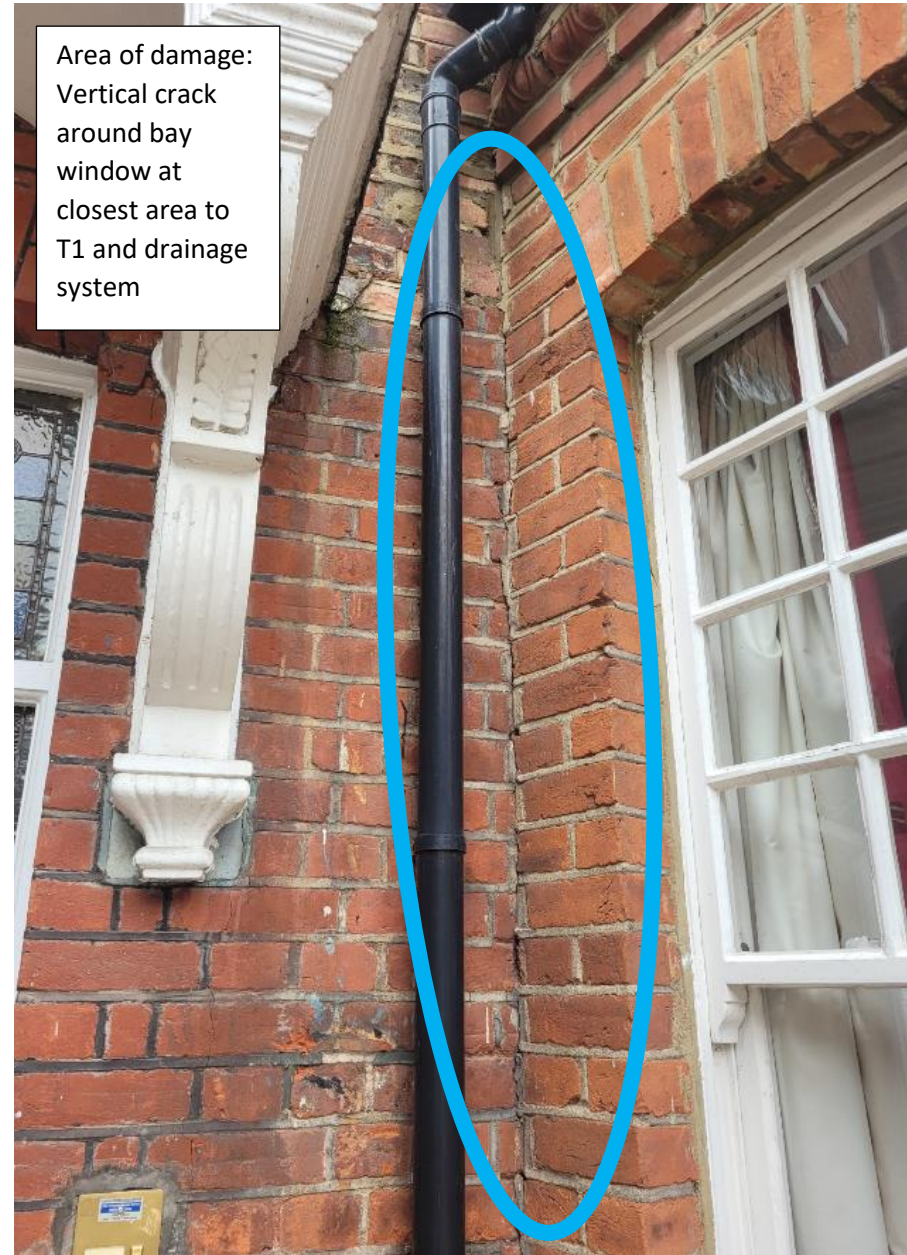
Area of damage:
Vertical crack
around bay
window at
closest area to
T1 and drainage
system

- 7.3 There is cracking to the bay window at the closest area to T1. The step cracking points towards the tree. Dr Martin Dobson suggests that there is a high association between tree related subsidence when step cracking points to a tree in the area of influence.

There is a potential link between the damages sustained at 66 Aberdare Gardens and the water extraction from T1. The camber to the front drive dips in the area where the damage to the bay window is persisting. Soil desiccation may have led to the damages because of water extraction from this area, as the camber is potentially linked with tree related subsidence.

Heavily reduce or remove and replace T1. If T1 was to be removed, any tree replacement in the same area should be from the low water demanding category as described in NHBC 4.2 page 4.

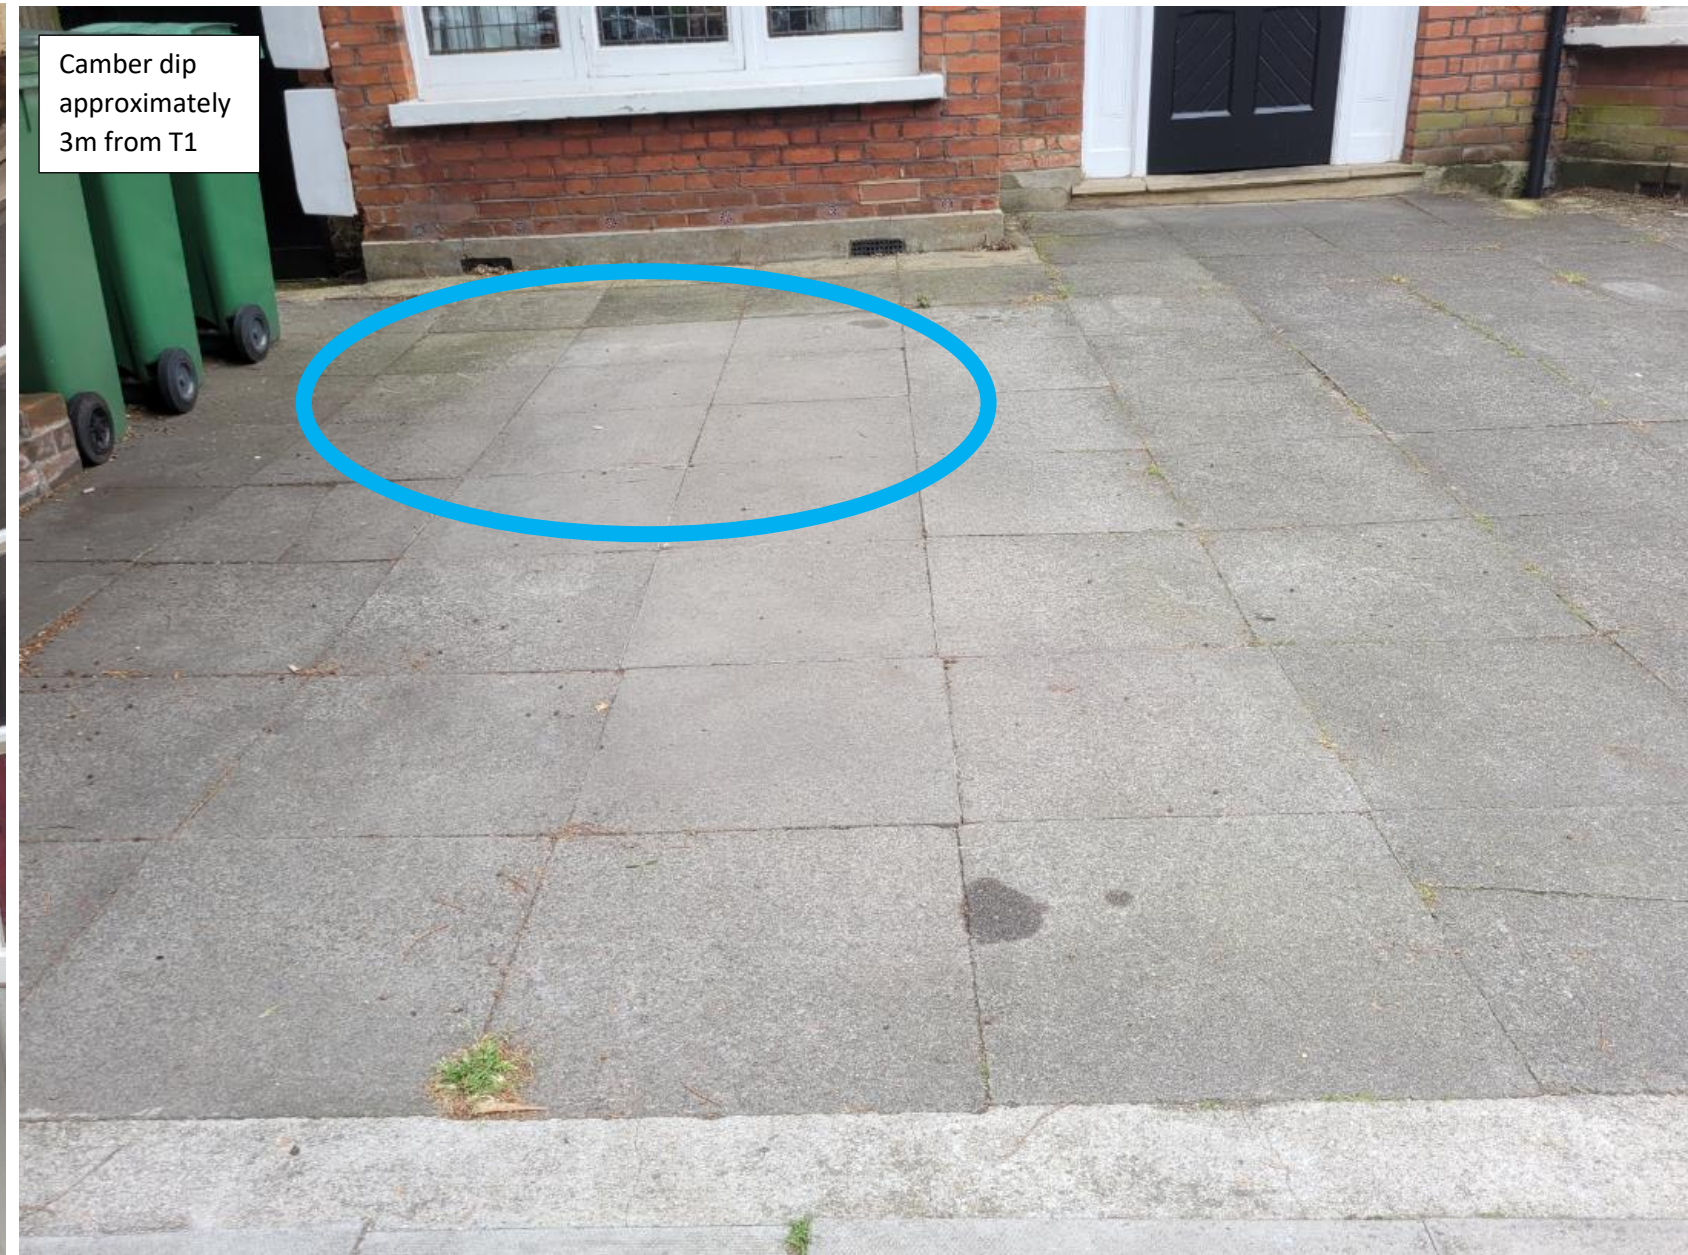
Camber dip
approximately
3m from T1

- 7.1 T1 is within the NHBC 4.2 area of influence of multiple properties.
- 7.2 There is a camber dip to the driveway between T1 and the damaged area of the bay window.

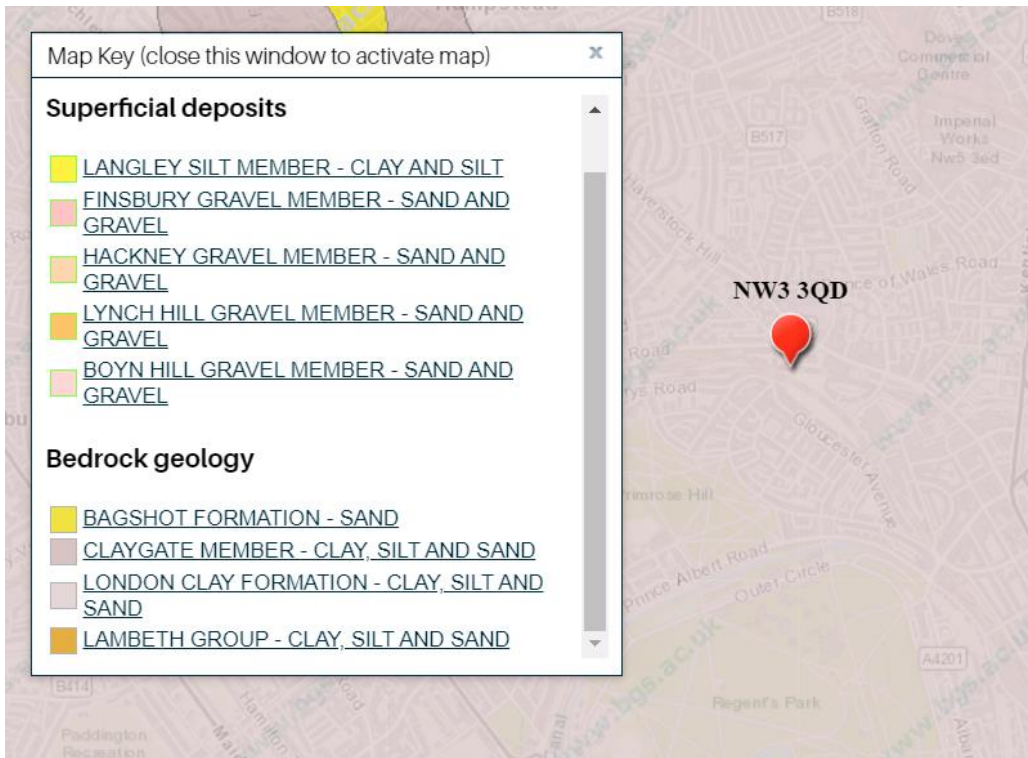
APPENDIX C: Bedrock geology

- 7.4 This site is situated on a clay bedrock.
- 7.5 The industry recognised management for property damages that have a *potential* association with tree related vegetative water extraction, is to reduce crown volume.
